COVENTRY ICE JAM FLOOD STUDY OF THE BLACK RIVER COVENTRY, VERMONT

**Prepared for:
Town of Coventry, VT**

**DuBois
& King^{INC.}**

October 10, 2025

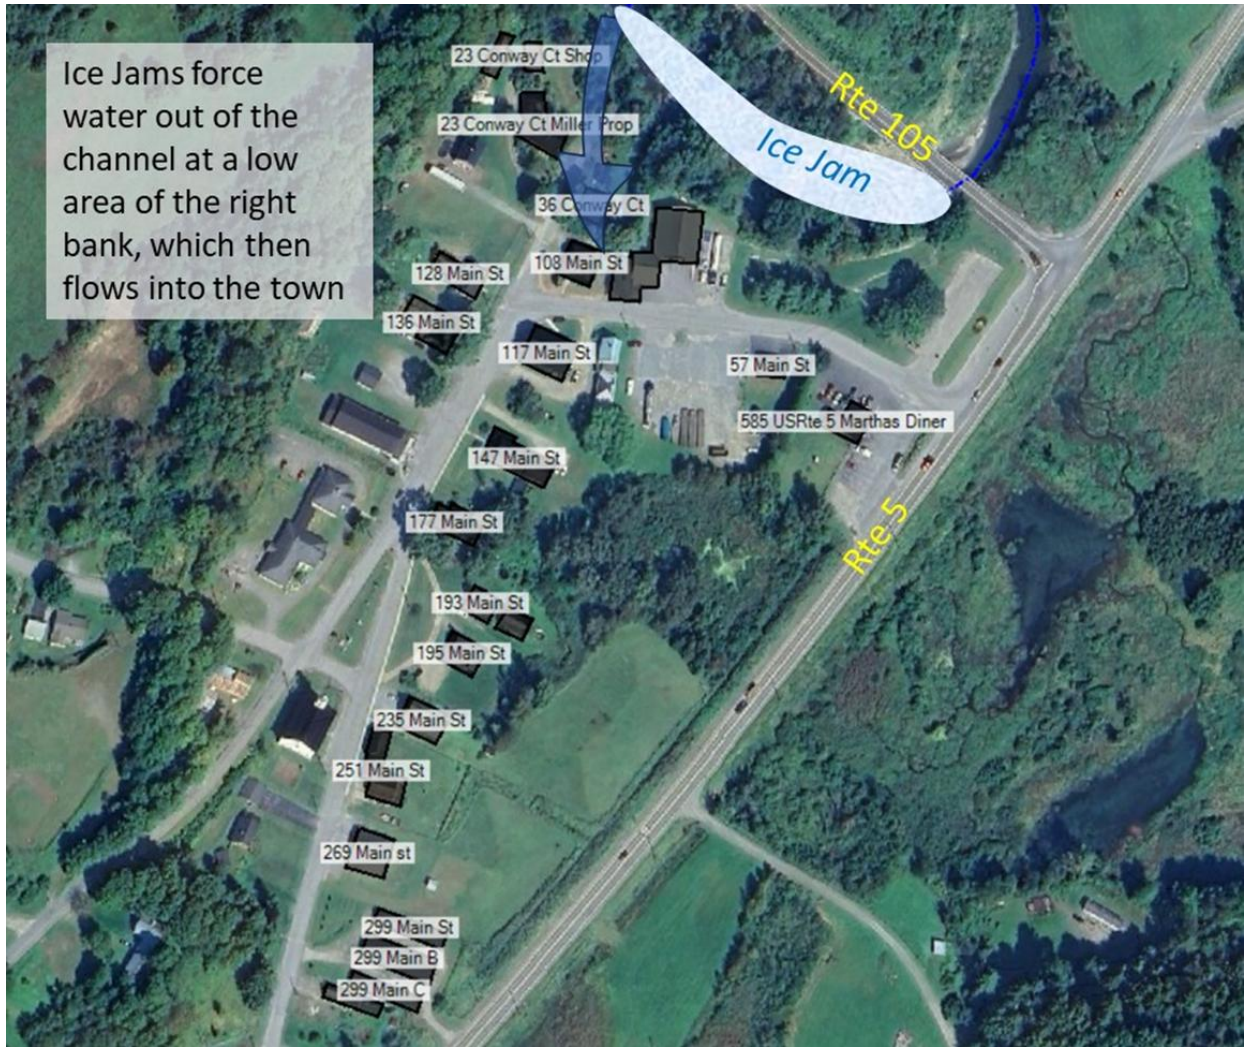
Figure 5. General Path of Flooding from Ice Jam in Coventry, VT

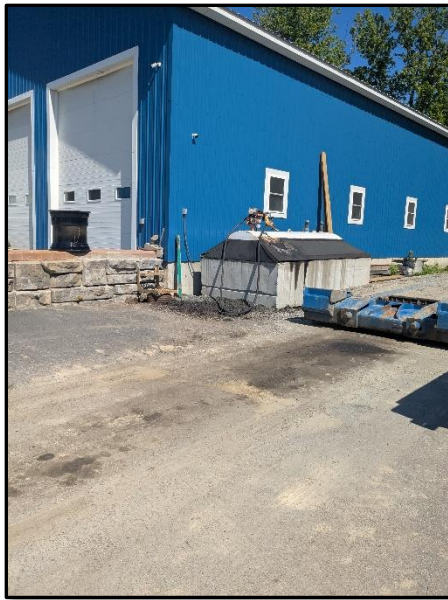
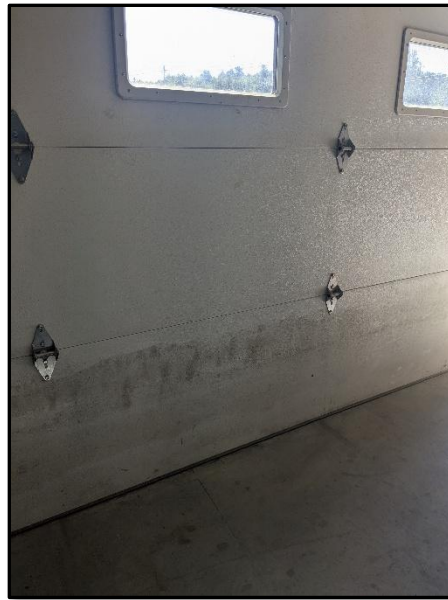
Photo 9a and 9b. The recently raised garage at 88 Main St (left). Sediment line inside the garage door (right). This is a remnant from the July 2023 open-water flood event.

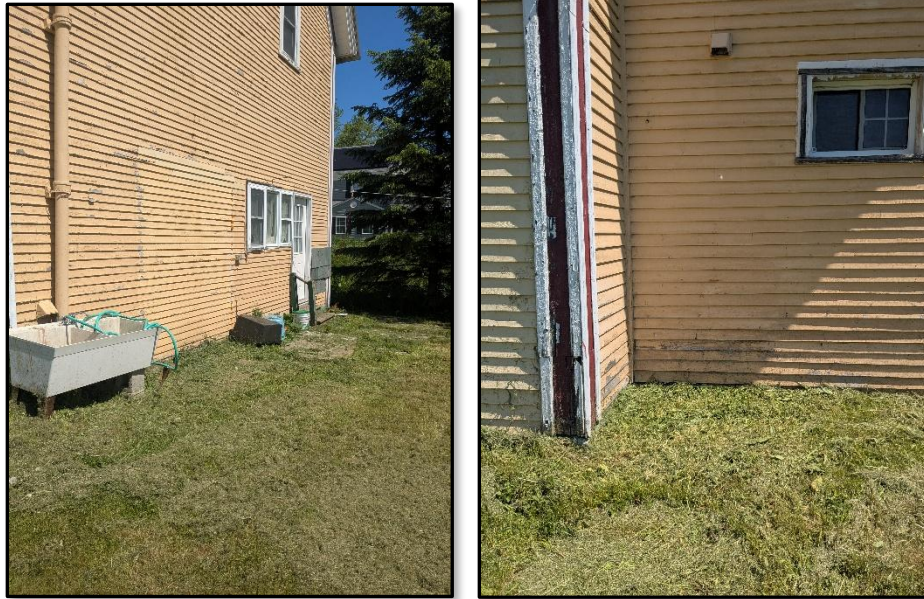
Photo 11a and 11b. The entrance to the lower apartment at 235 Main Street (left). Sediment and damage to siding from the July 2023 flood were observed on the south side of 235 Main Street (right).

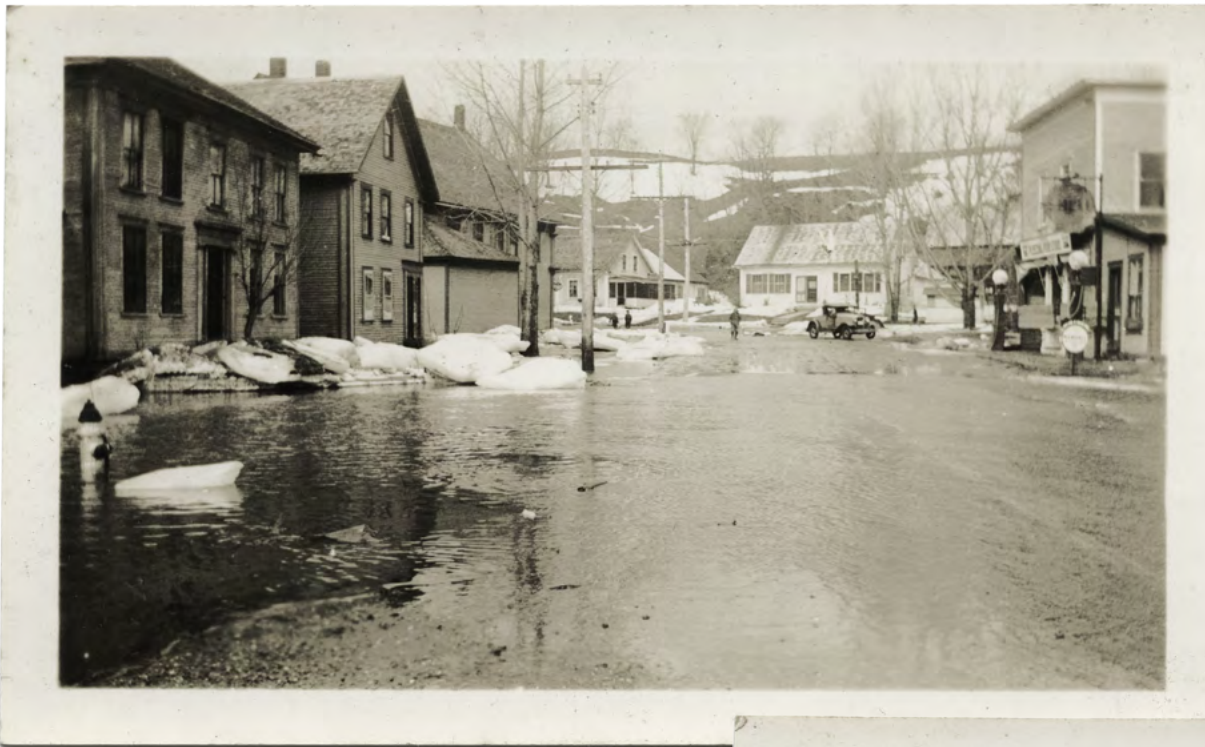
Ice chunks along main street and Newport street.
Water has subsided some in this photo for rowboat
is no longer next to garage on right of photo.

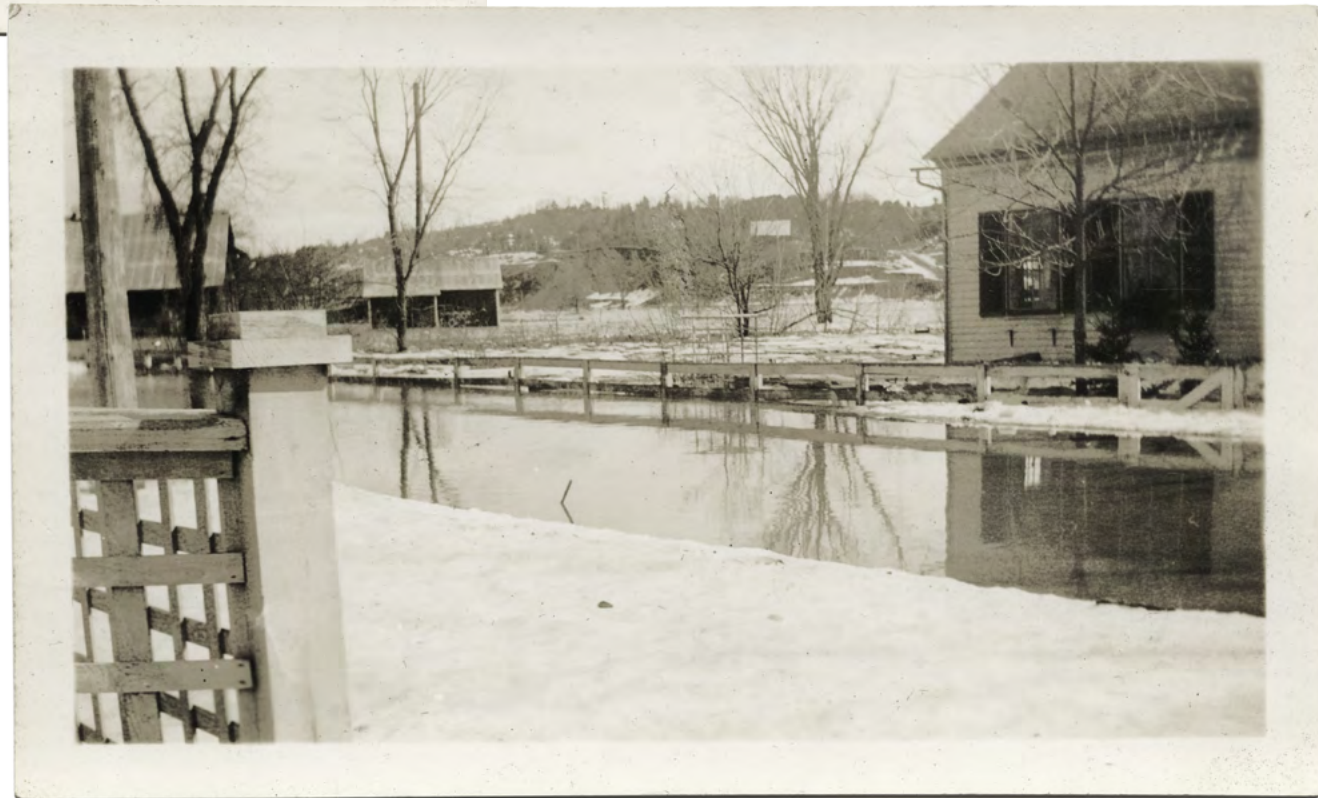
Spring flooding with ice jams on main streets
March 19th 1936 - the Black river is beyond far
fence - river level is same or above that of the street
in these images. Street in foreground with water is
old Rte 14. In far background is Rte 5. Both roads
intersected in the center of the village until 1960.

In terms of ice jam and related flood water height,
ice would have had to be 10 + feet or so in depth to
push water over river banks in village

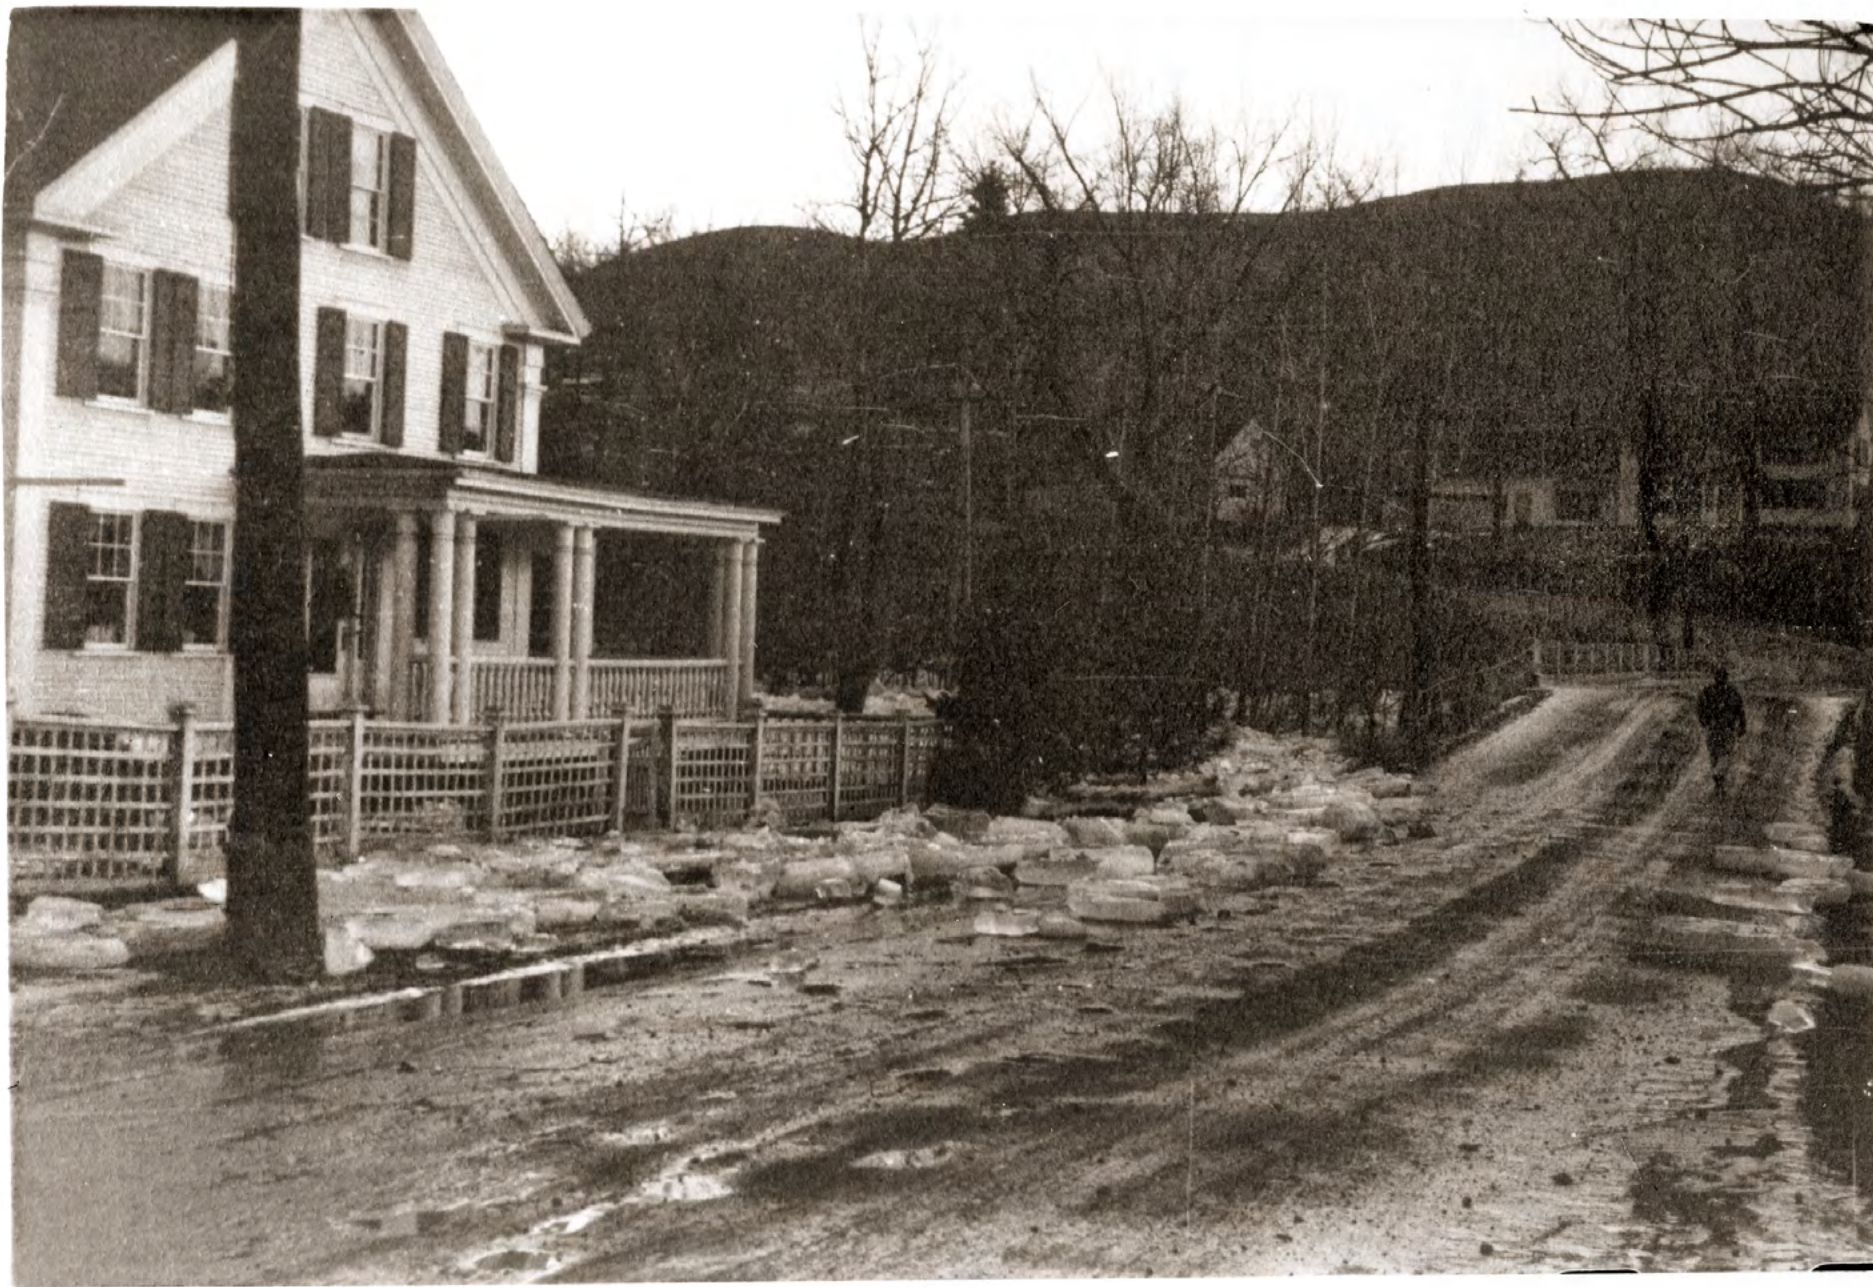
Ice Jam approx. Spring 1950 Miller/Cowle house and Rte 14 bridge

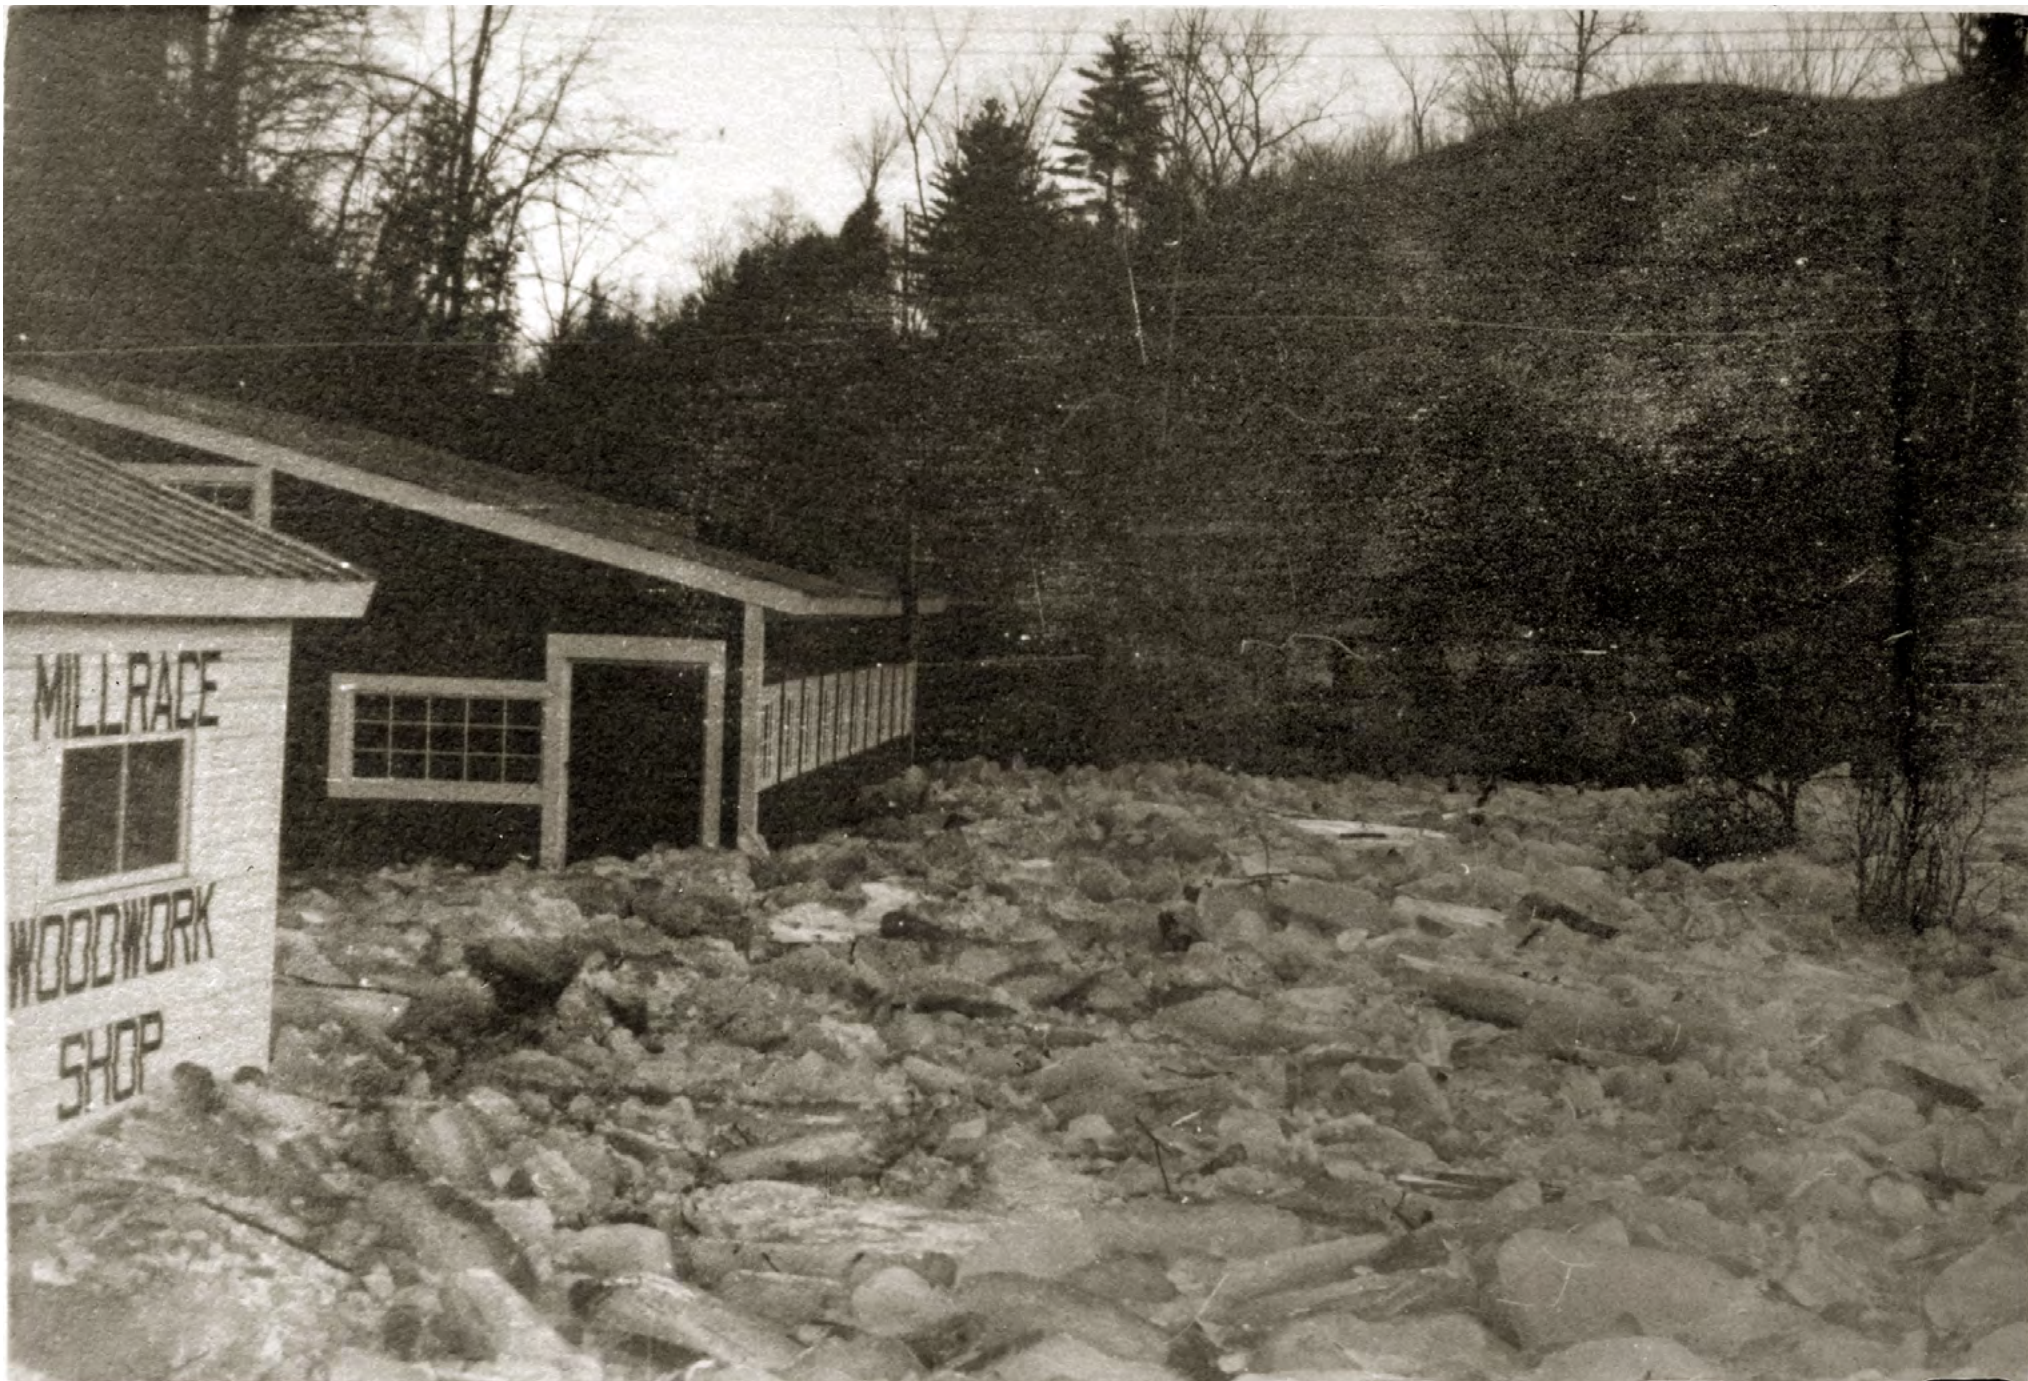
Ice Jam approx. 1950 Miller/Cowle property

Note how clean the ice is. Ice jams did not bring in as much silt/mud before the planting of corn in much of the Black river bottom land upstream from Coventry village. Ice flow in this photo is on the lawn, river channel is beyond and to right

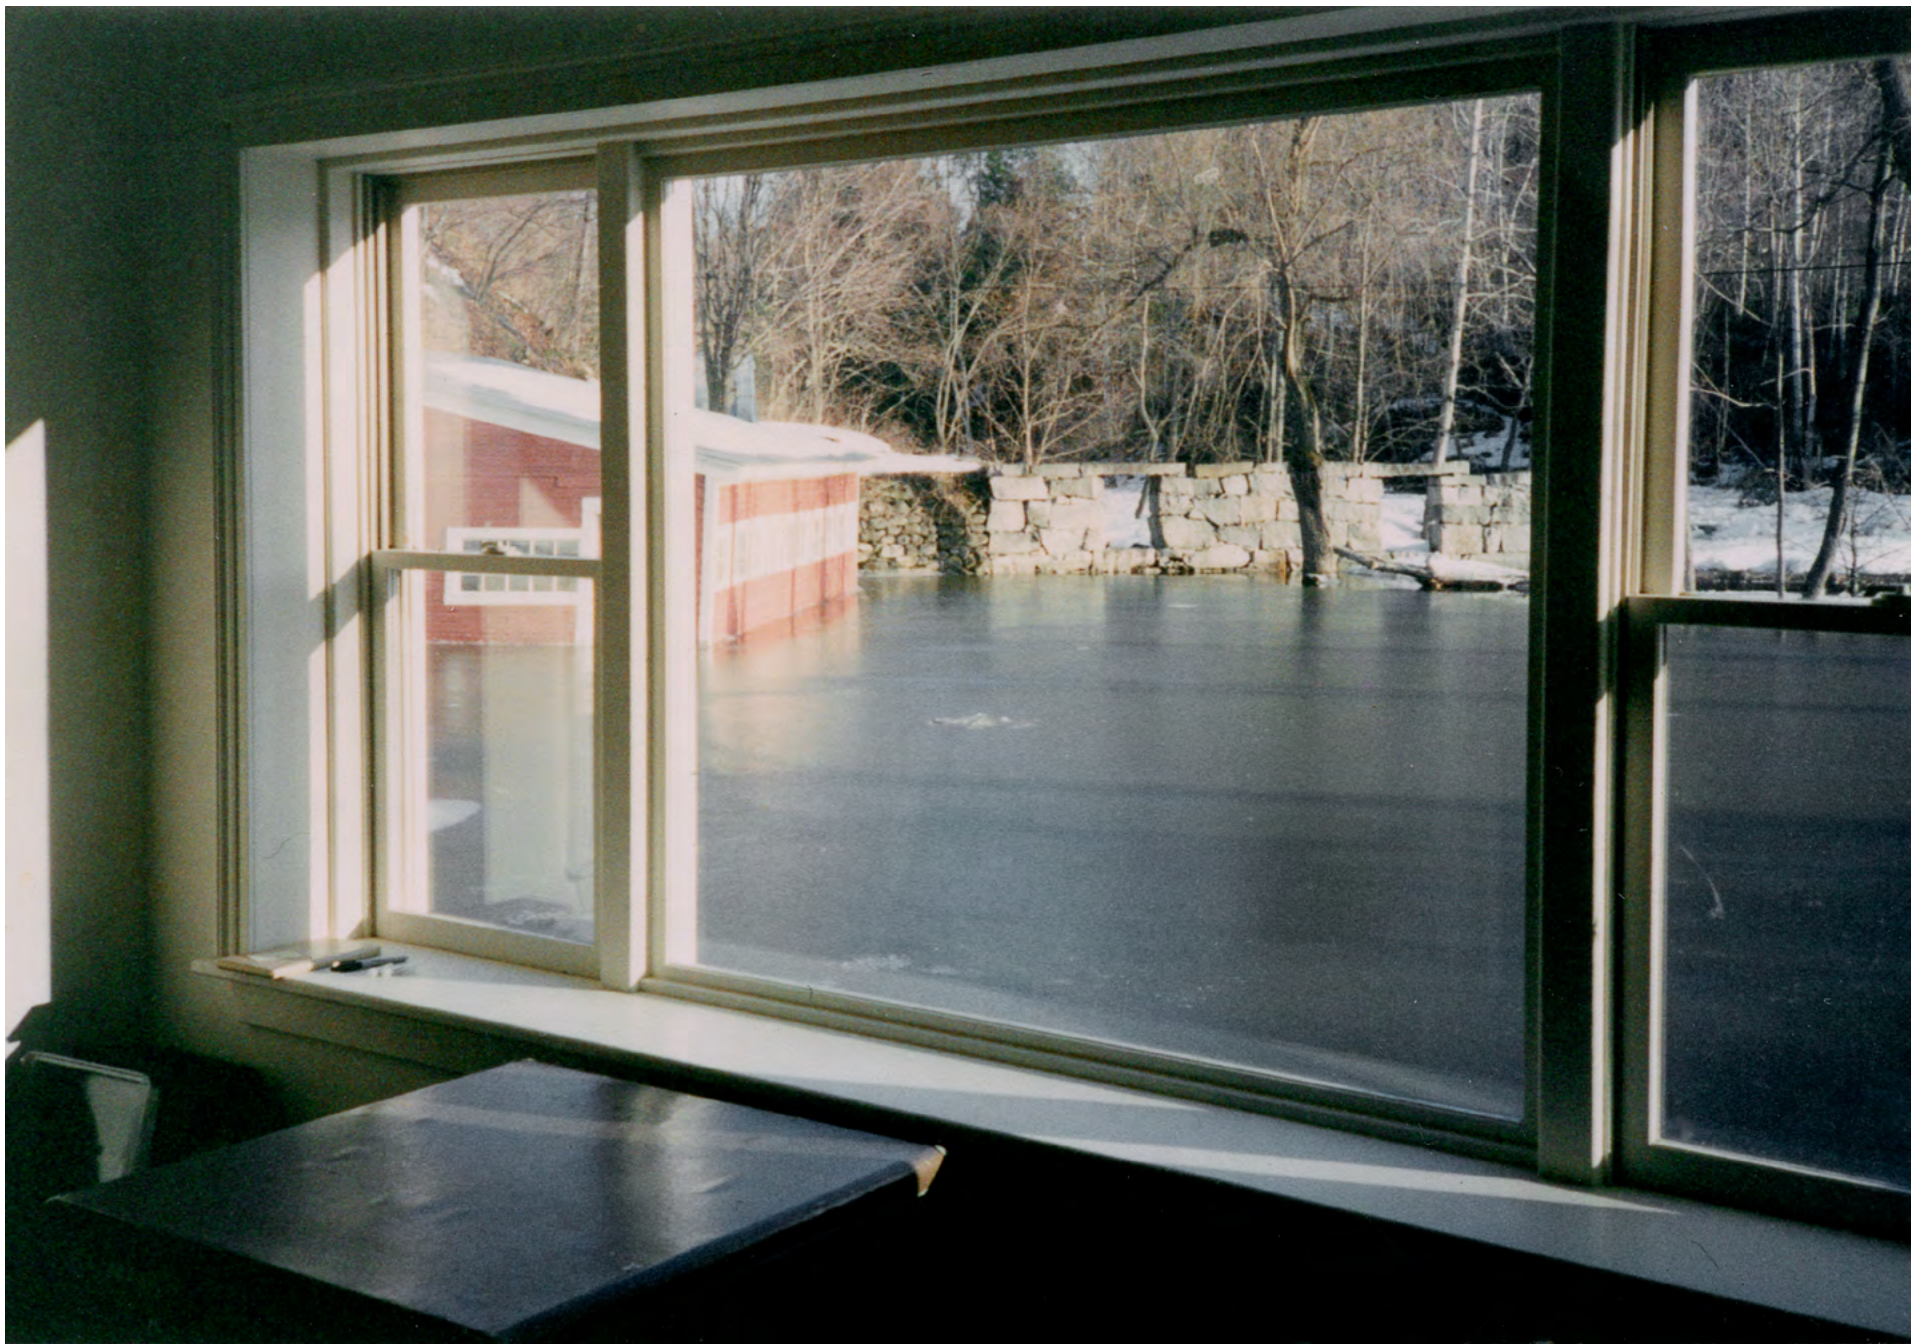
Ice Jam Feb 1993 - Coventry village experienced severe flooding --- This photo taken in late March/early April soon after a second ice jam caused by warm weather and rain came downstream to the village and ran into the first ice jam; thus causing the Black river to rise very quickly (10 or so feet within a couple of minutes) . (note same shed in previous photo) **Ice wall depth in river channel varied at least 10-12 feet in places**

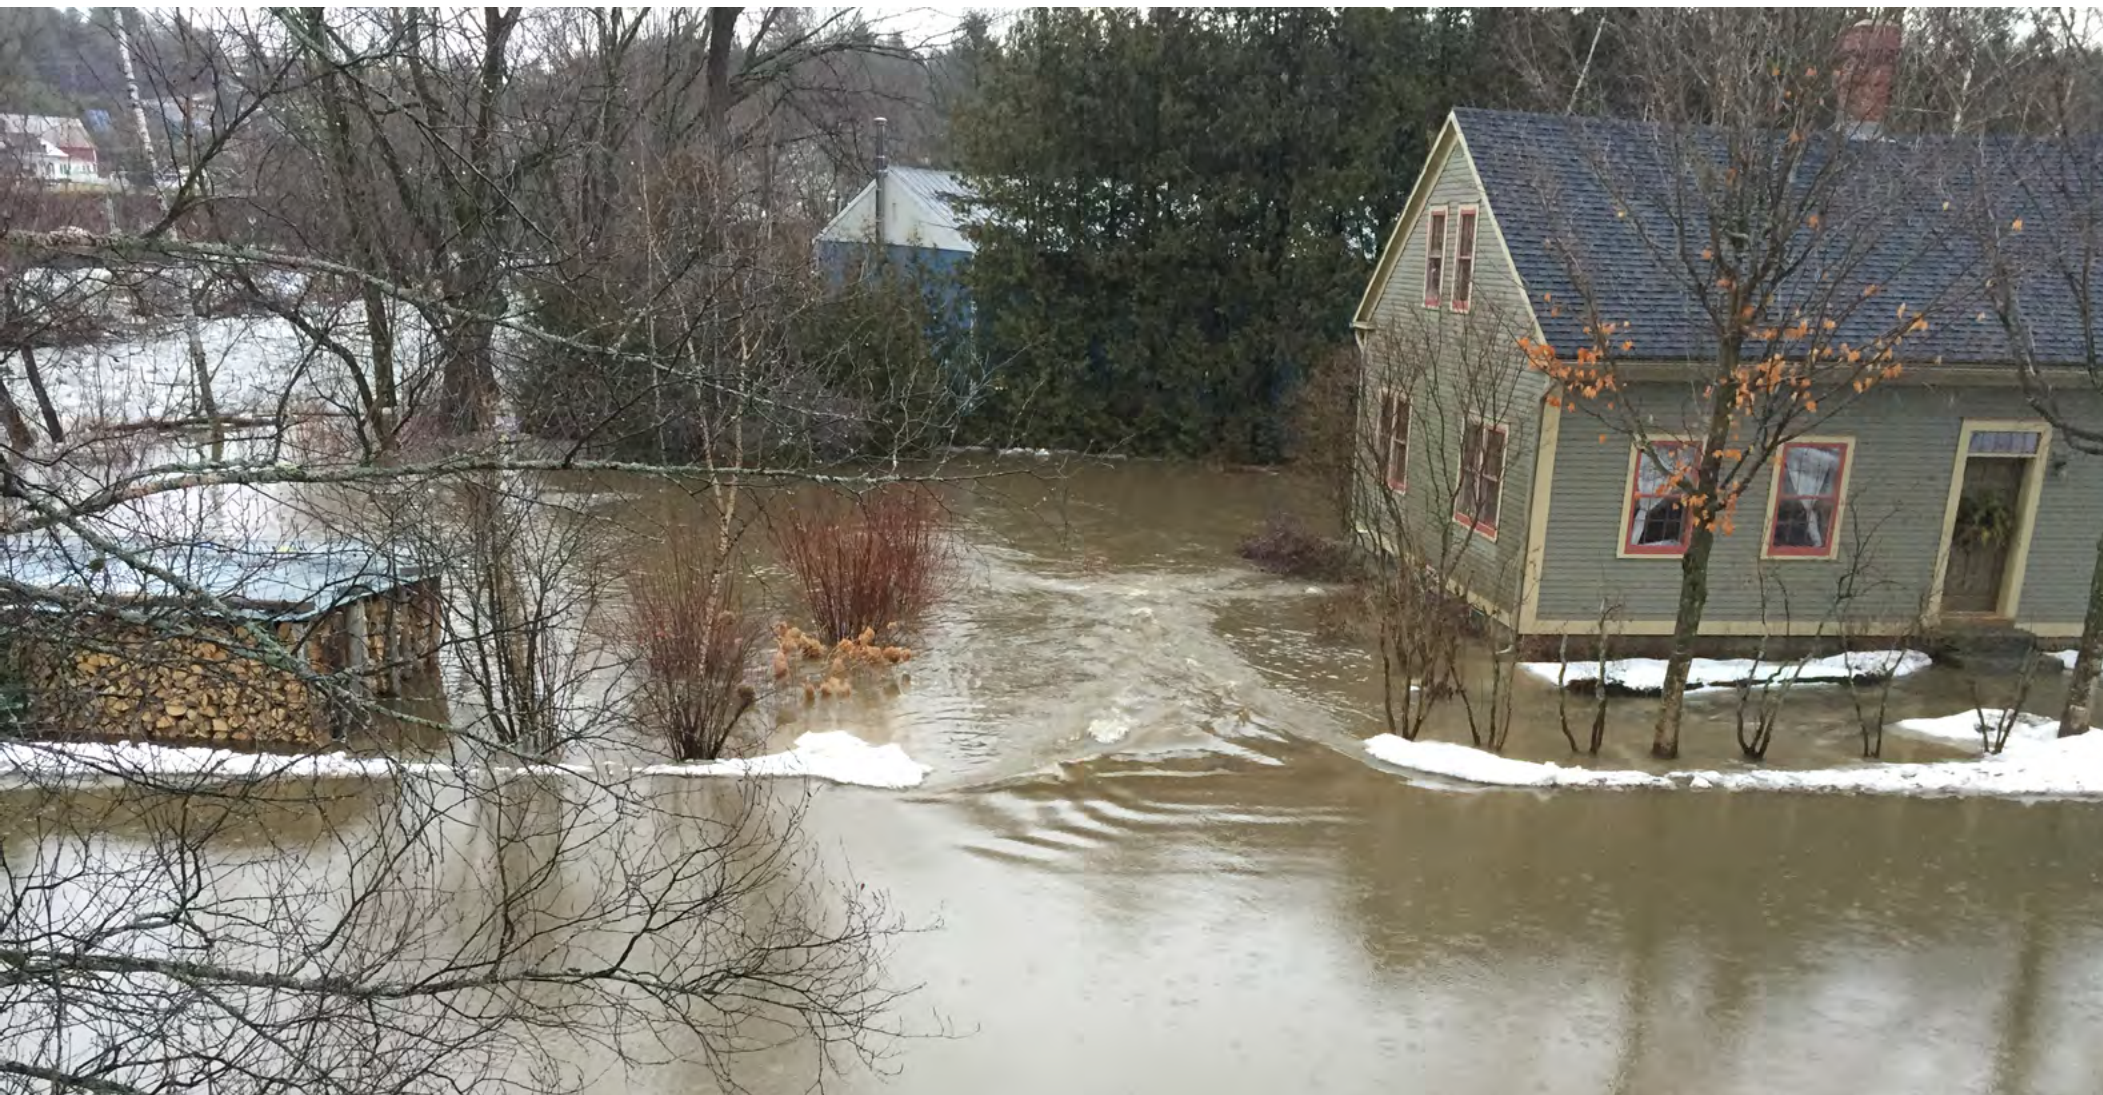
Ice jam and subsequent flooding, Coventry village, Feb 2016 - many basements in village near river filled with water - furnaces, ductwork and oil tanks inundated. Blue garage building to left of house had river flowing through it, approx, 4 feet deep
River in this photo approximately 1.5 feet deep running across street and into lawn next.

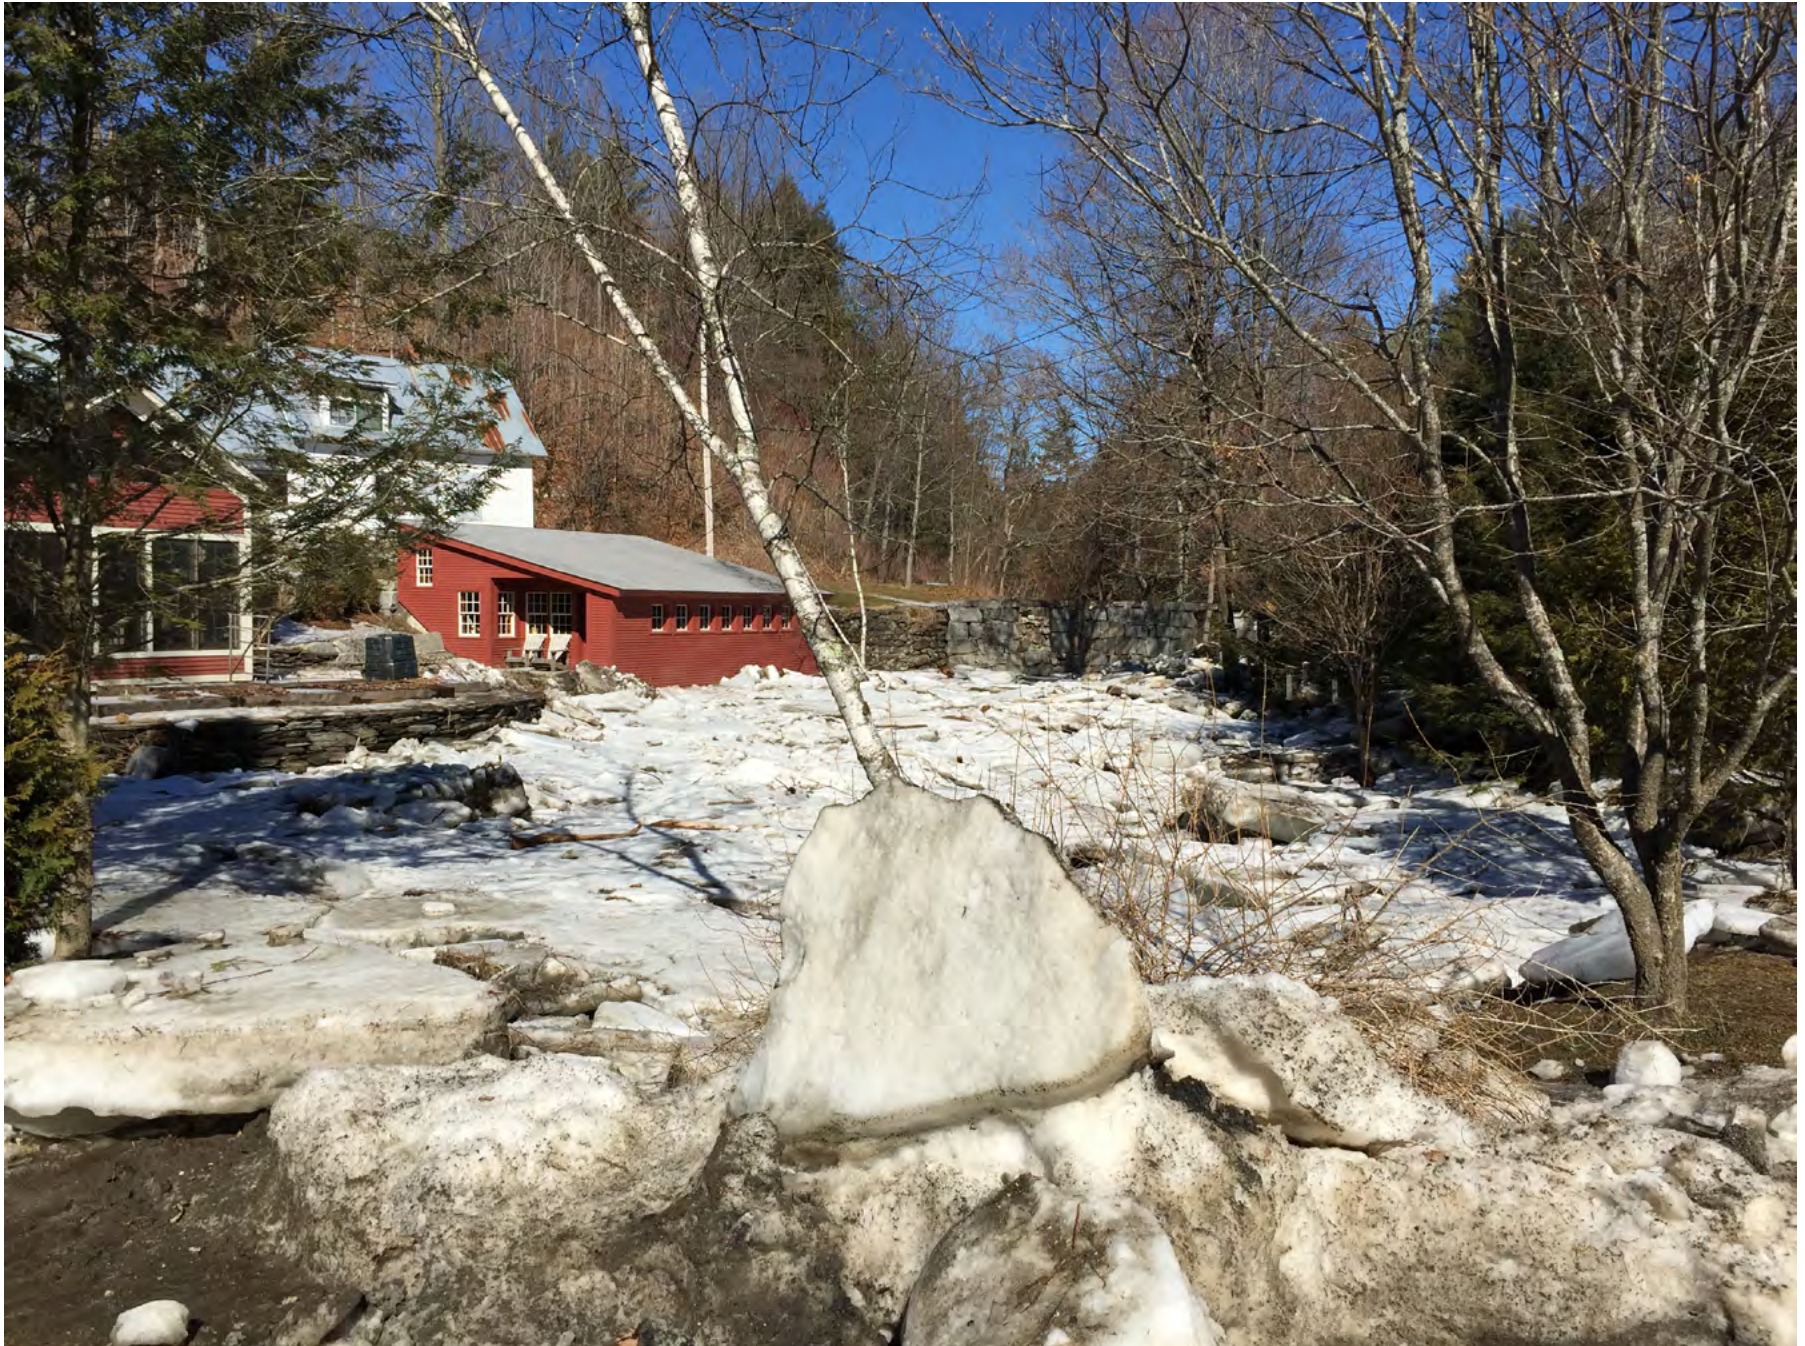
Feb 2016 ice jam and flood aftermath in late March -early April

Note much more silt and debris in 2016 vs 1950s

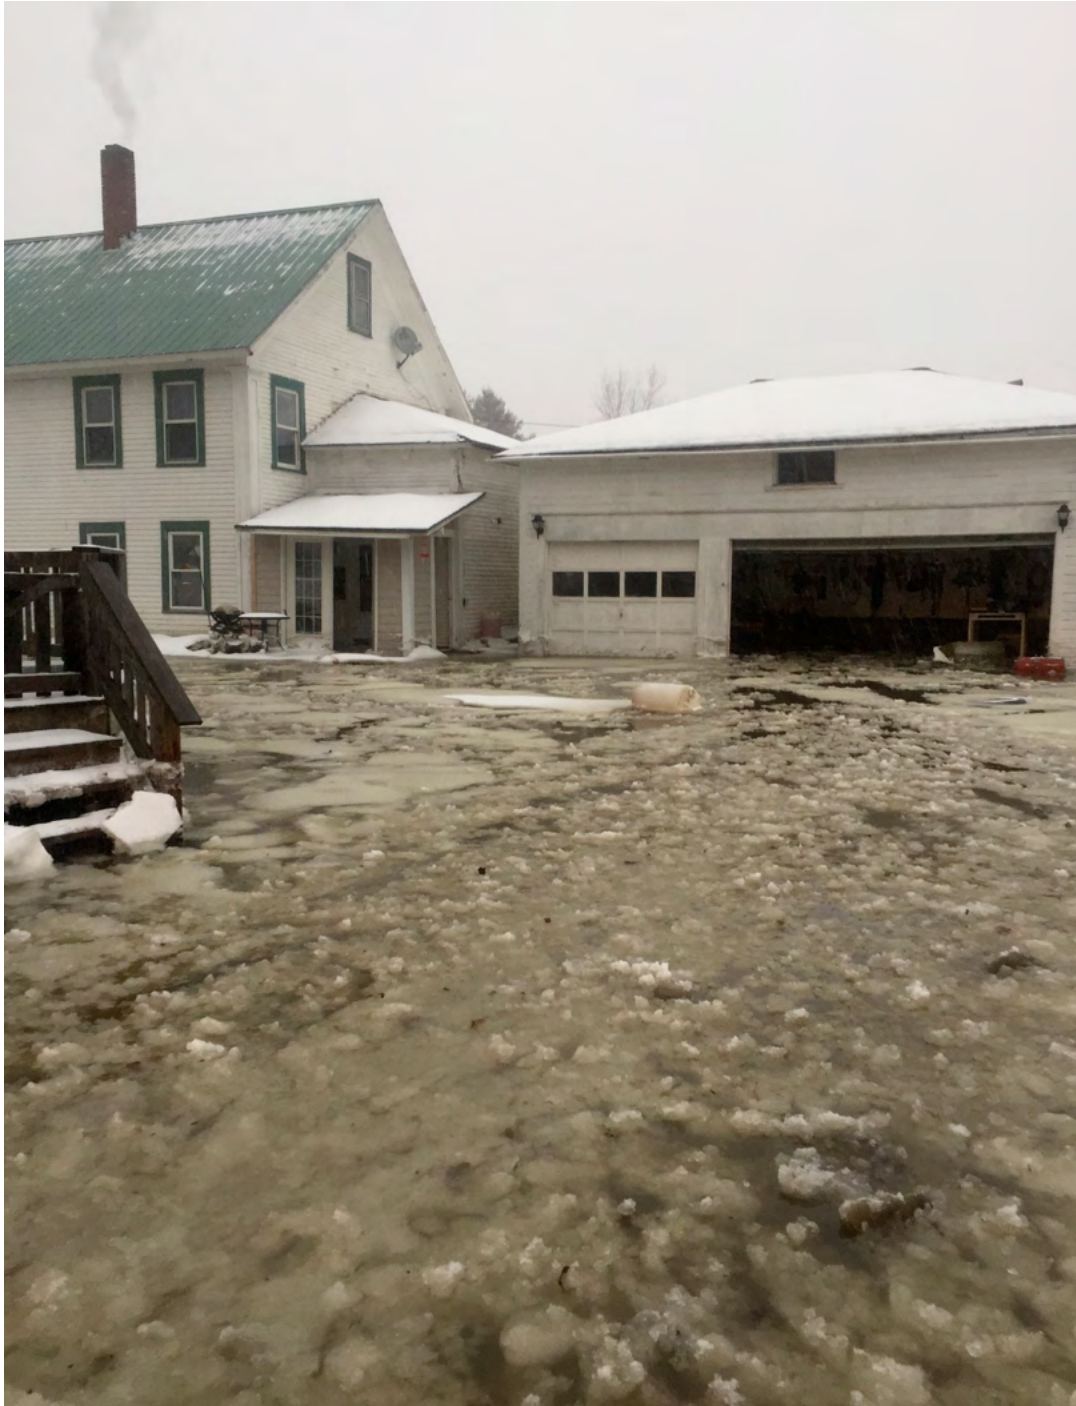
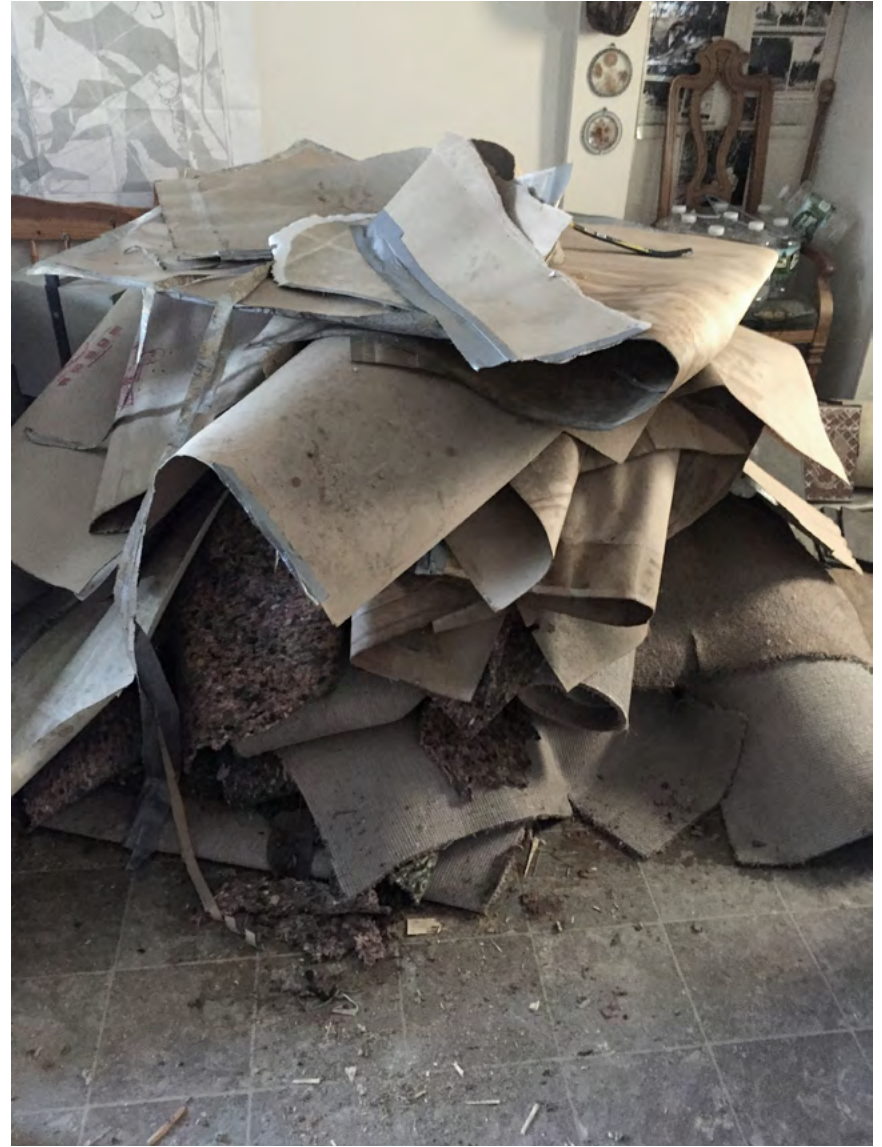
- Carpeting, insulation, drywall, furnace, furniture damaged or destroyed

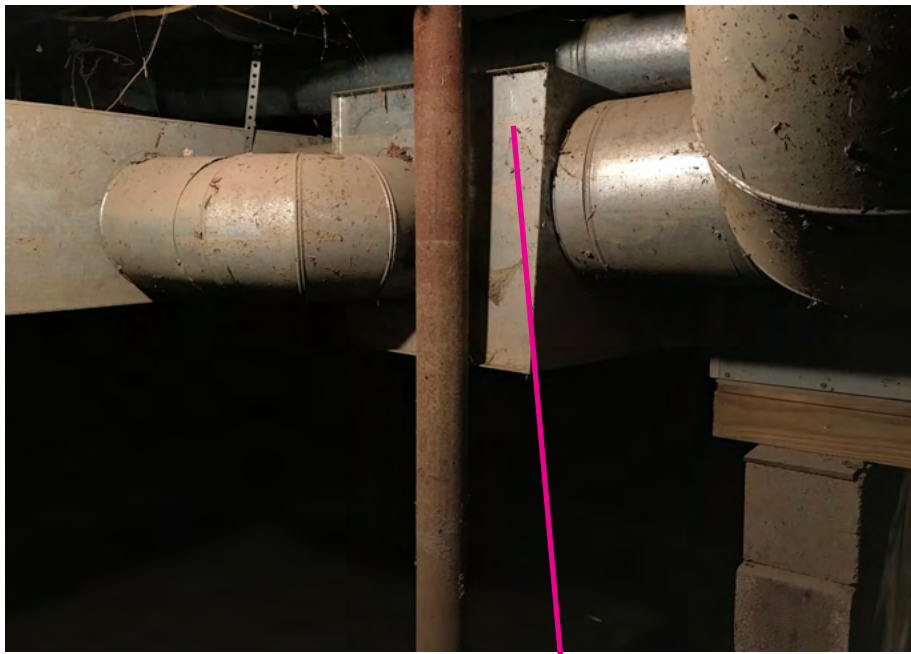
basement flood water level mark on furnace duct work

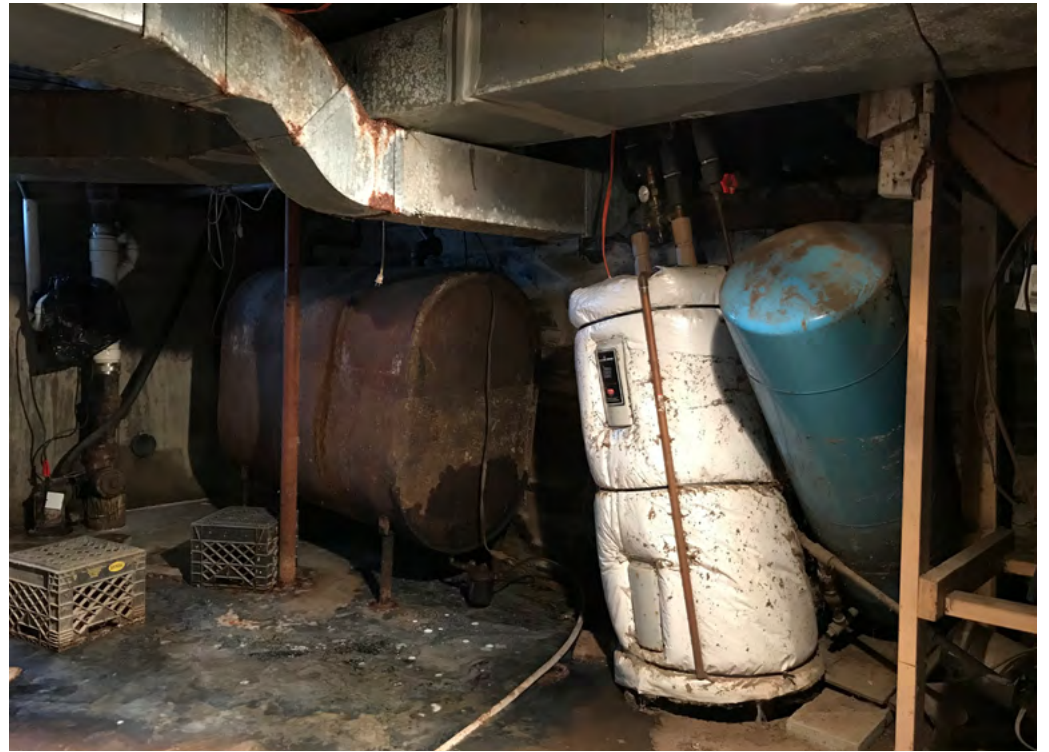
furnace, water heater, pressure tank destroyed, oil tank must be replaced

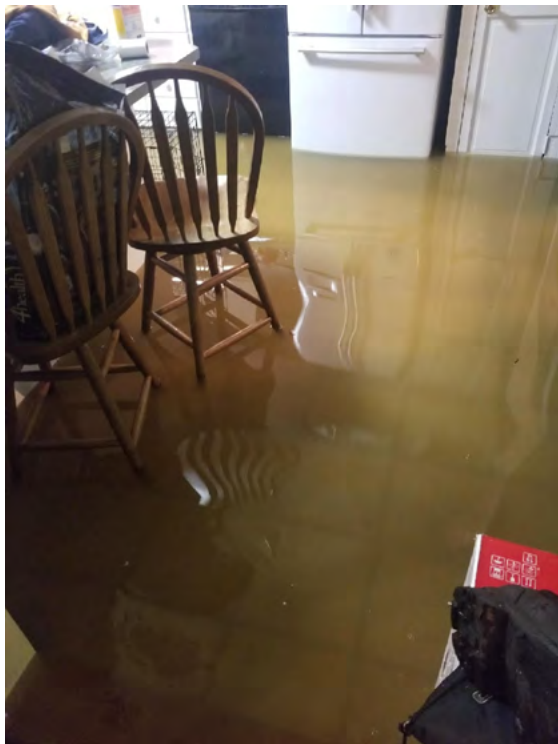
Hardwood kitchen floor, dry wall, insulation, furniture, personal items destroyed

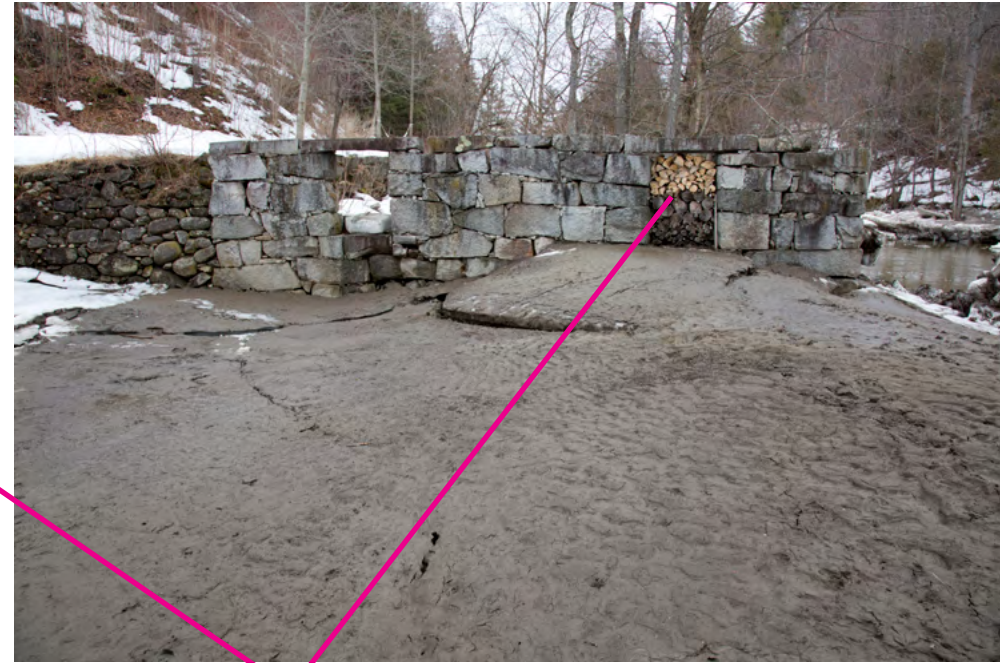
April 2018 Silting on lawn (3-4 inches deep in places) and also grist mill foundation with **flood level mark** - extensive silt in water up to this depth

This grist mill granite wall served to hold back river ice (many chunks 10x10x2 feet thick) from directly impacting house and sheds
