COVENTRY ICE JAM FLOOD STUDY OF THE BLACK RIVER COVENTRY, VERMONT

**Prepared for:
Town of Coventry, VT**

**DuBois
& King^{INC.}**

October 10, 2025

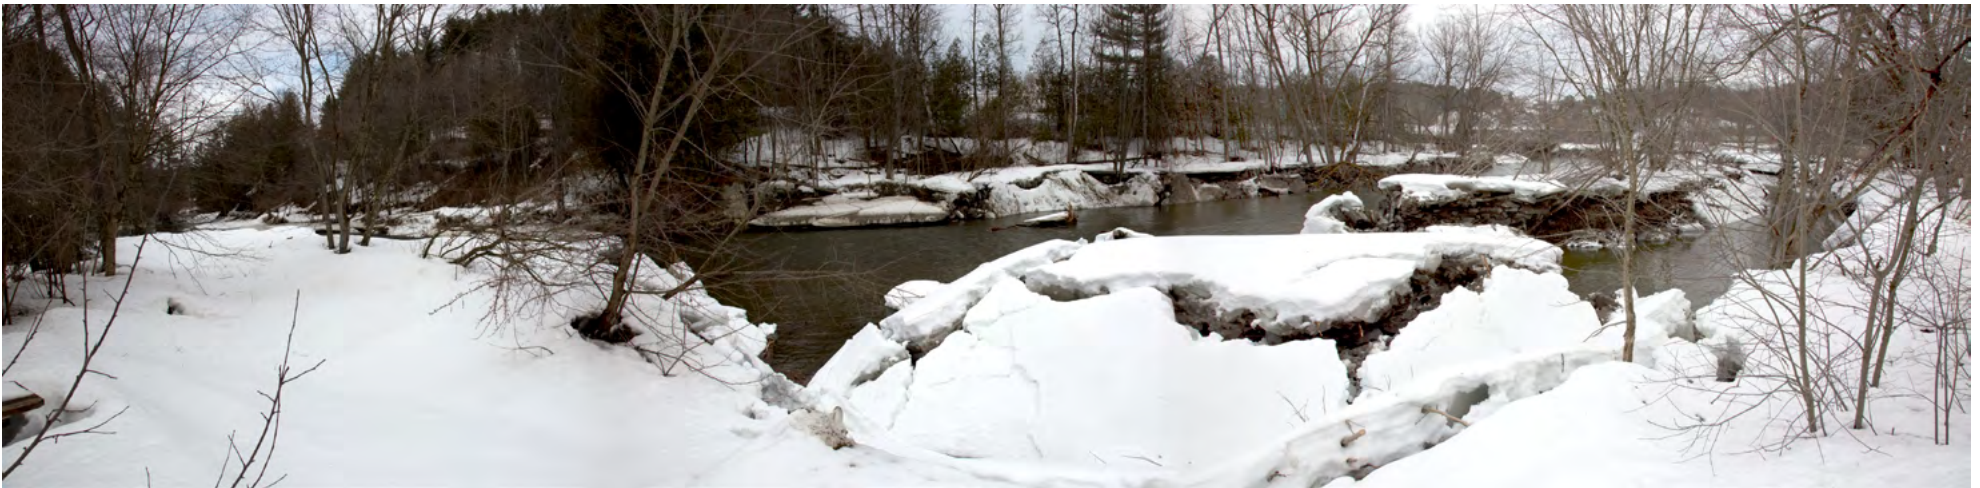
Black River, late-March 2019. River channel opening with more thawing.

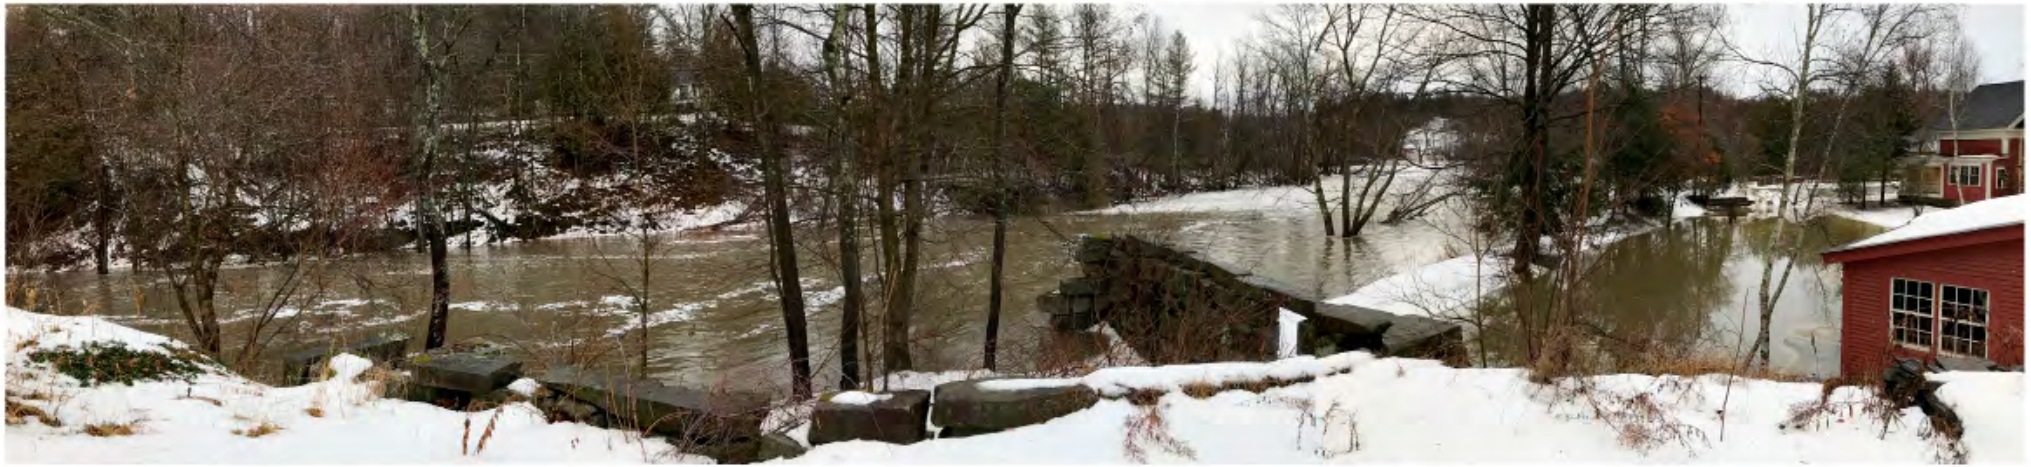
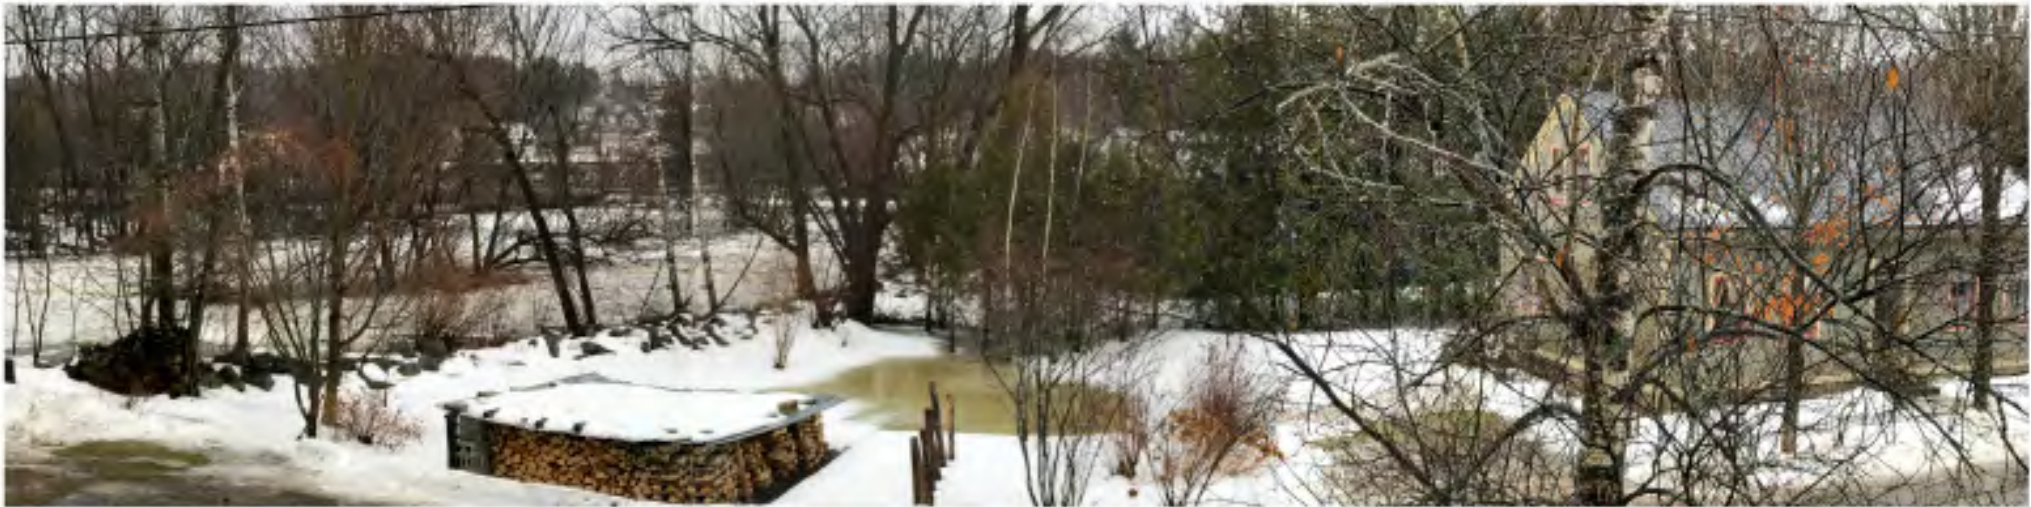
Coventry village - Ice jam and high water Jan 12, 2020

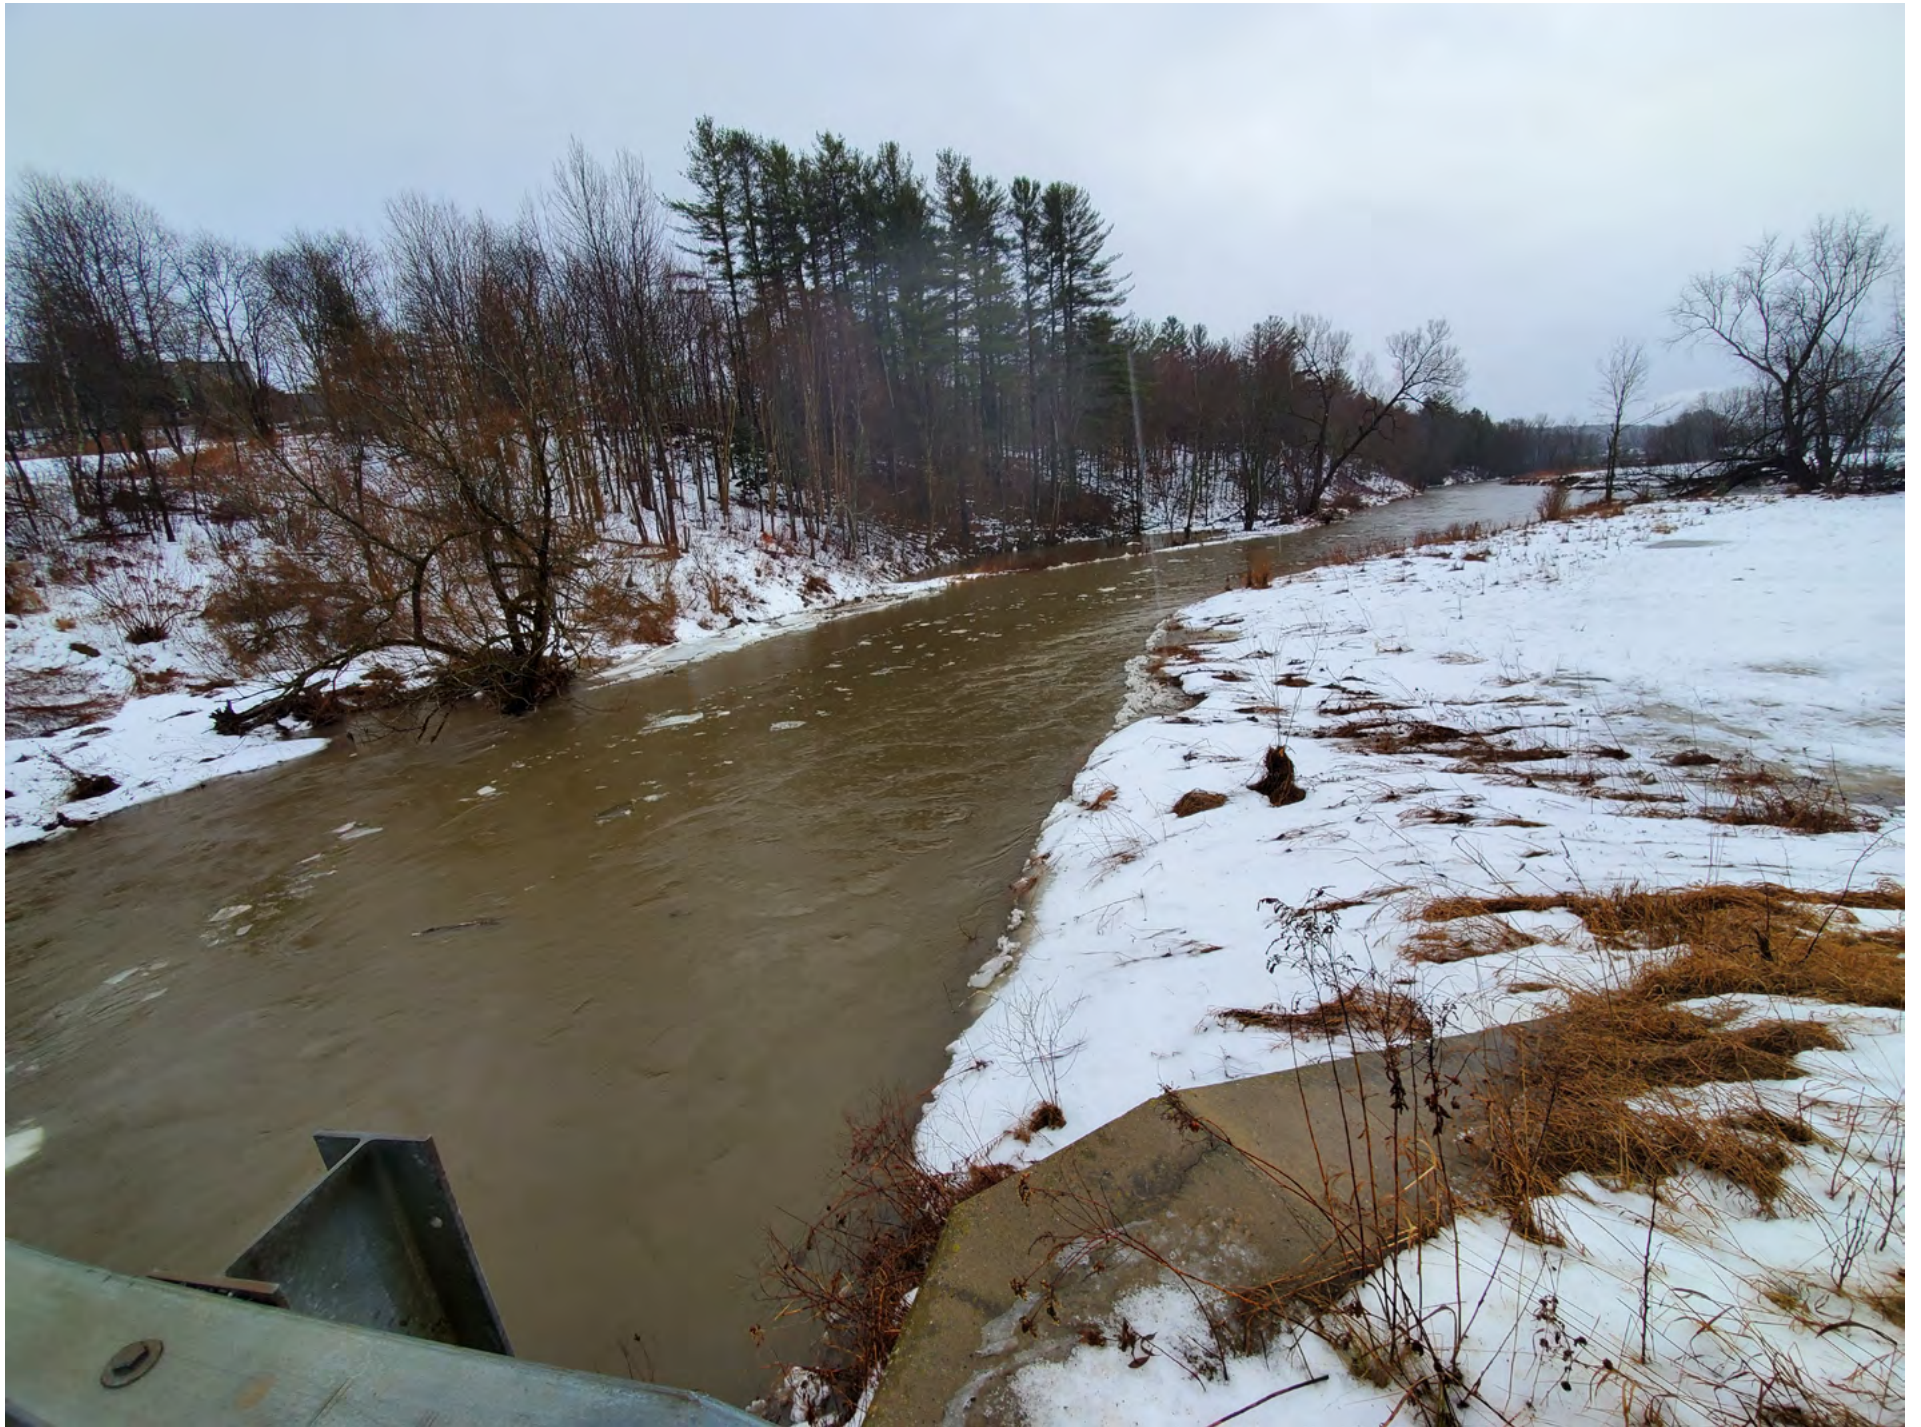
Ice jam and high water Jan 12, 2020 - At bridge above Upper Falls

Note: River channel now open with very little remaining ice at this point for it has travelled downstream into oxbow area
