COVENTRY ICE JAM FLOOD STUDY OF THE BLACK RIVER COVENTRY, VERMONT

**Prepared for:
Town of Coventry, VT**

**DuBois
& King^{INC.}**

October 10, 2025

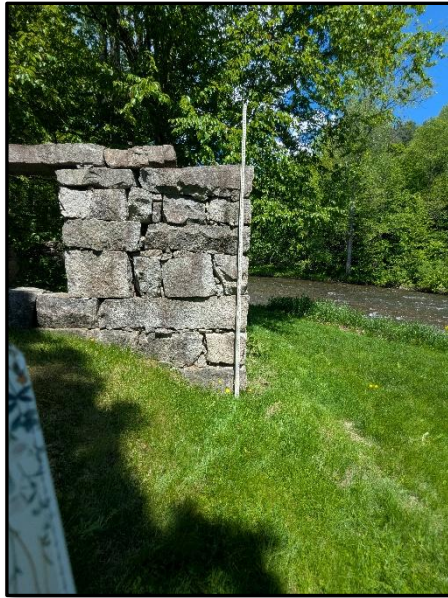
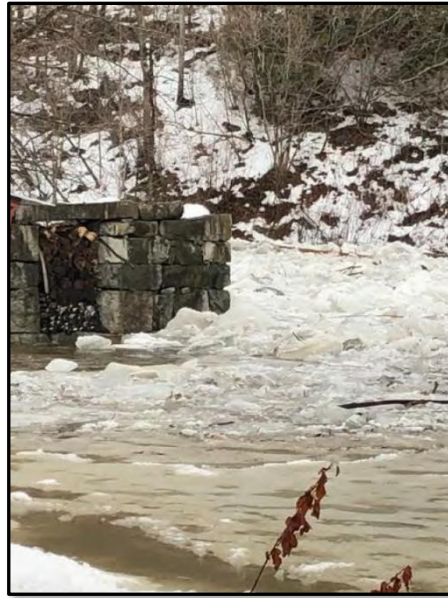
Photo 7a and 7b. The remnants of a foundation on the property of 23 Conway Court (May 2025 – left) and during the ice jam storm (Dec 22, 2018) (Miller, n.d.).

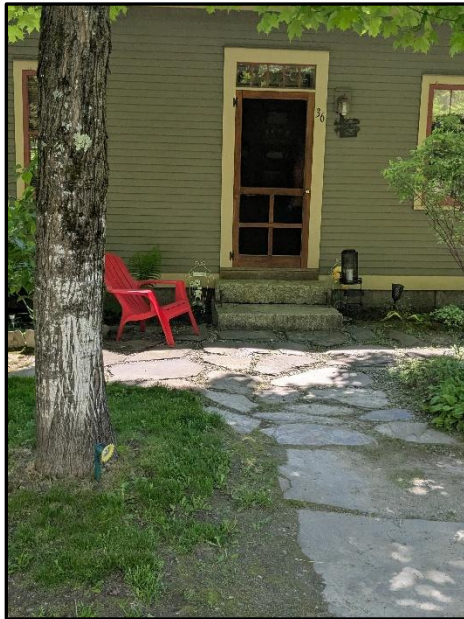
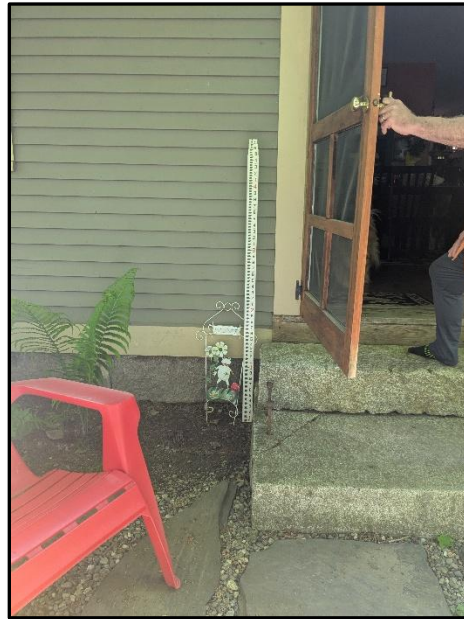
Photo 8a and 8b. The front of the home at 36 Conway Court. The owner noted that ice and water have reached the sill of the doorway (approximately 2 ft above the adjacent ground) but haven't overtopped into the home.

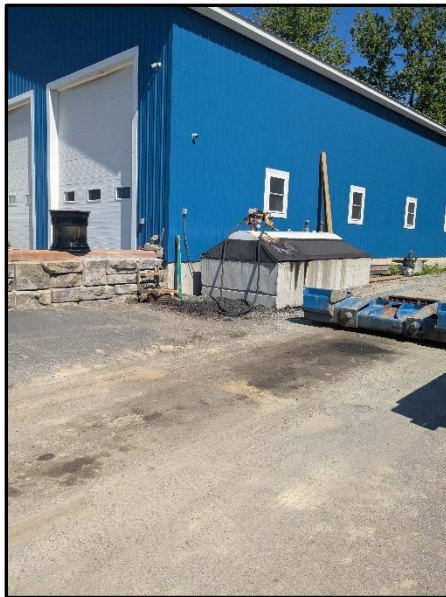
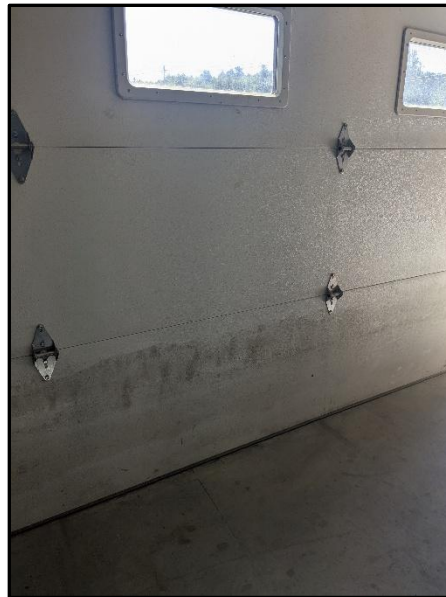
- The July 2023 storm resulted in flooding over the Route 5/Route 14 North intersection. Flows also overtopped the bank at 55 Conway Court and backwater reached the lower apartment at 235 Main Street.
- Sometime after the ice jam flood in 2018, the commercial garage at 88 Main Street burned and was rebuilt 2.5 feet higher than the previous construction. It flooded during the July 2023 storm to a depth of approximately 2 feet. A high water line was observed inside the garage. A sediment line on the inside of the garage door can be seen in Appendix B.

Photo 9a and 9b. The recently raised garage at 88 Main St (left). Sediment line inside the garage door (right). This is a remnant from the July 2023 open-water flood event.

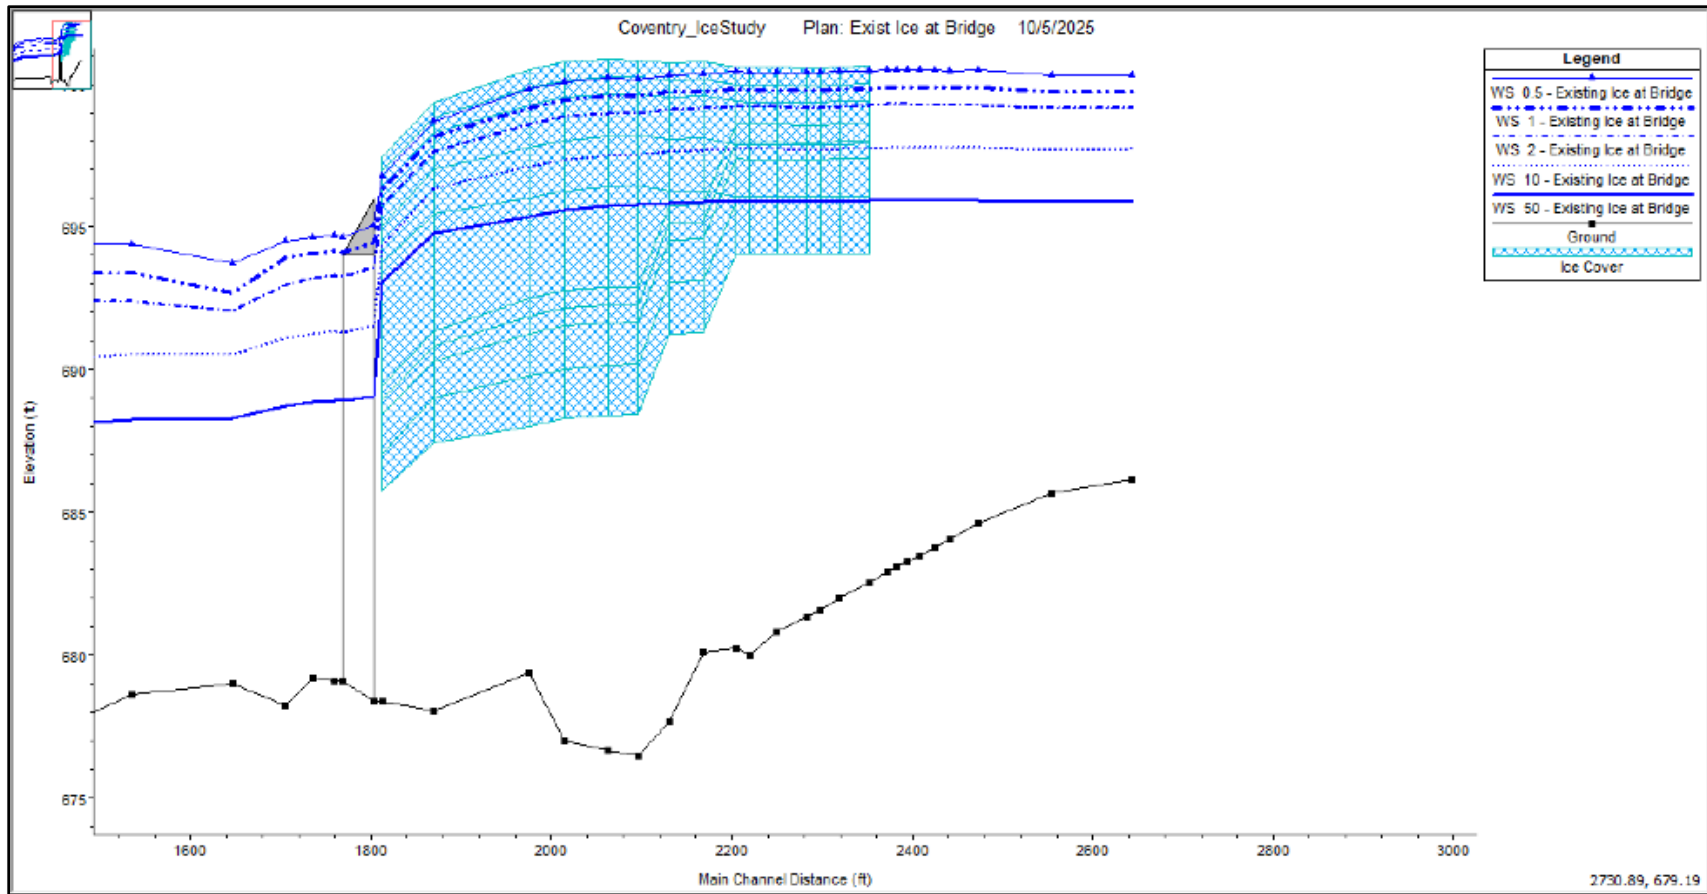
Ice jam and water surface profiles for existing conditions on the Black River.

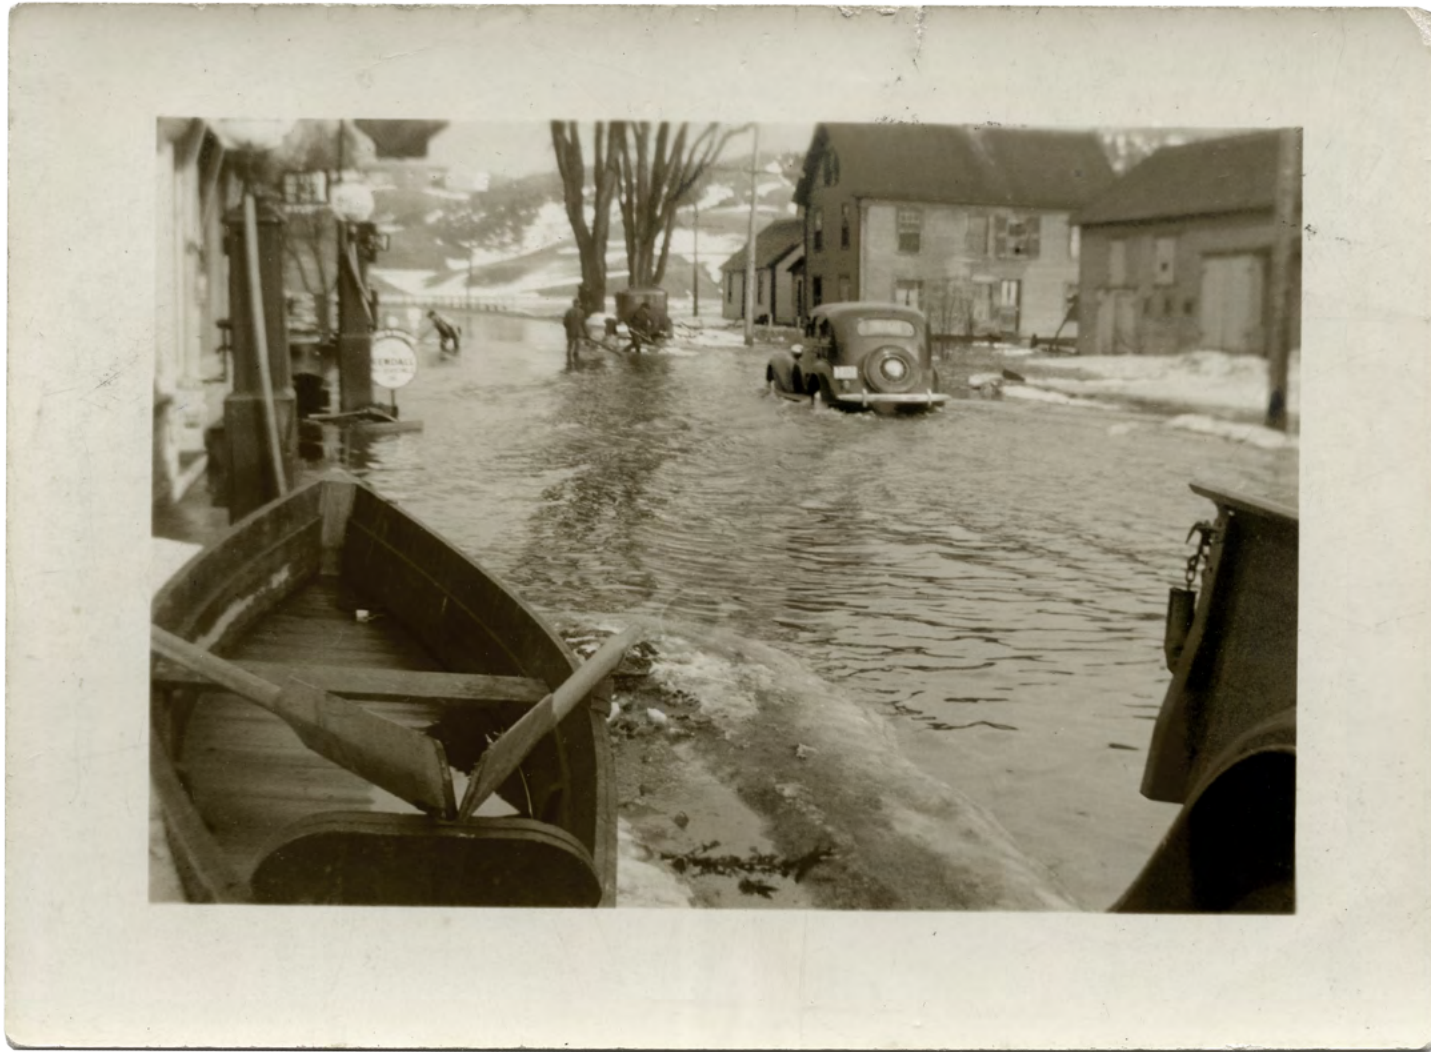
Spring flooding with ice jams on main streets March 19th 1936

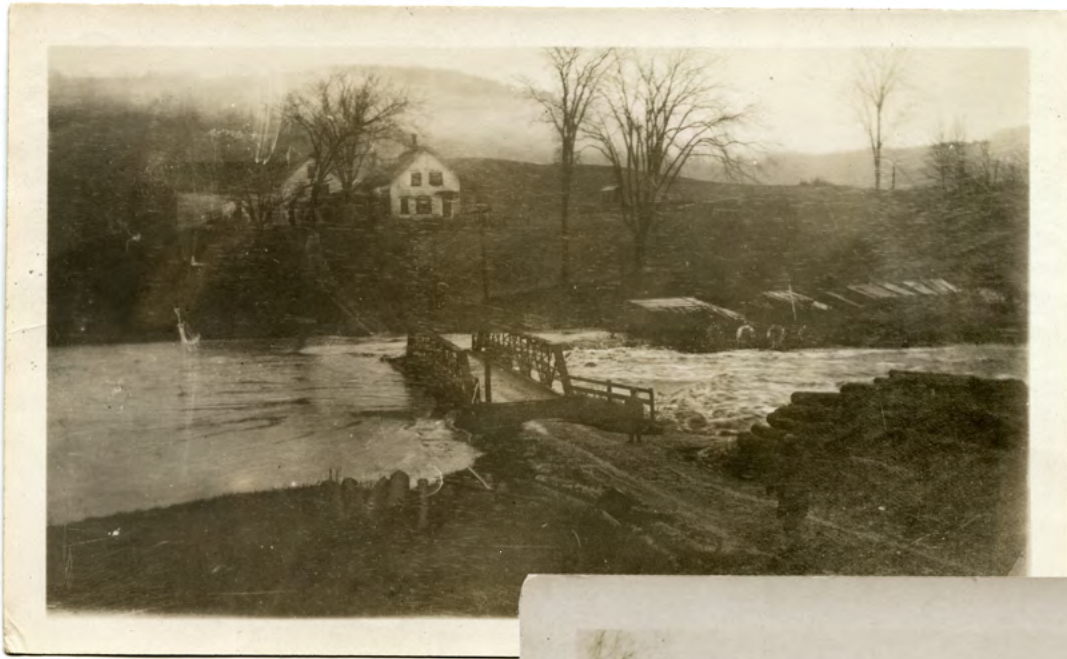
Mill yard lumber piles, much of which has already washed downstream.

Heerman sawmill inundated and detached from its foundation begins to float over the upper falls in November 1927.

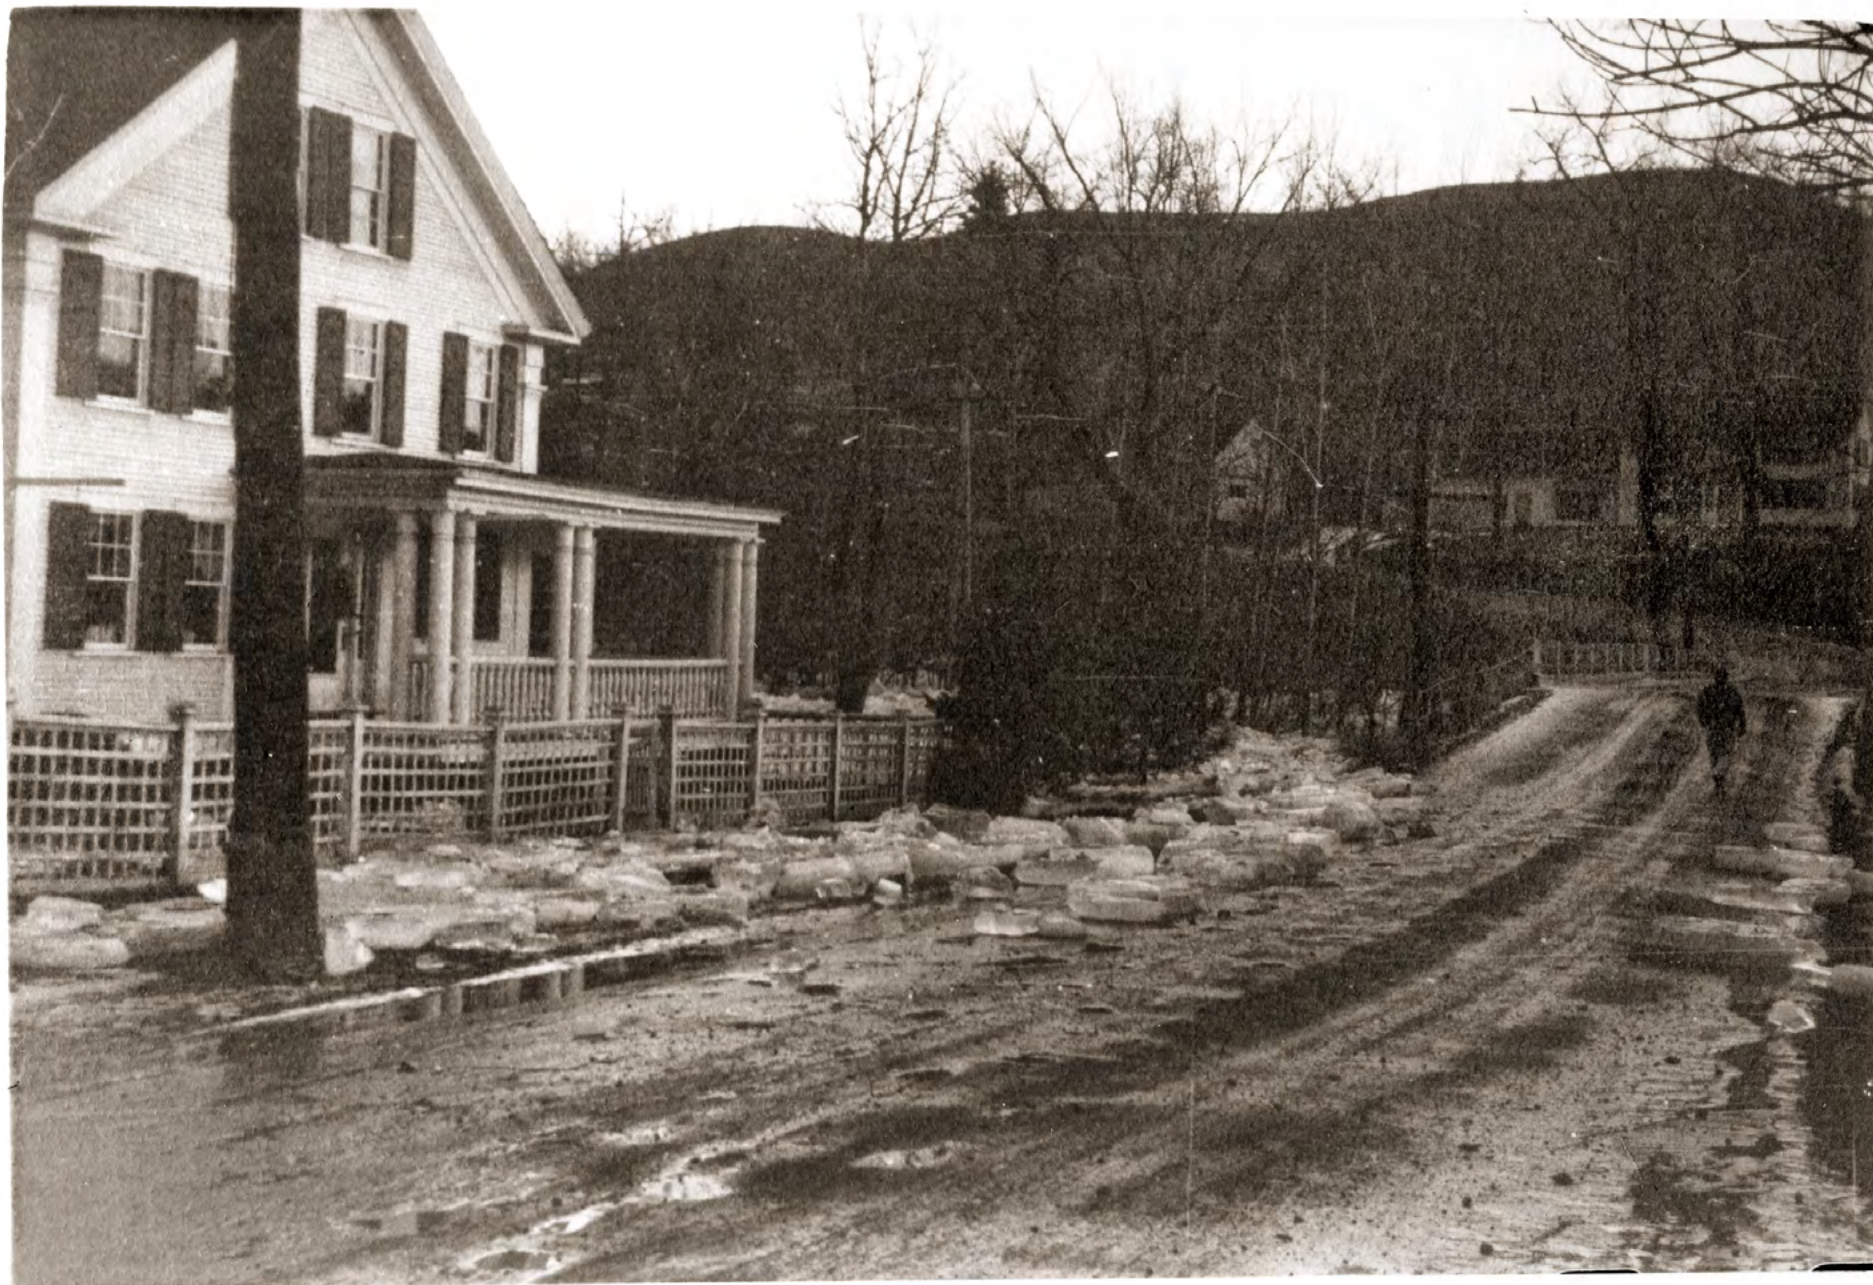
Ice Jam approx. Spring 1950 Miller/Cowle house and Rte 14 bridge

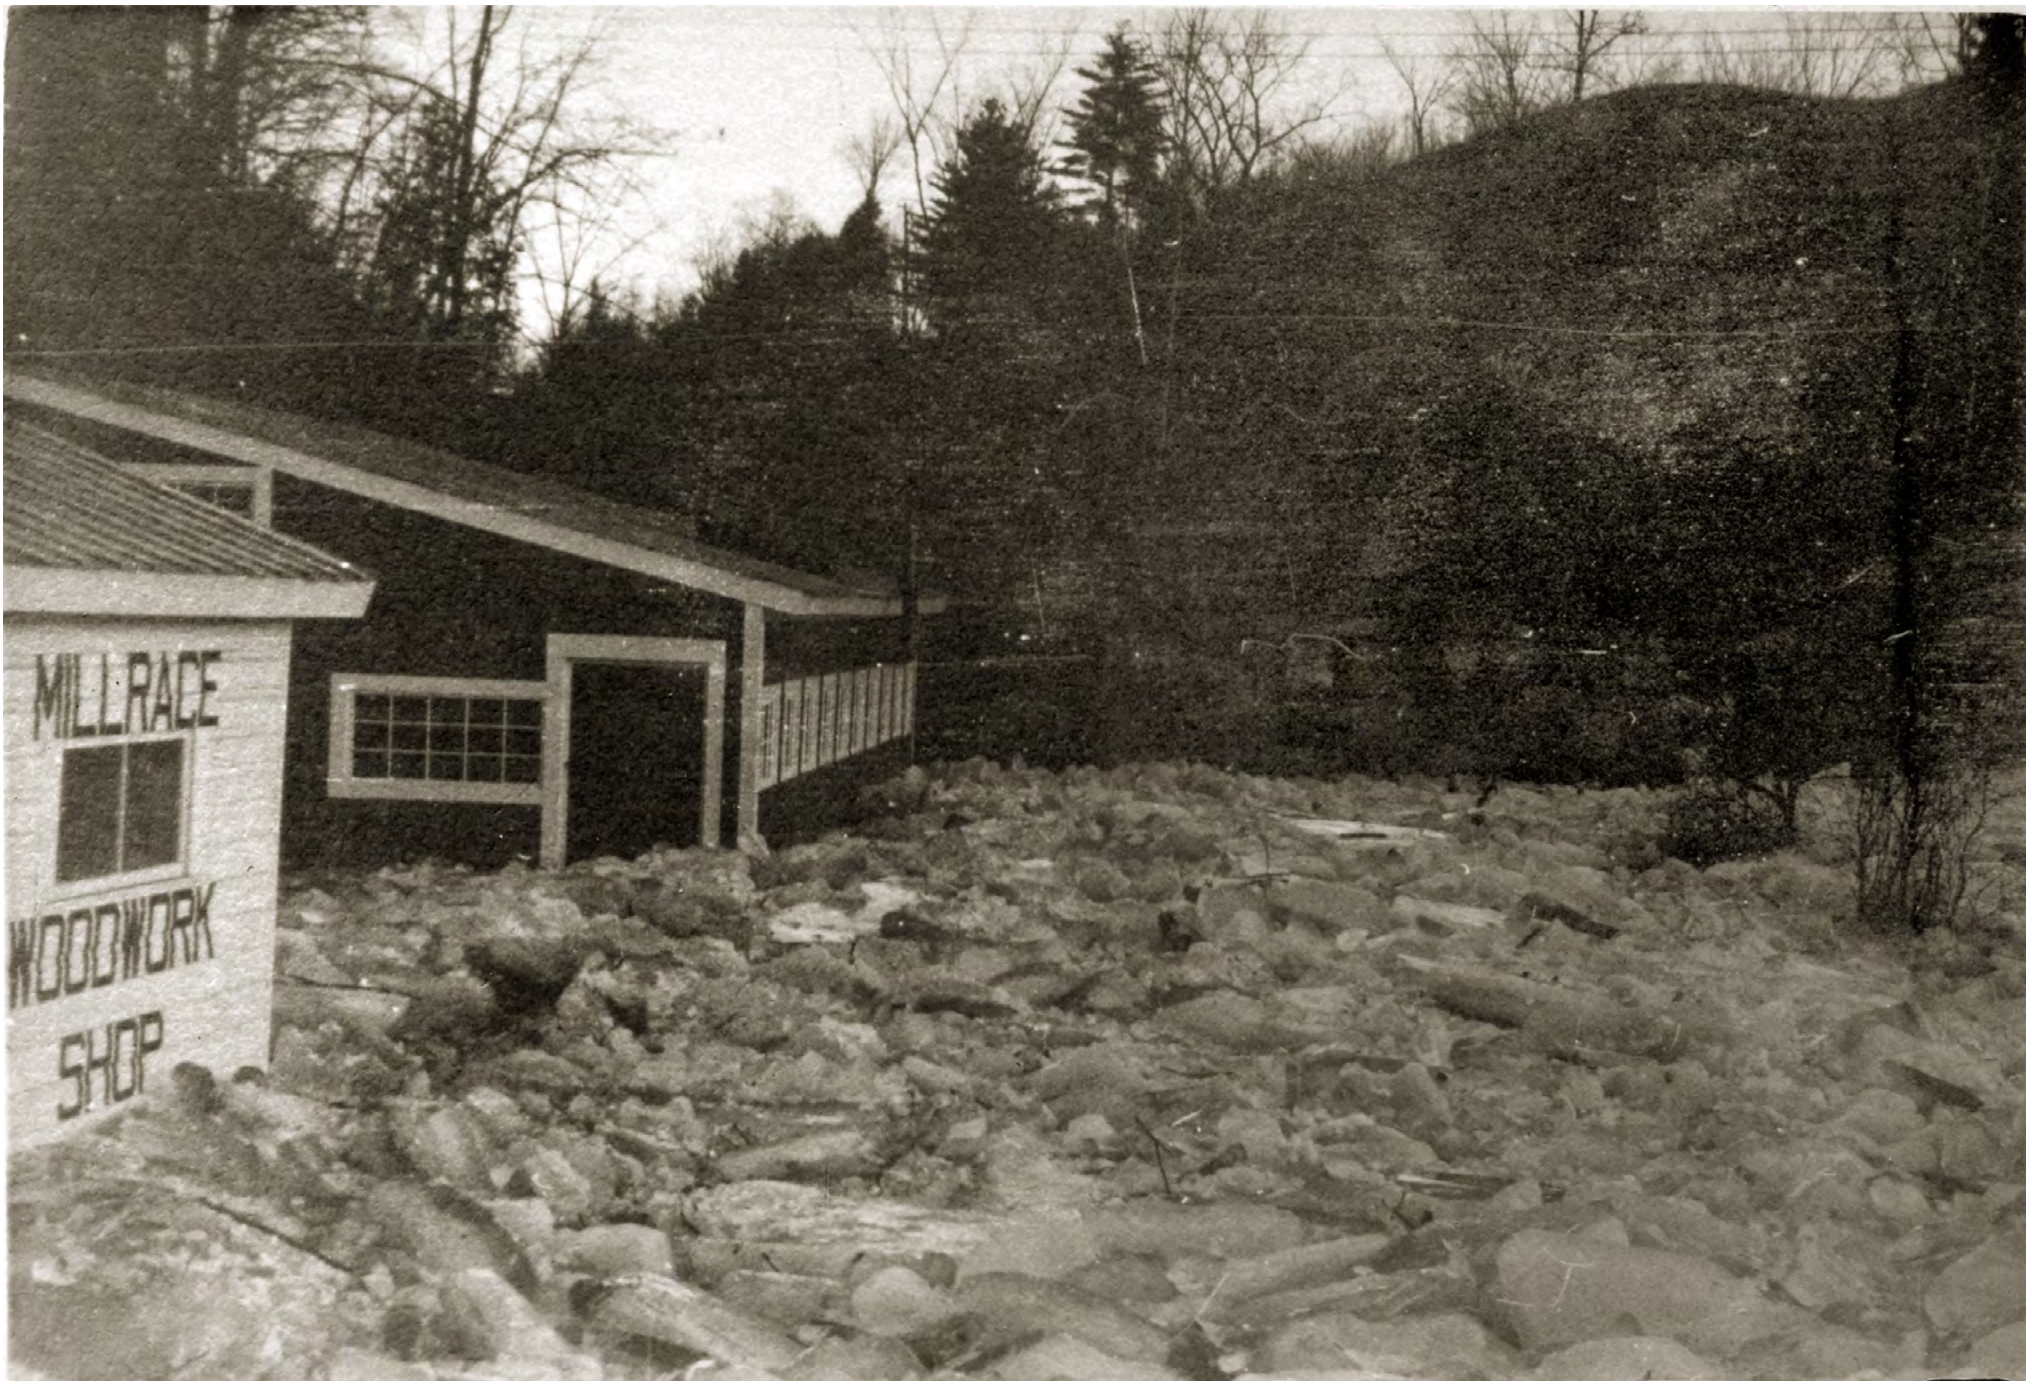
Ice Jam approx. 1950 Miller/Cowle property

Note how clean the ice is. Ice jams did not bring in as much silt/mud before the planting of corn in much of the Black river bottom land upstream from Coventry village. Ice flow in this photo is on the lawn, river channel is beyond and to right

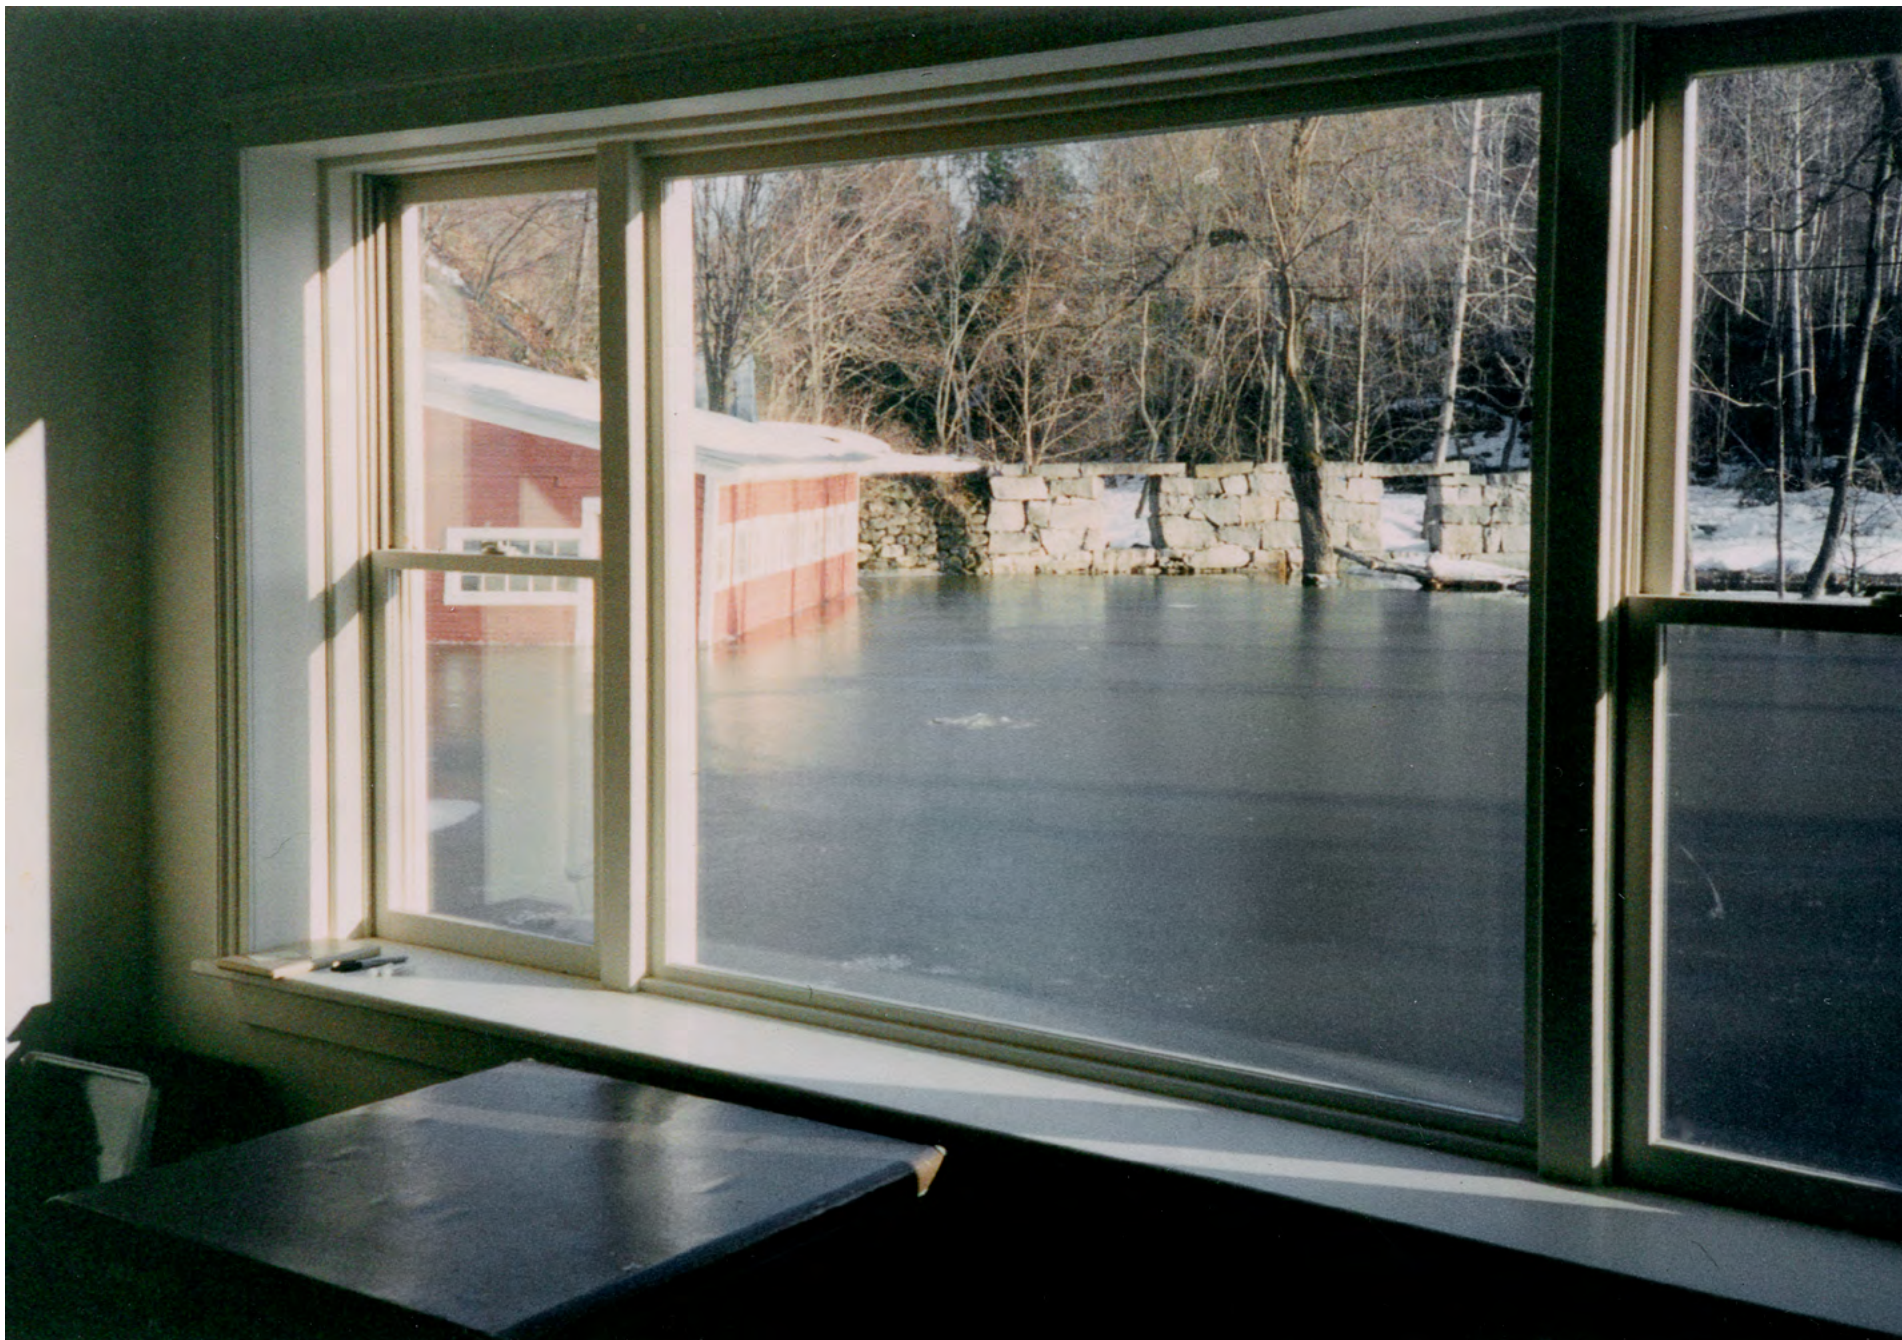
Ice Jam Feb 1993 - Coventry village experienced severe flooding --- This photo taken in late March/early April soon after a second ice jam caused by warm weather and rain came downstream to the village and ran into the first ice jam; thus causing the Black river to rise very quickly (10 or so feet within a couple of minutes) . (note same shed in previous photo) **Ice wall depth in river channel varied at least 10-12 feet in places**

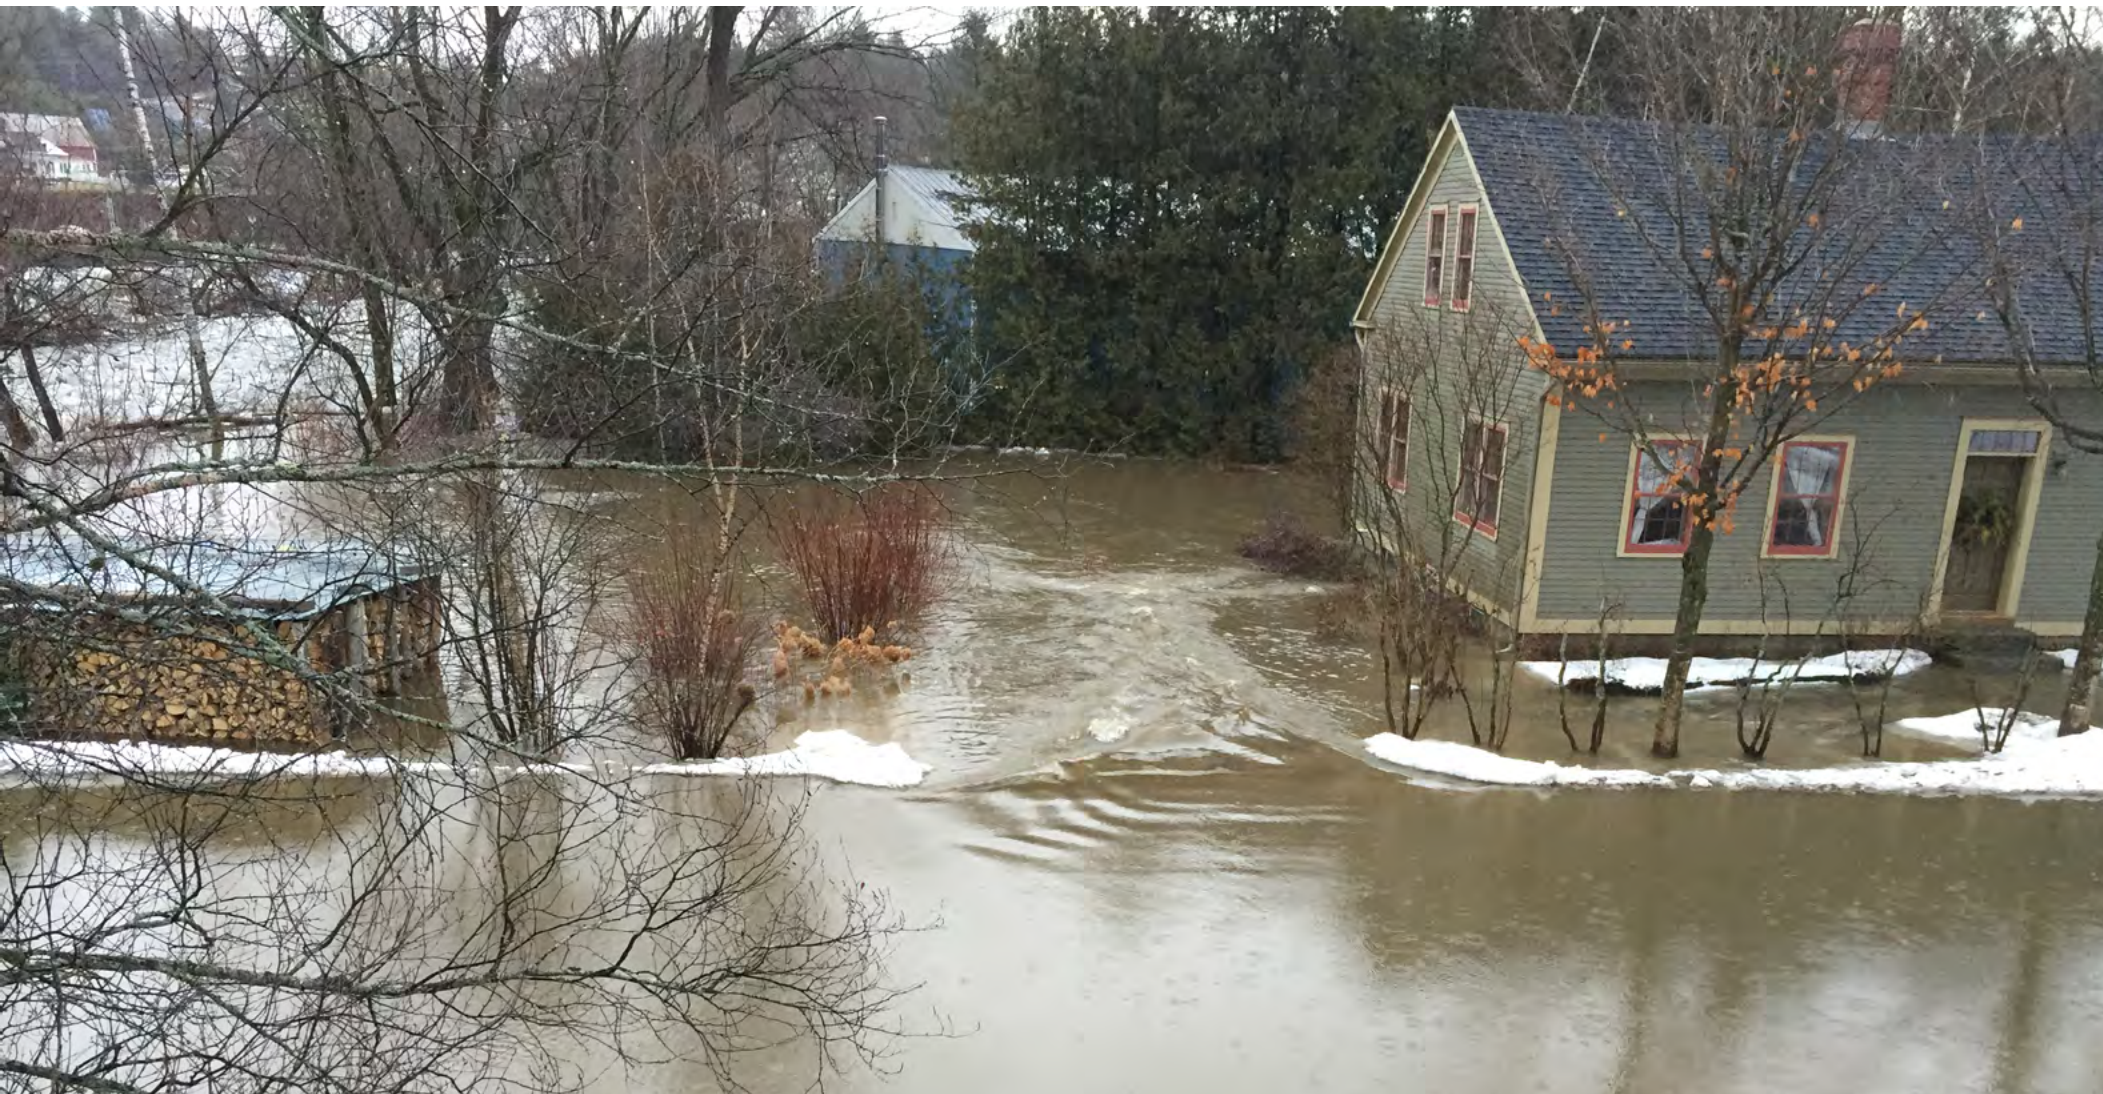
Ice jam and subsequent flooding, Coventry village, Feb 2016 - many basements in village near river filled with water - furnaces, ductwork and oil tanks inundated. Blue garage building to left of house had river flowing through it, approx, 4 feet deep
River in this photo approximately 1.5 feet deep running across street and into lawn next.

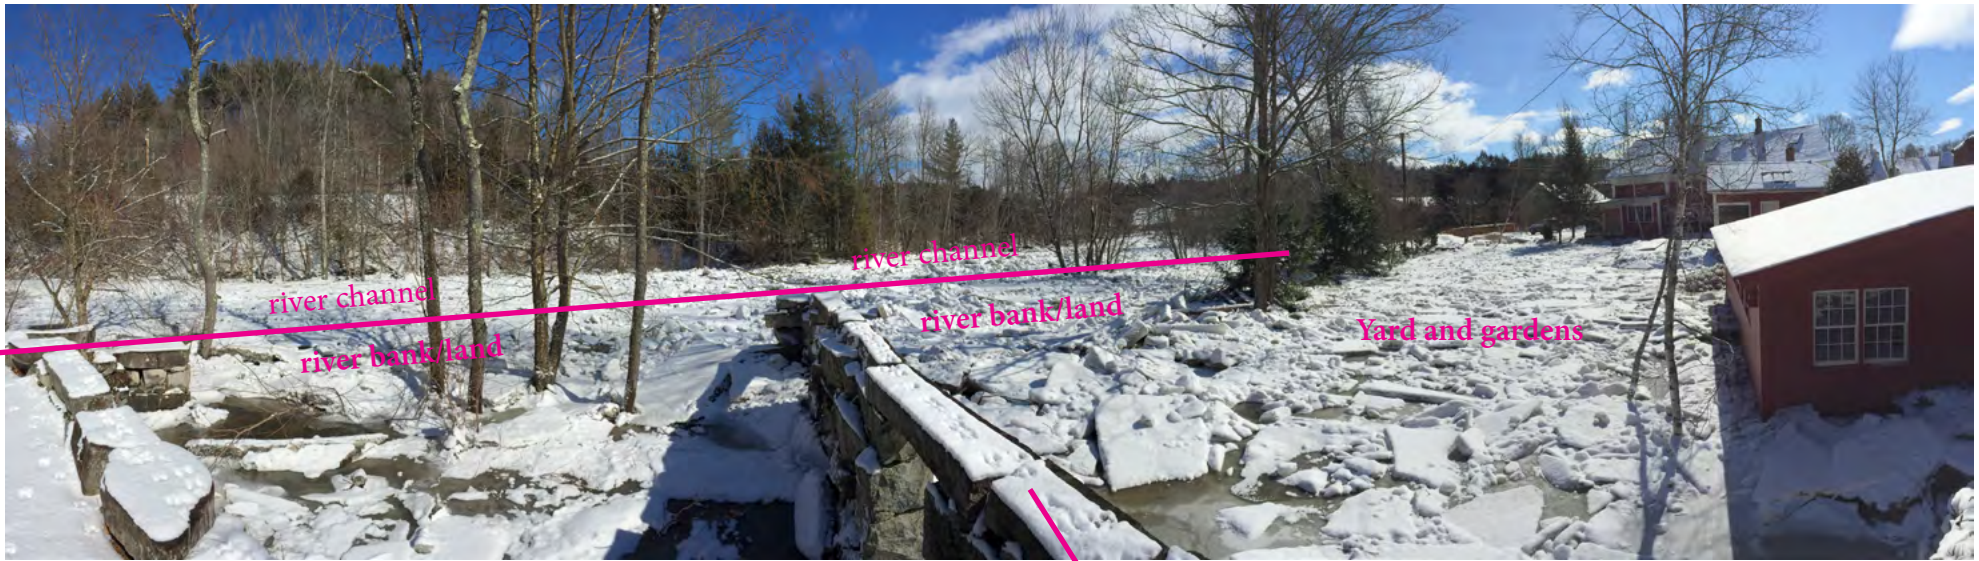
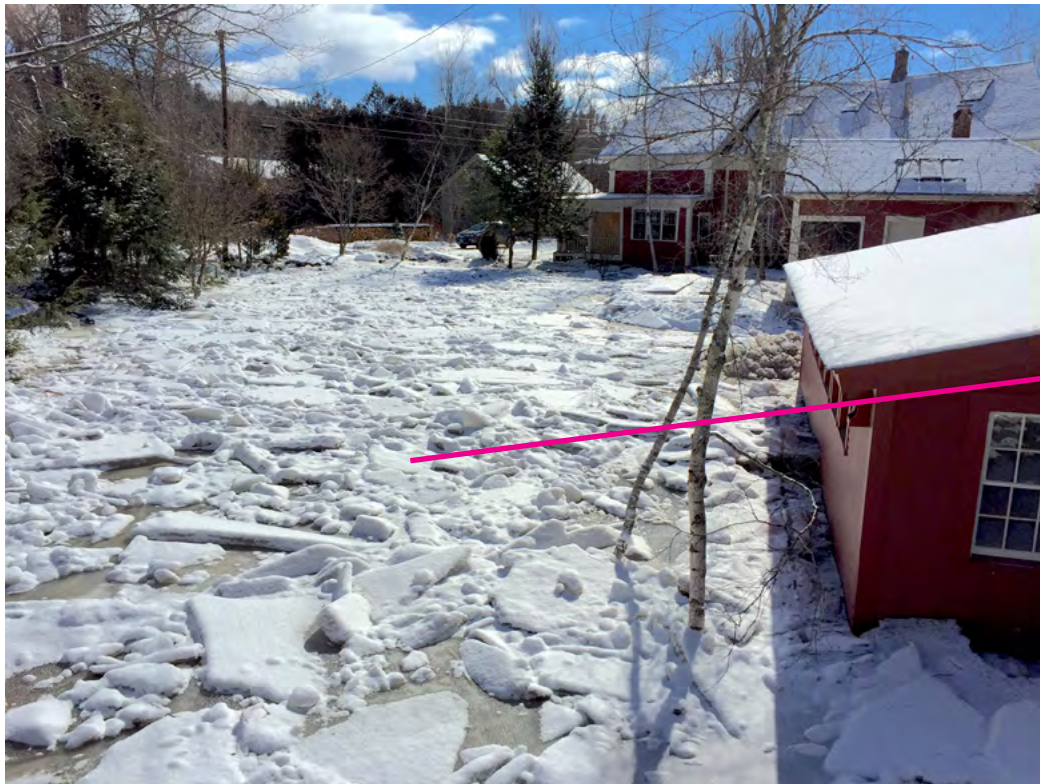
Remaining grist mill foundation wall serves to hold some of the more intense ice flow from hitting sheds and house with direct force
Ice in river channel in background 10-12 feet deep

Water and ice depth on back yard approximately 5- 6 feet deep

**Ice jam and subsequent flooding, Coventry village, Feb 2016 a day or so after initial flood when weather has cleared and MUCH COLDER - very common sequence; thus potential of second ice jam with Spring melt/rain combination making for second flood within a few months
Note: this scenario has been much more common in recent years - double ice jams and flooding - because of erratic weather patterns**

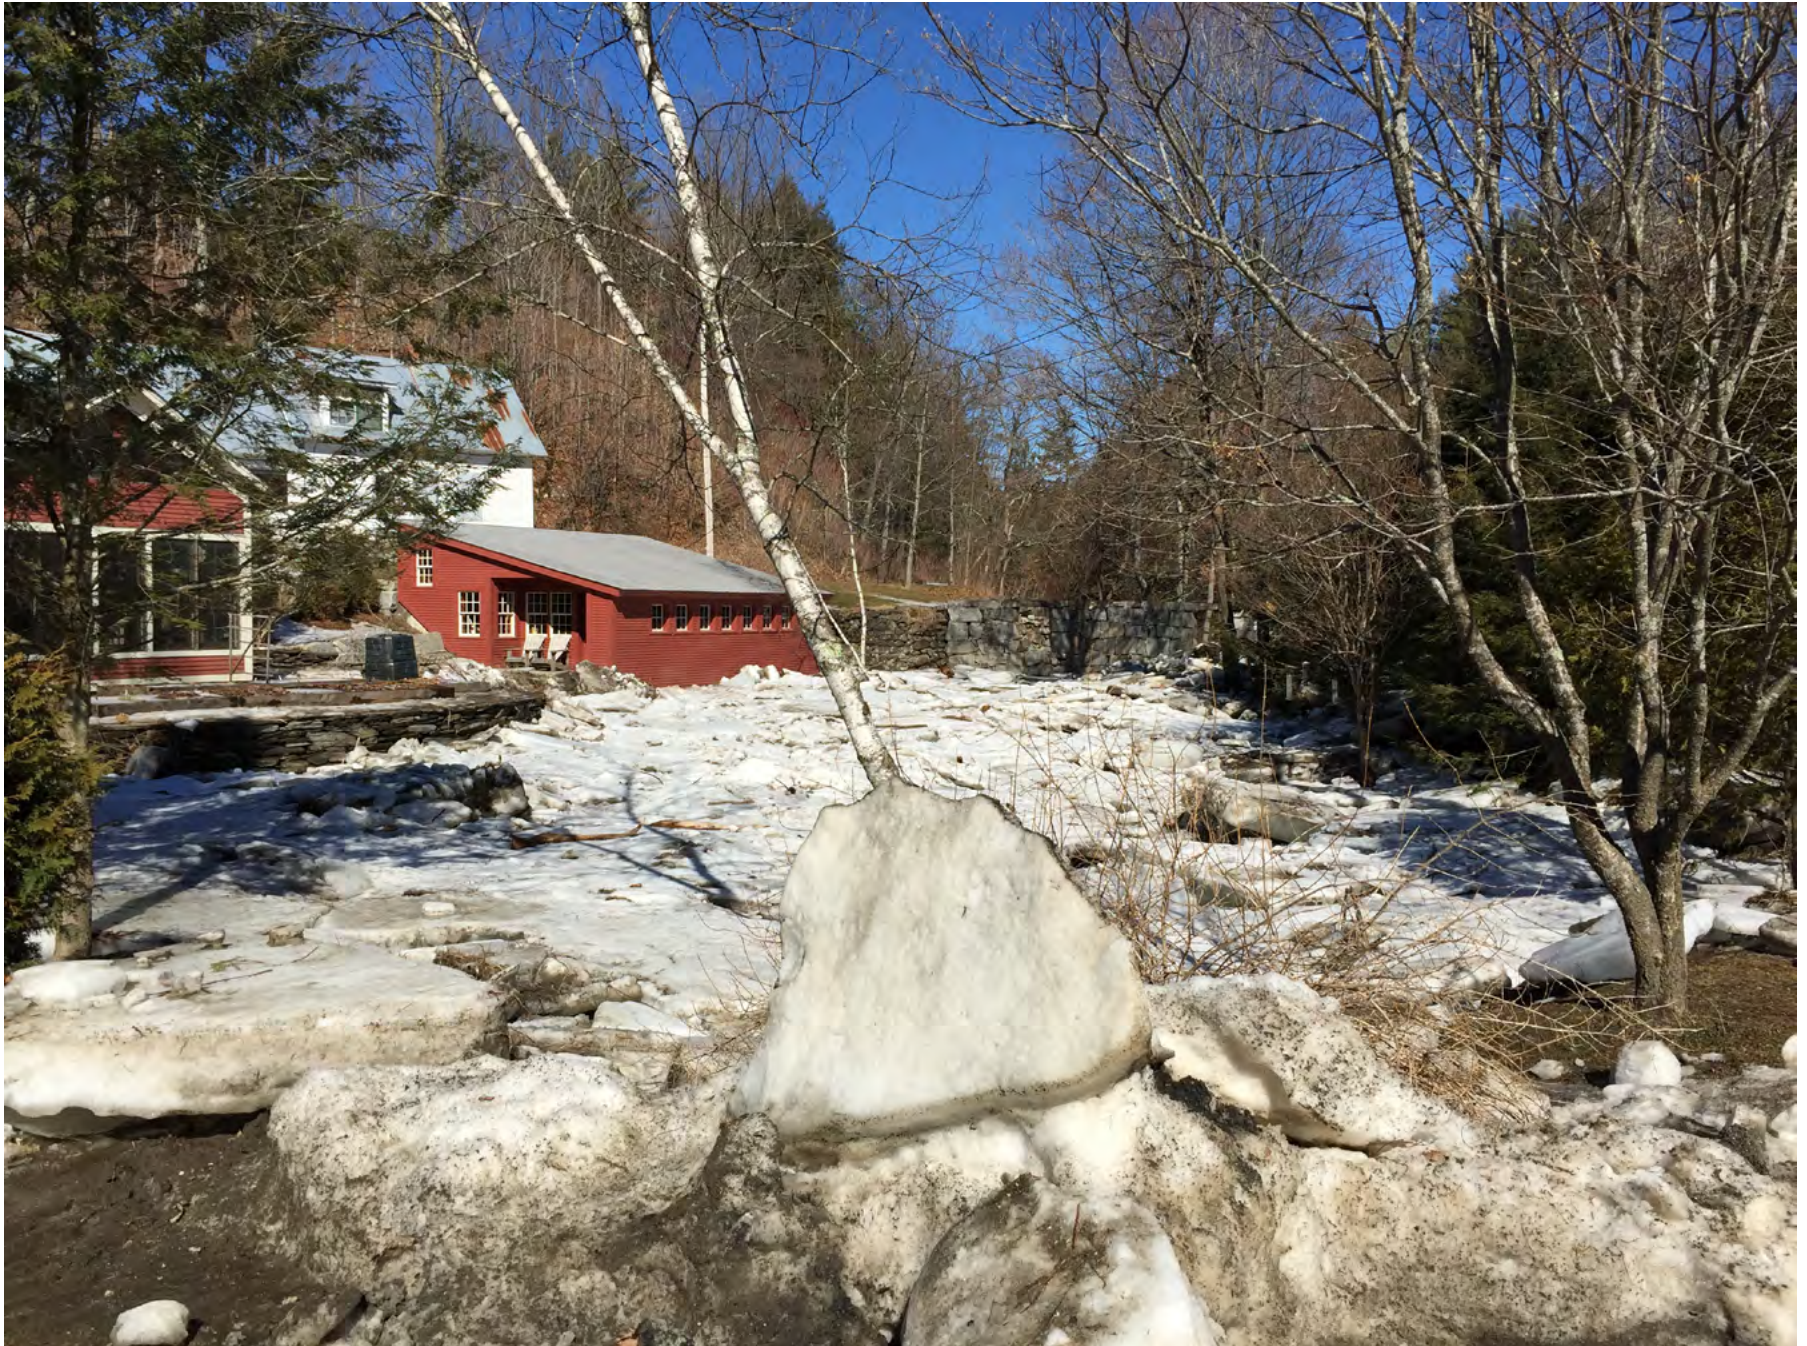
Feb 2016 ice jam and flood aftermath in late March -early April

Note much more silt and debris in 2016 vs 1950s

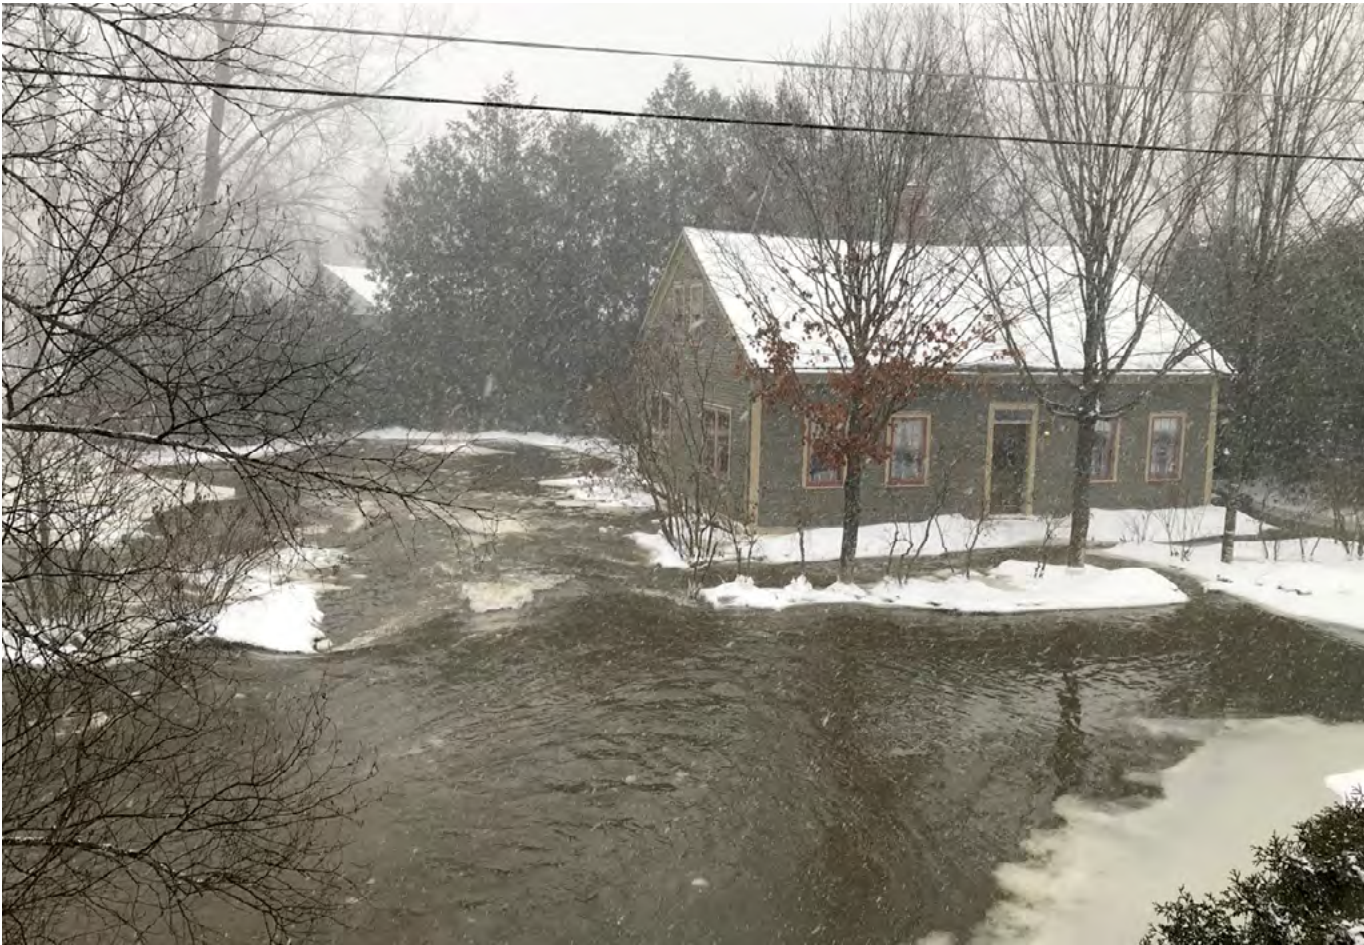
January 13, 2018 Coventry village - Ice jam occurred early morning, Jan 13 - river changed course and flowed through yard and property, across street into another yard and then into much of low-lying village. River flowed at a depth of approx 3 feet across this street through garage in background
