COVENTRY ICE JAM FLOOD STUDY OF THE BLACK RIVER COVENTRY, VERMONT

**Prepared for:
Town of Coventry, VT**

**DuBois
& King^{INC.}**

October 10, 2025

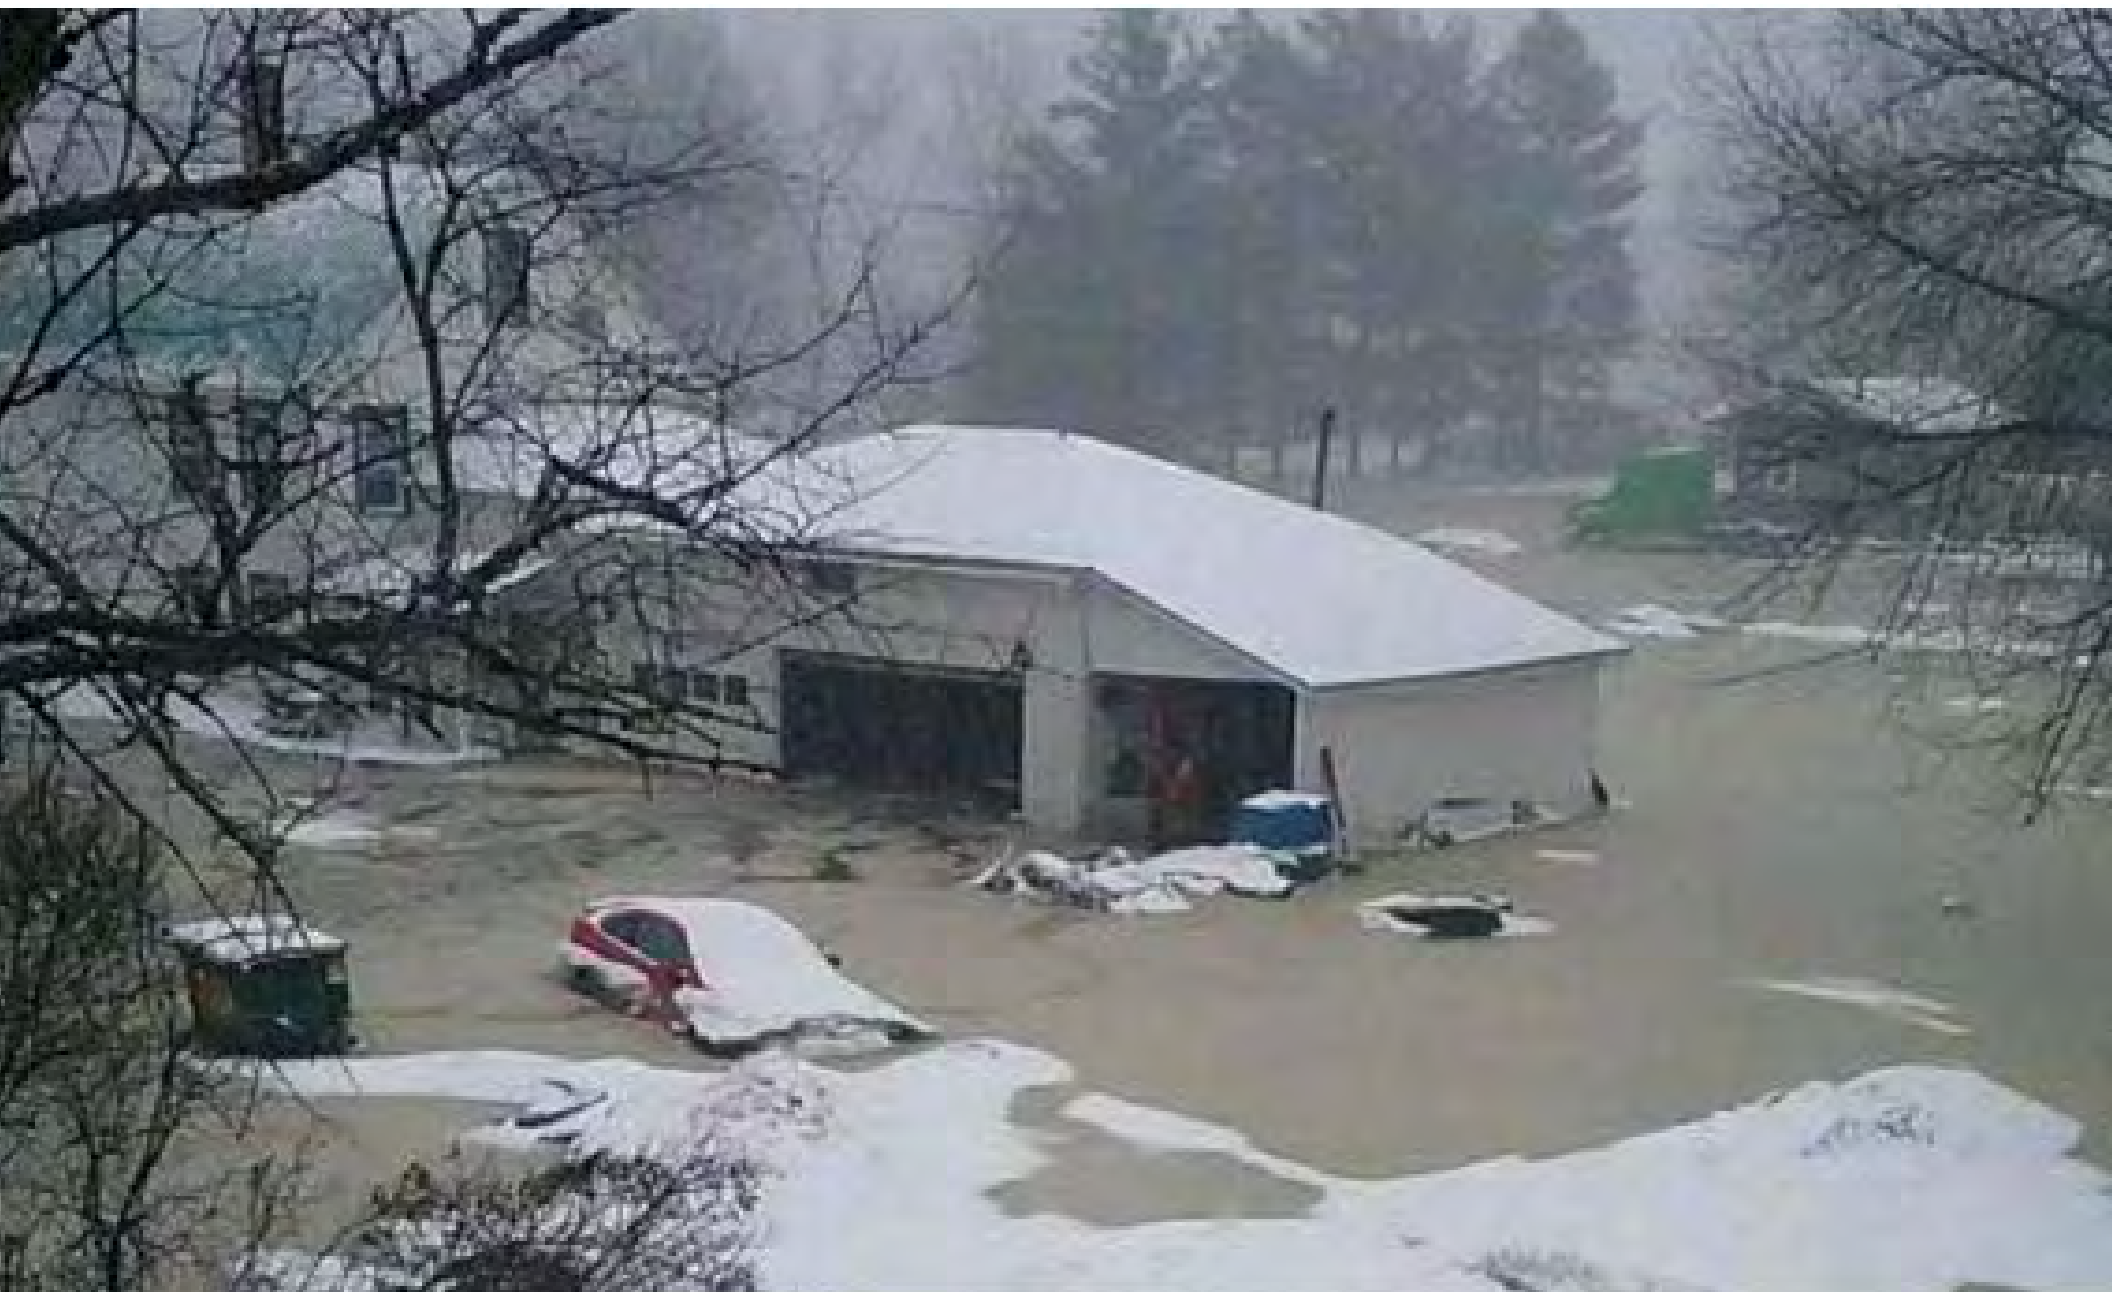
January 13, 2018 - morning - Main Street, Coventry village inundated from ice jam

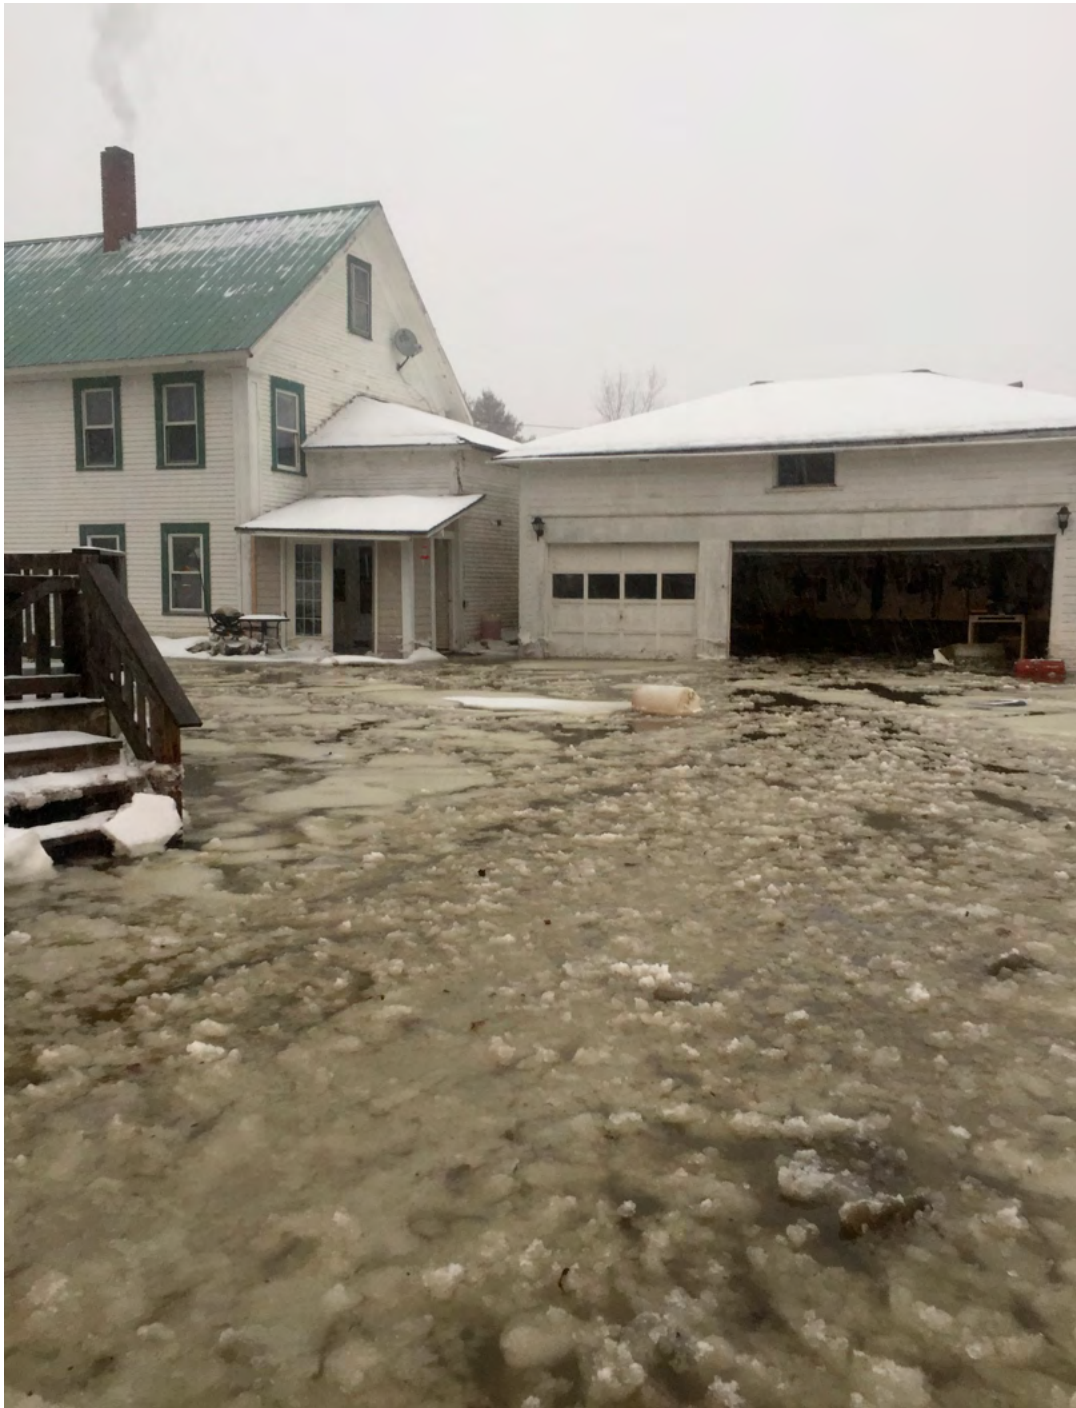
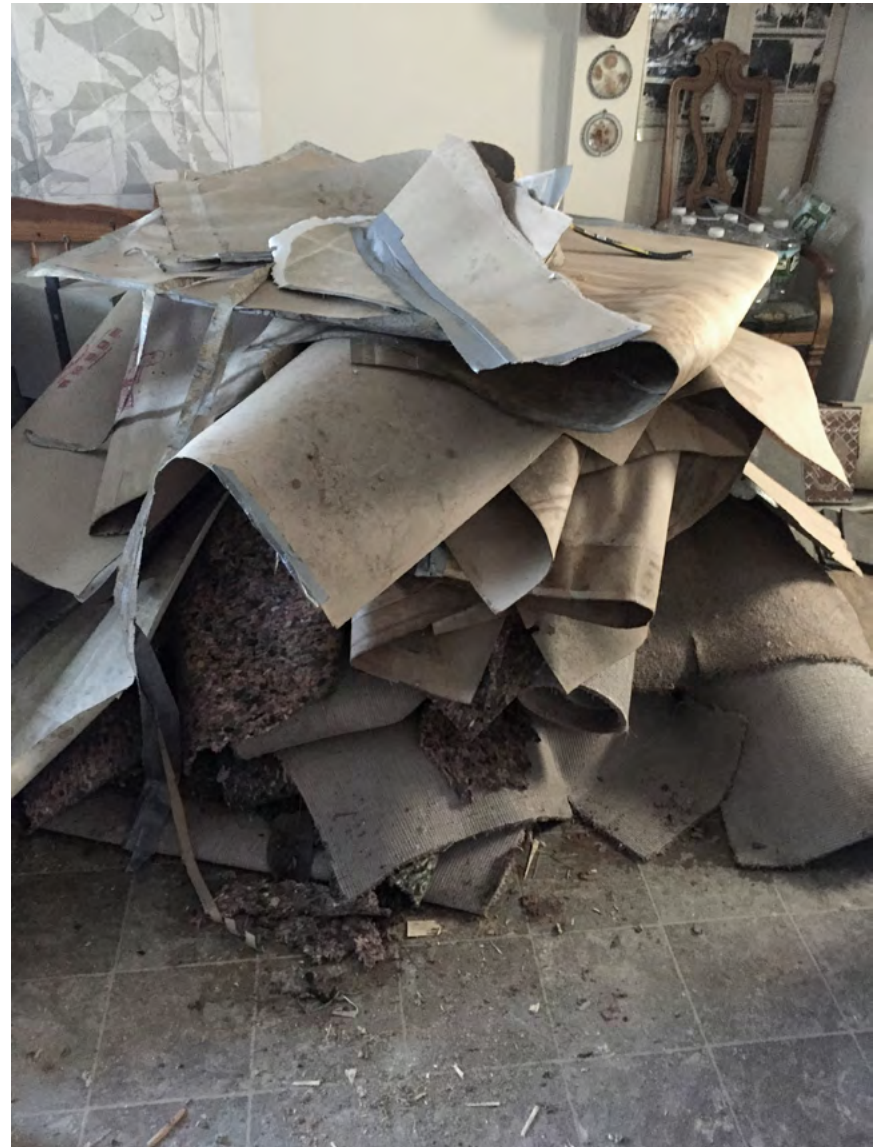
- Carpeting, insulation, drywall, furnace, furniture damaged or destroyed

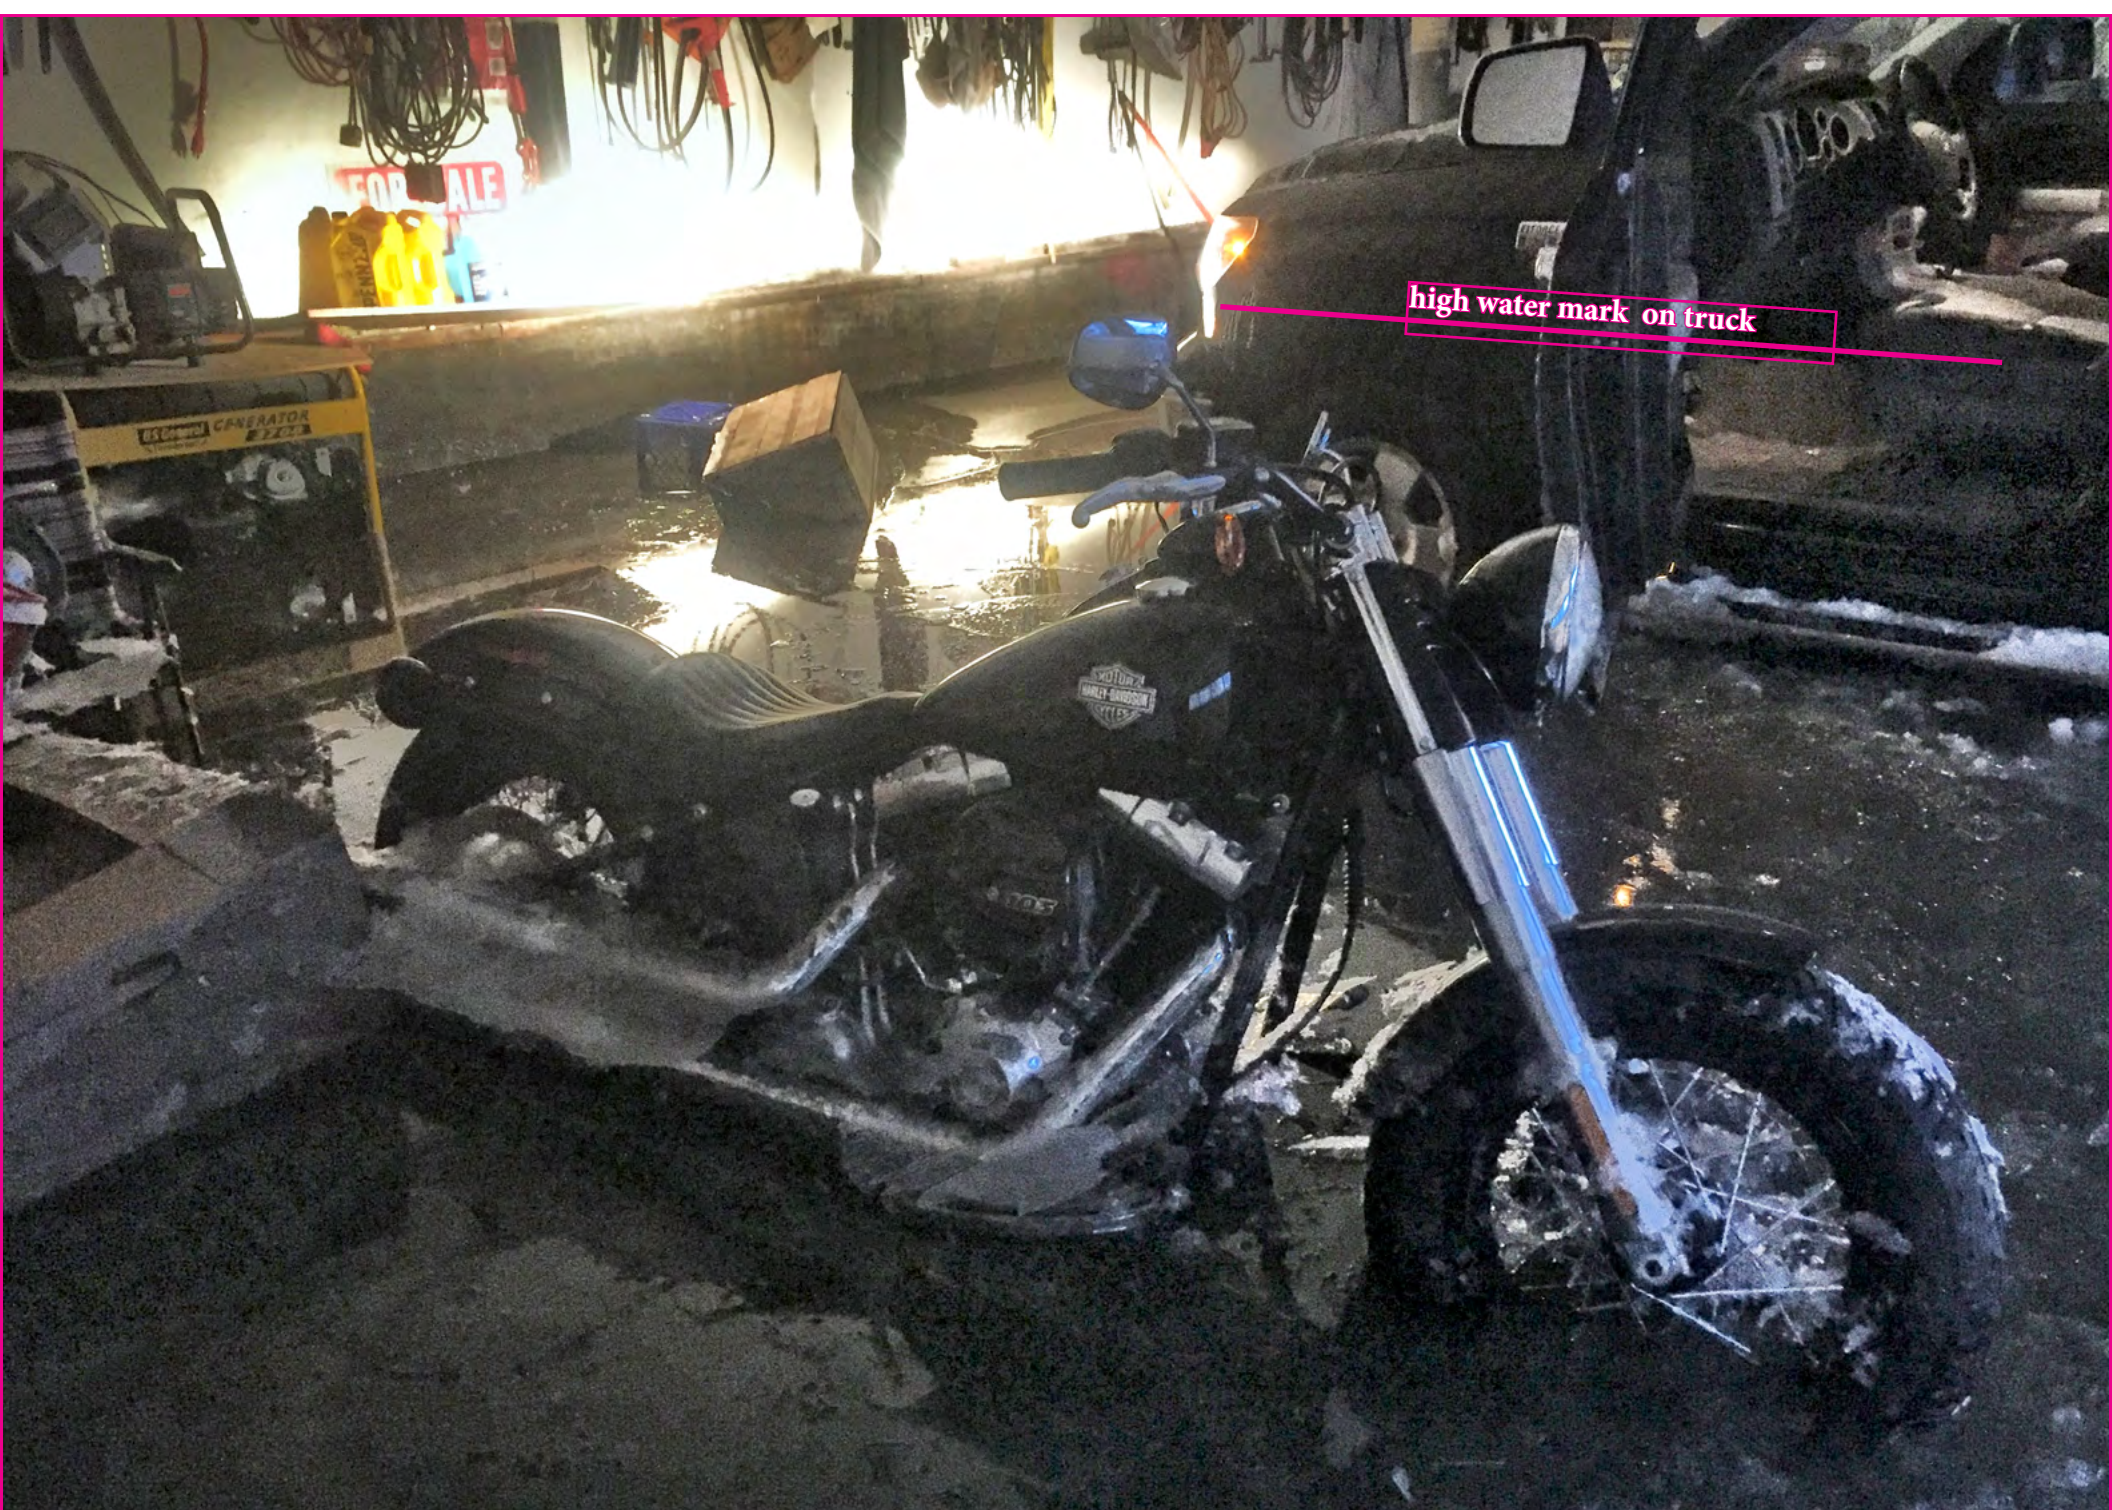
high water mark on truck

Main street Coventry village

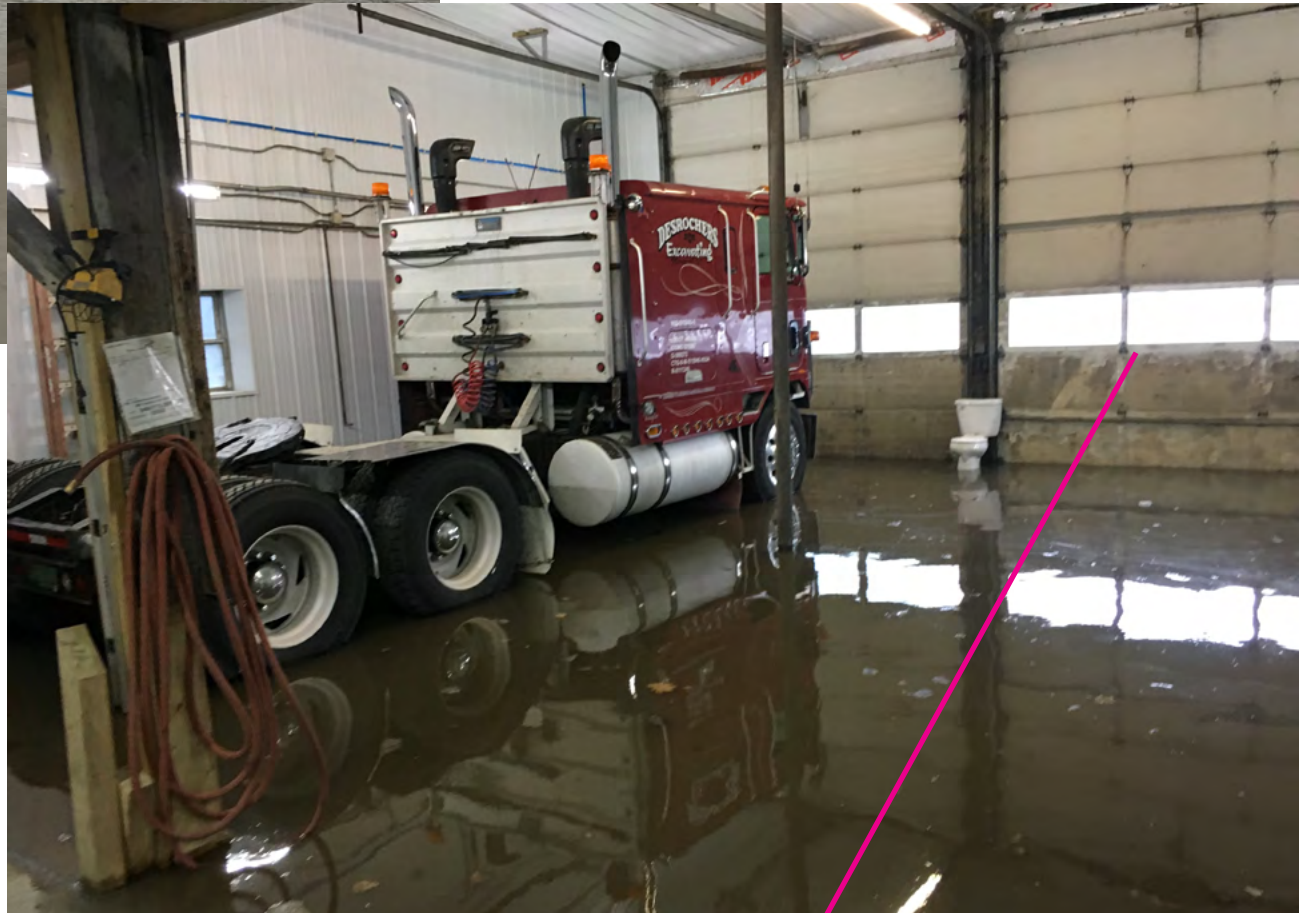
Note high water crested mark during January 13, 2018
Inside garage bay after most of water has subsided January 2018

Trucking and excavating business inundated inside garage and outside in parking lot - machinery, furnace, smaller heavy equipment damaged

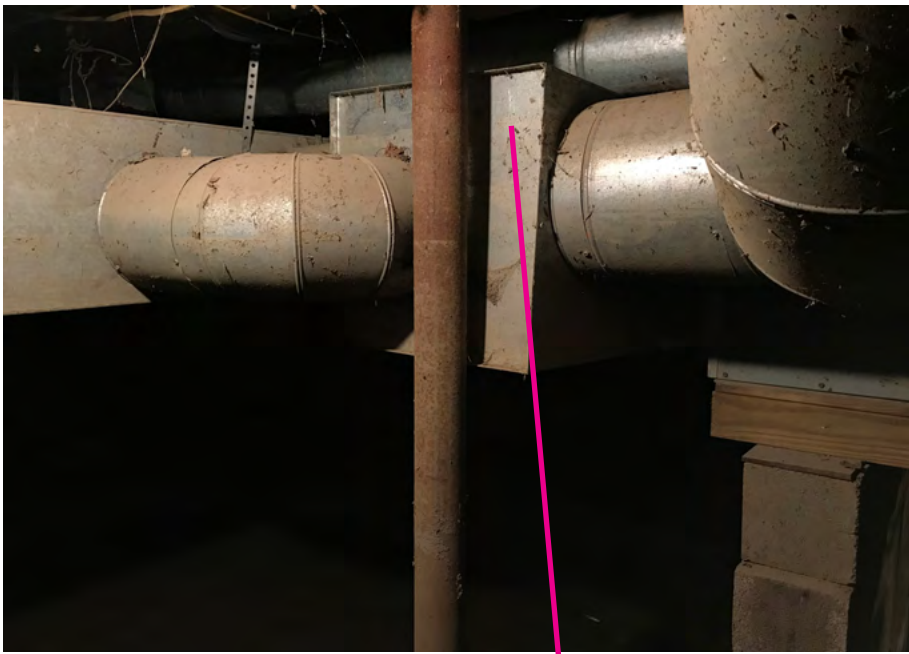
basement flood water level mark on furnace duct work

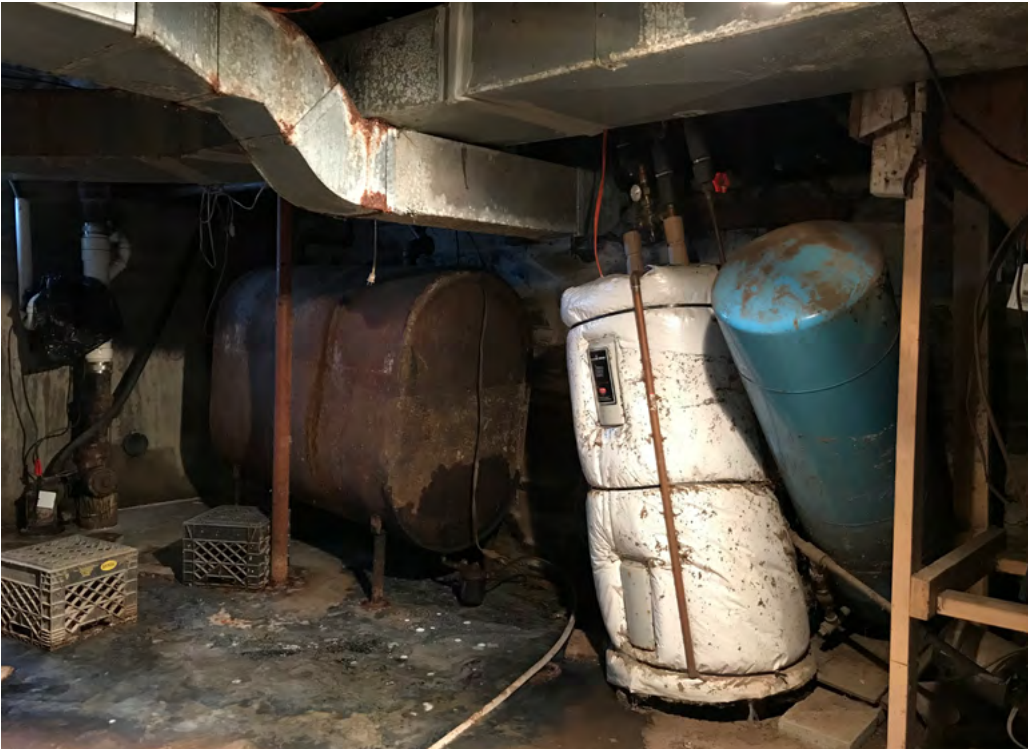
furnace, water heater, pressure tank destroyed, oil tank must be replaced

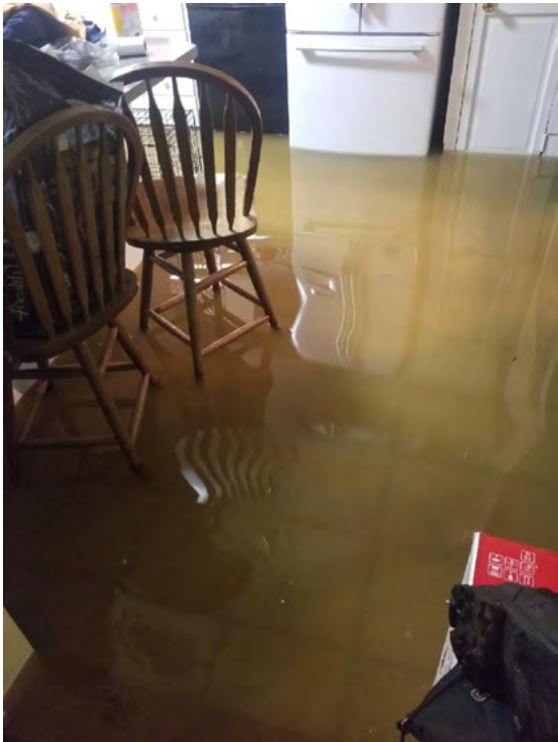
Hardwood kitchen floor, dry wall, insulation, furniture, personal items destroyed

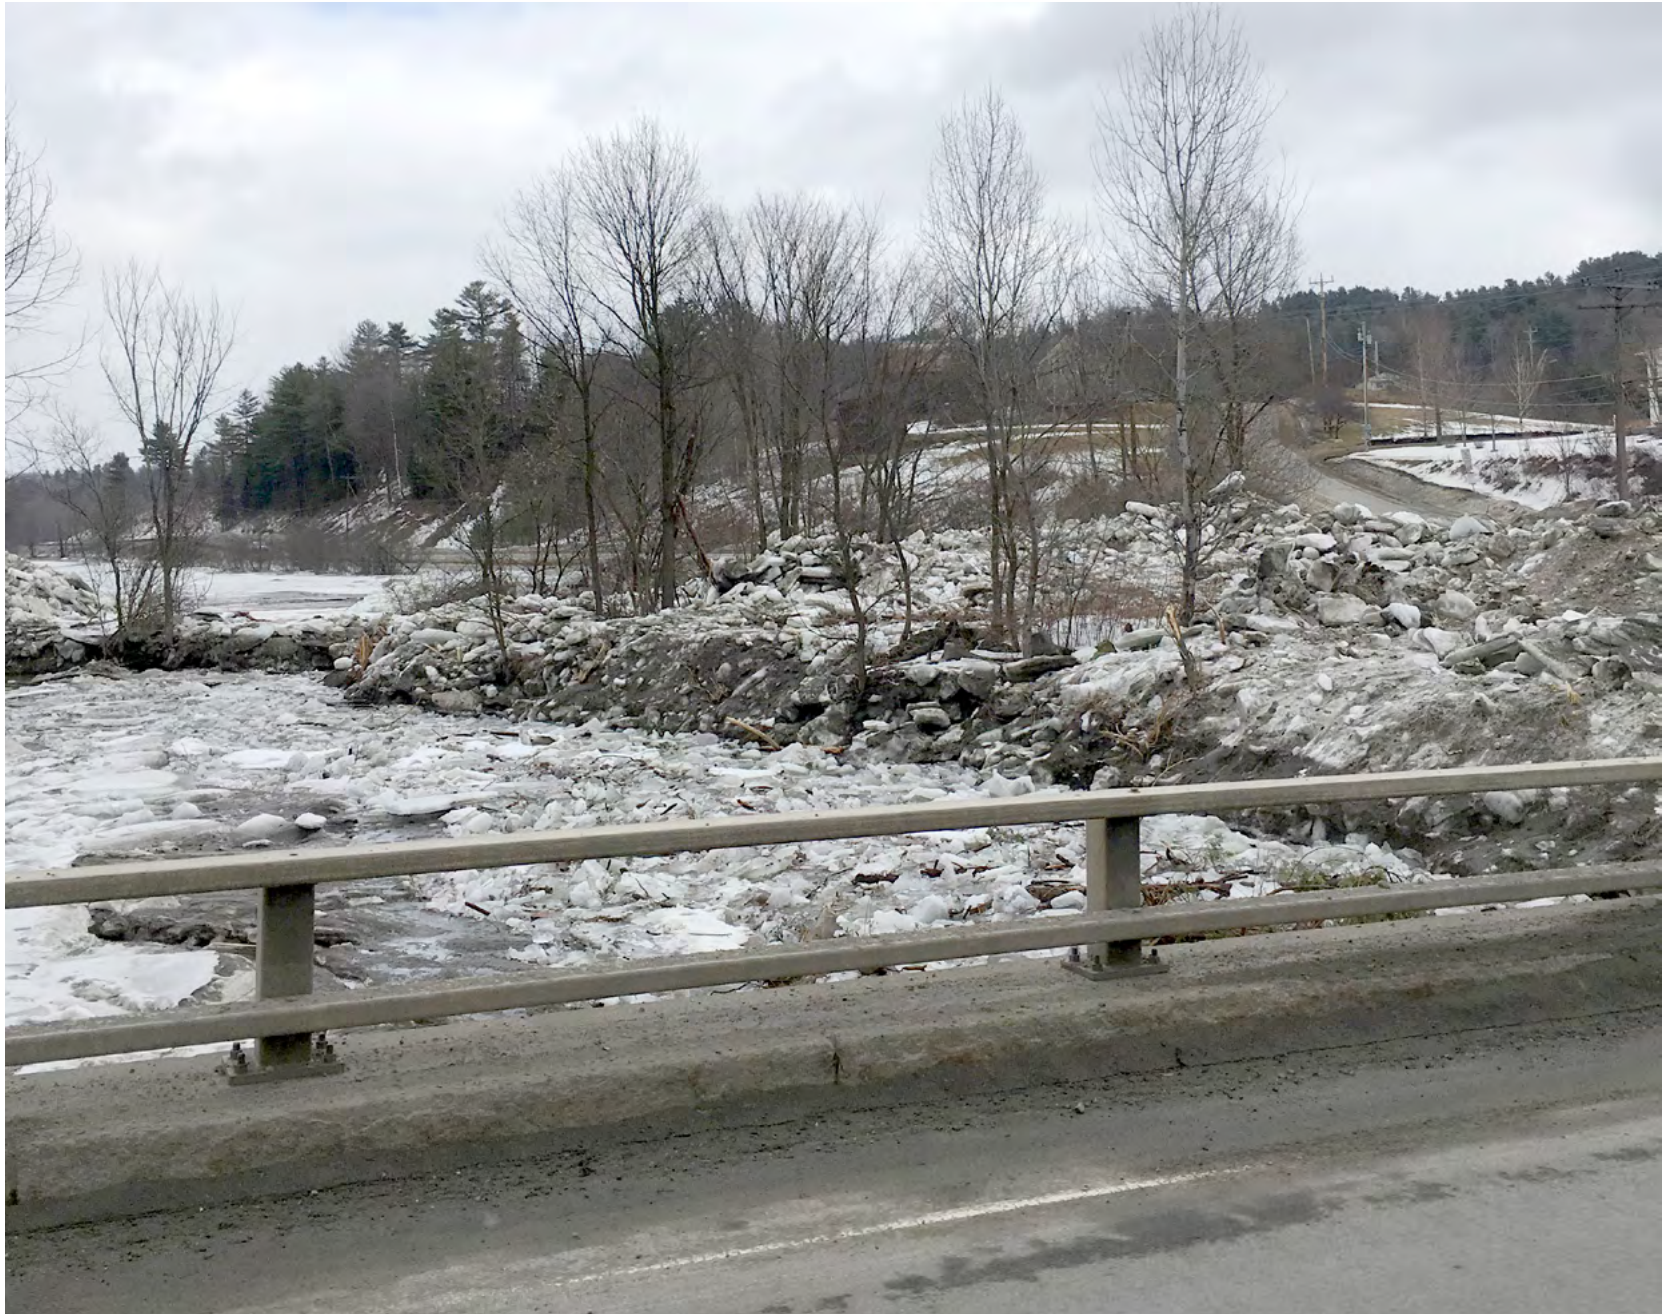
ice jam below Rte 14 bridge Coventry January 17 2018

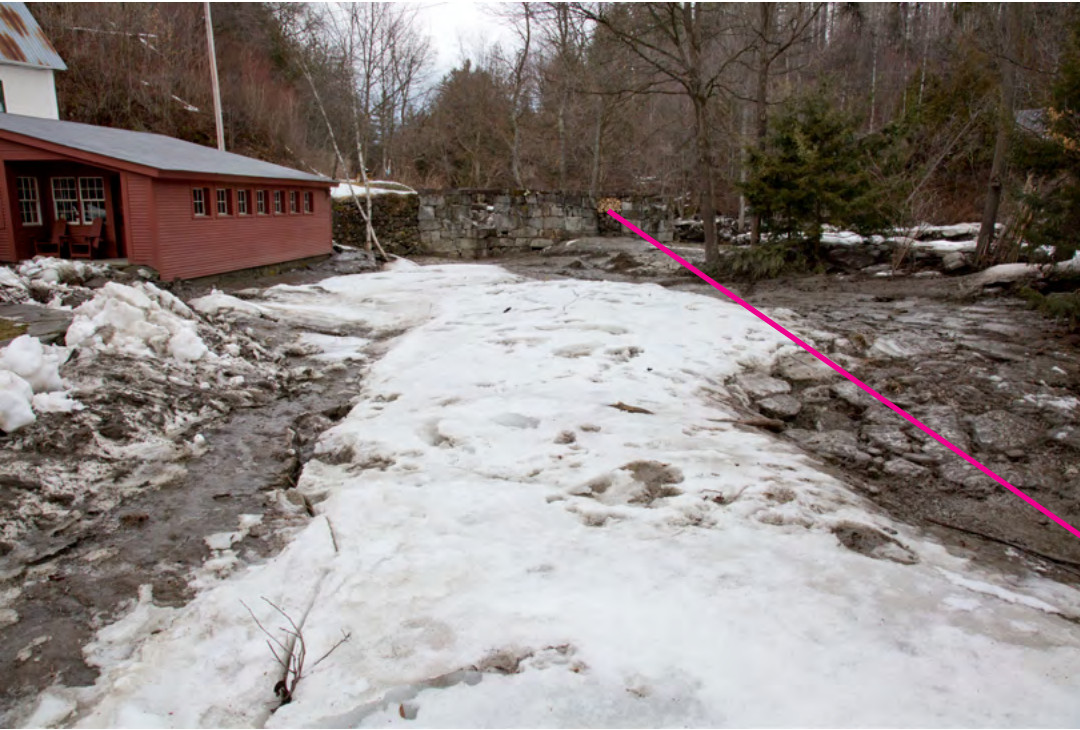
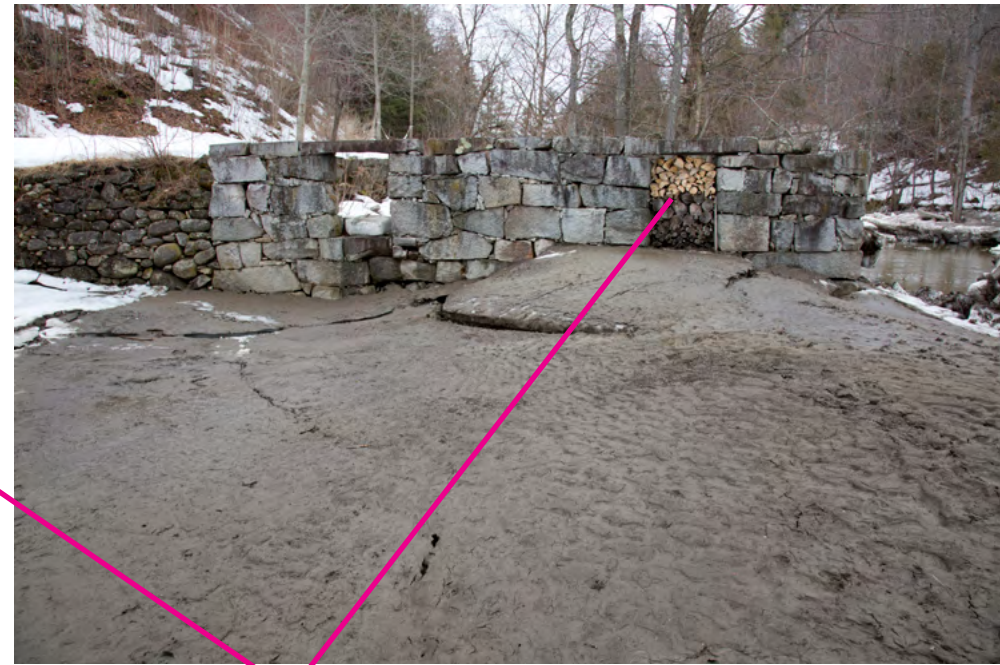
Late March 2018 Lawn and shrubbery damage, extensive silt deposits and clean-up

April 2018 Silting on lawn (3-4 inches deep in places) and also grist mill foundation with **flood level mark** - extensive silt in water up to this depth

This grist mill granite wall served to hold back river ice (many chunks 10x10x2 feet thick) from directly impacting house and sheds

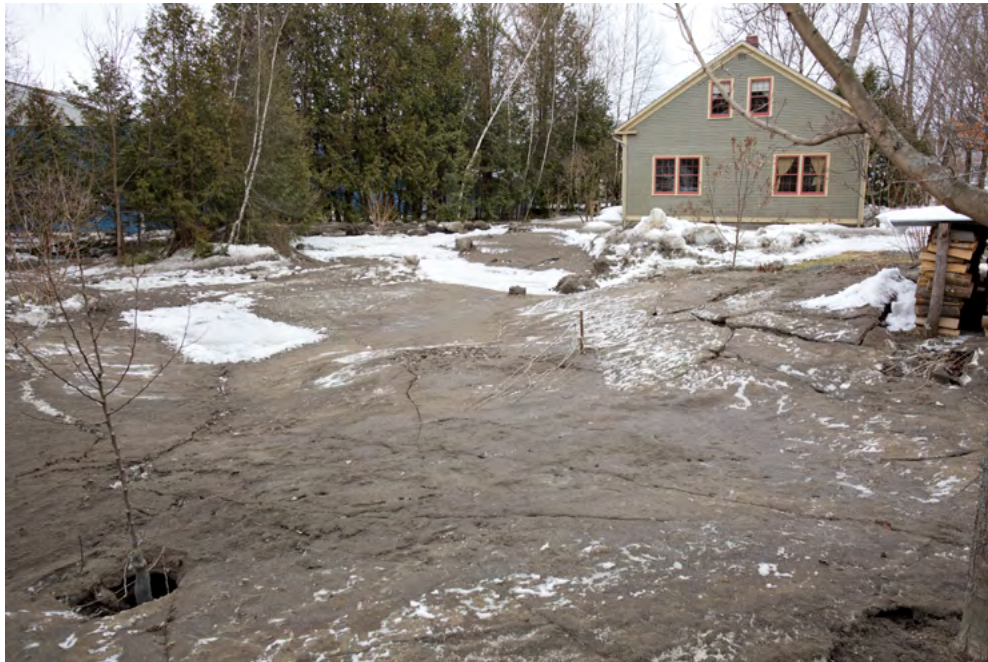
Ice and silt damage on another property in village, April 2018

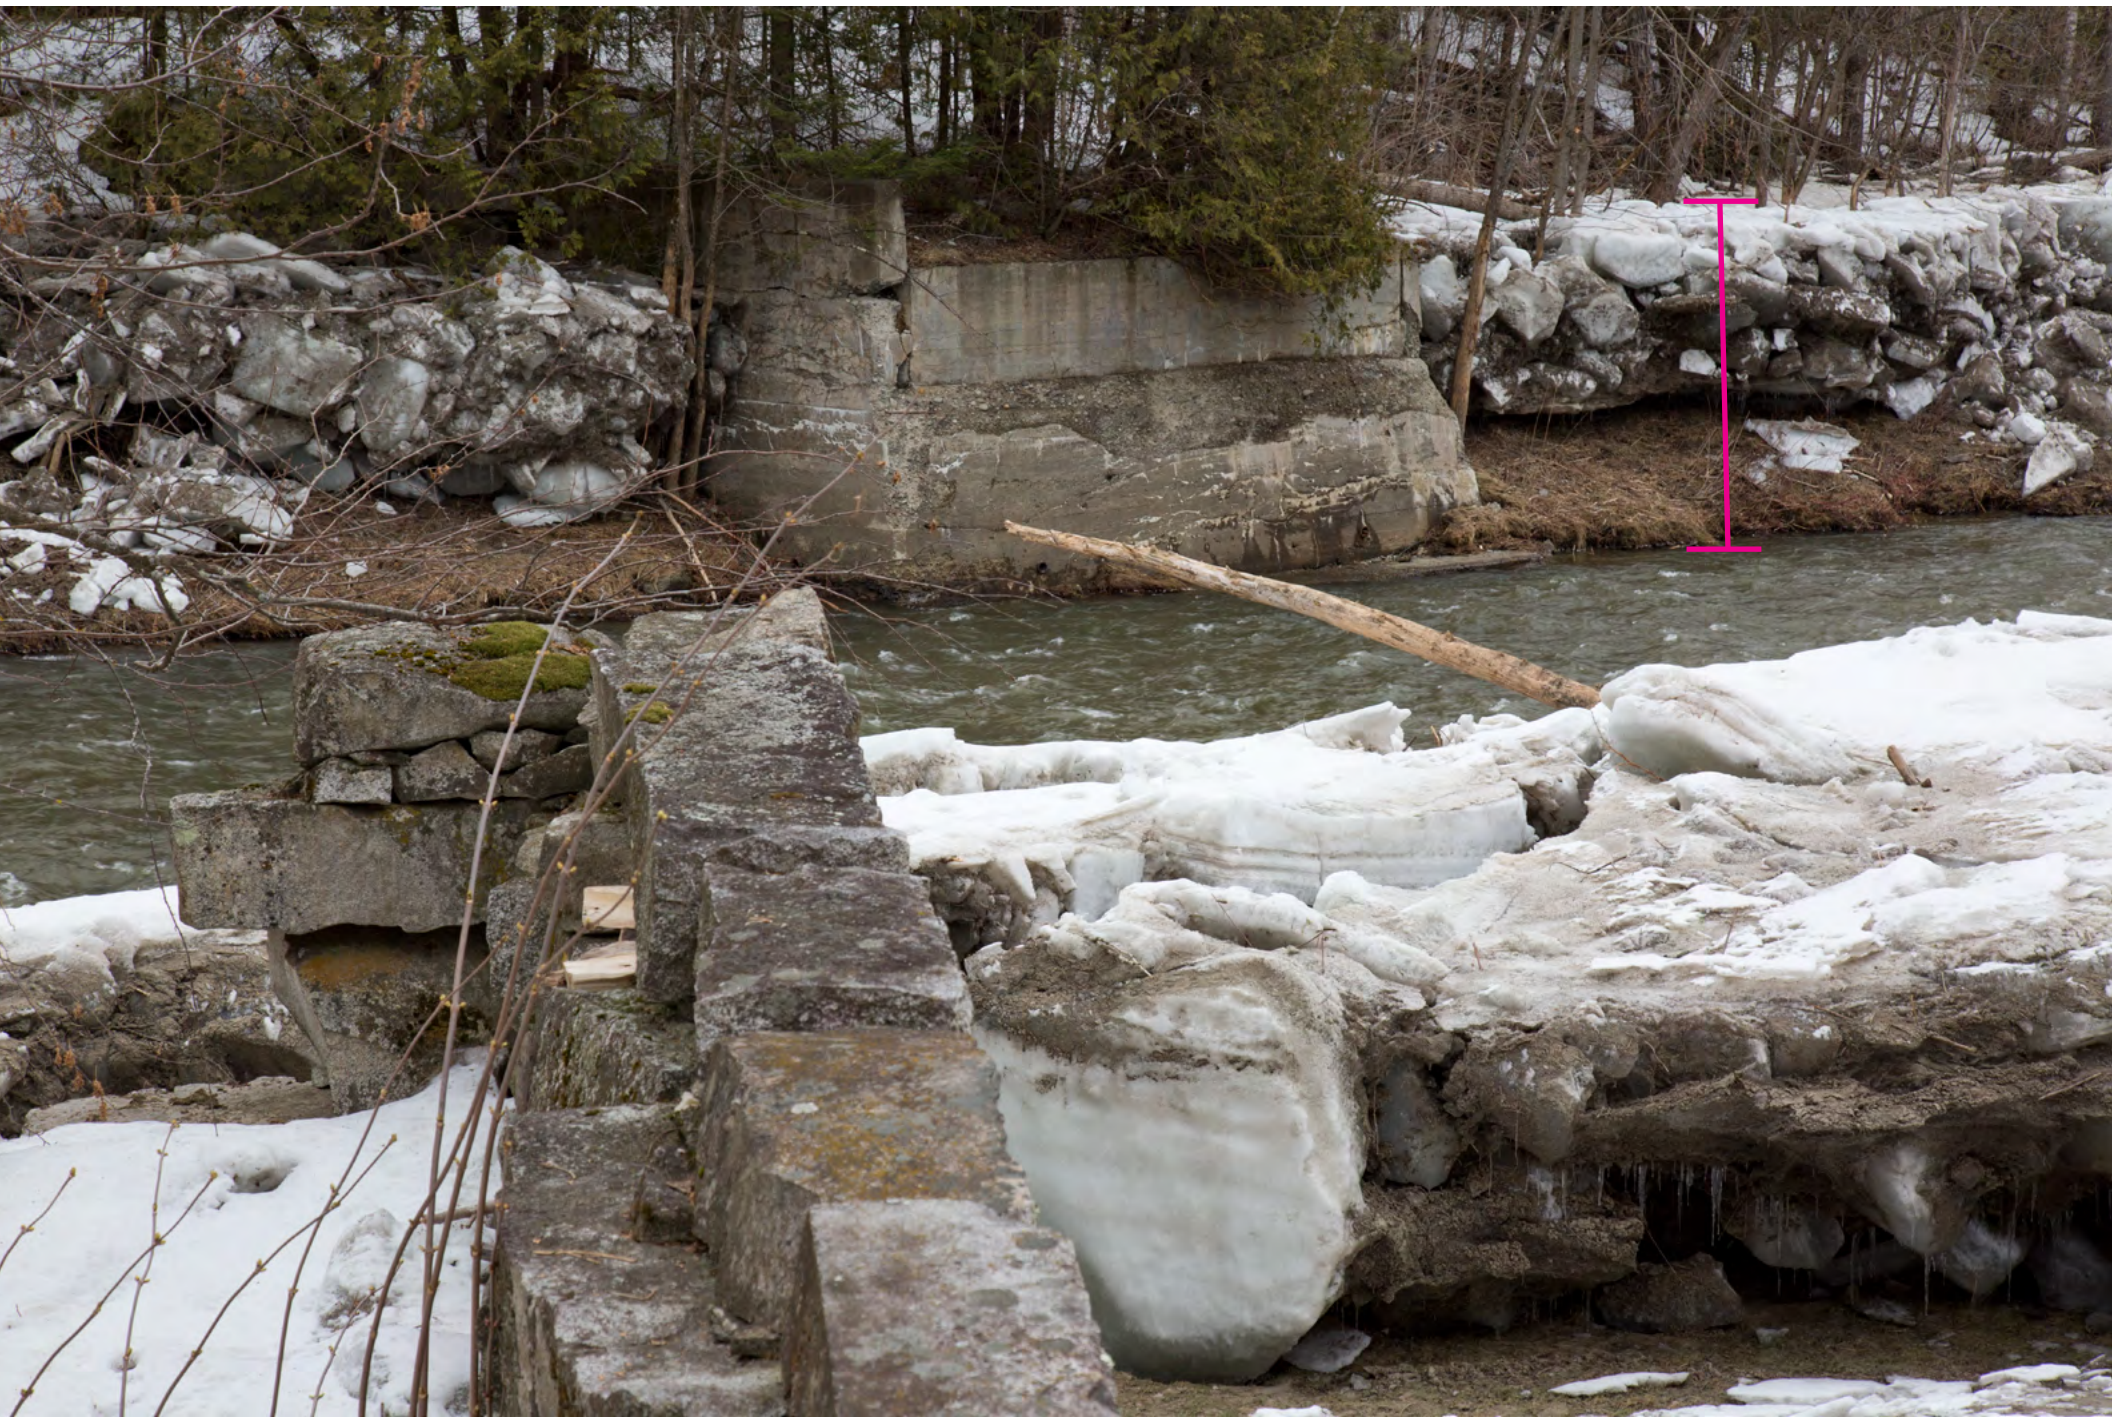
mid-April 2018 **Grist mill foundation in foreground** Note height of ice jam to right of bridge abuttment (approx 15 feet) 3 months after ice jam

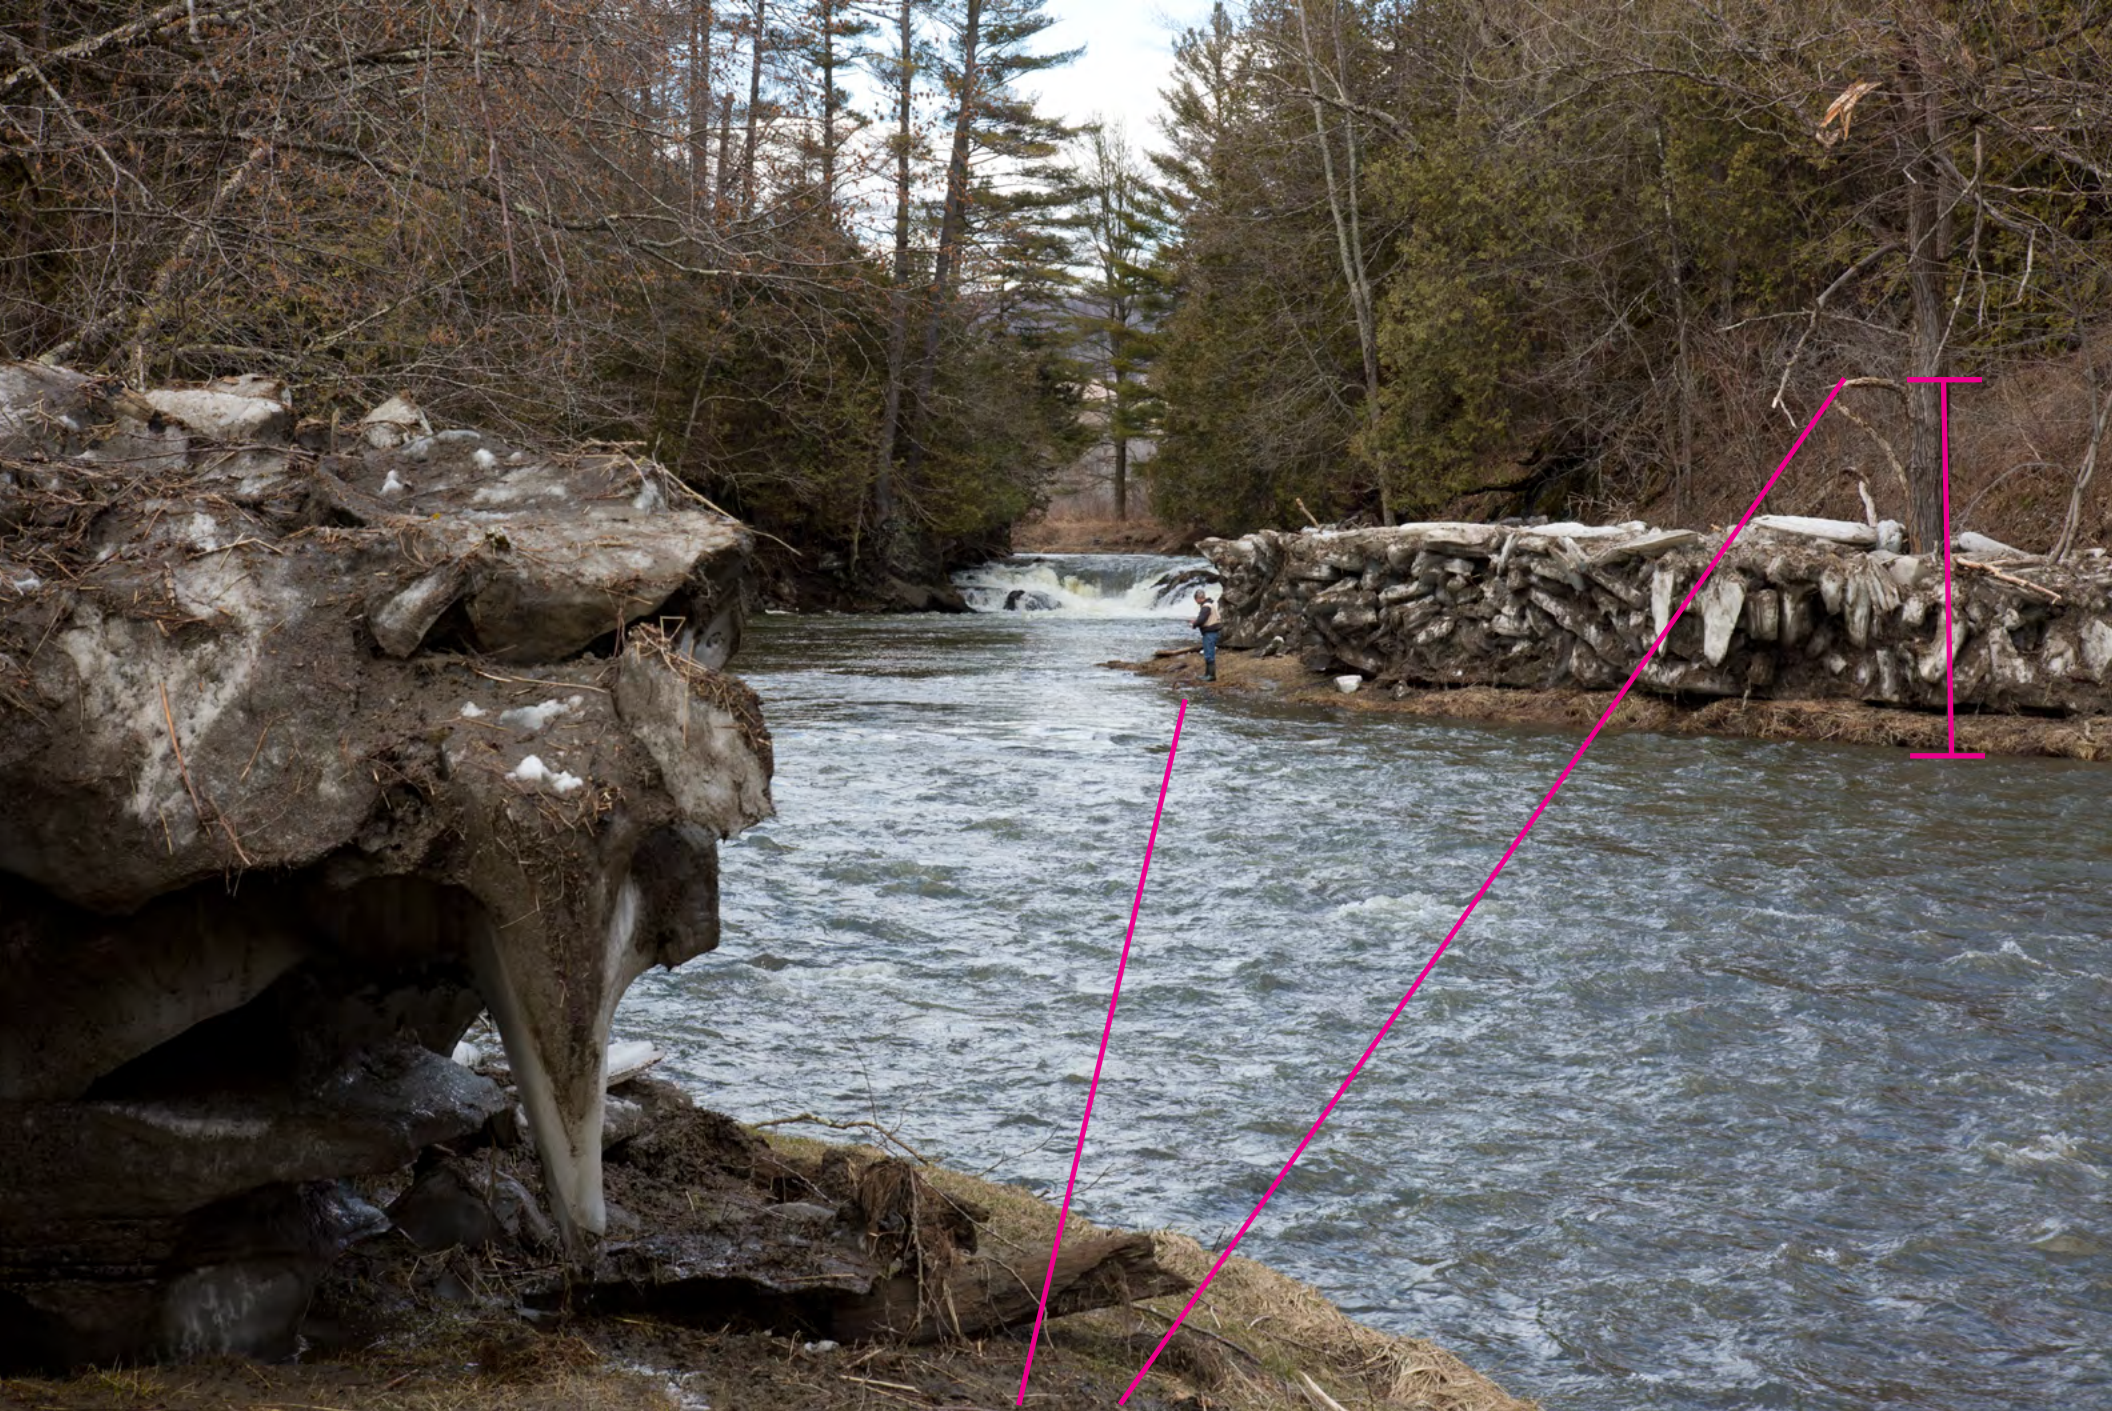
Late April 2018, lower fall - note fisherman near ice pack - note also broken tree limbs and scuff marks on tree bark from ice 6-8 feet above ice pack suggesting the initial ice jamb was substantially higher on Jan 13th, 2018
