COVENTRY ICE JAM FLOOD STUDY OF THE BLACK RIVER COVENTRY, VERMONT

**Prepared for:
Town of Coventry, VT**

**DuBois
& King^{INC.}**

October 10, 2025

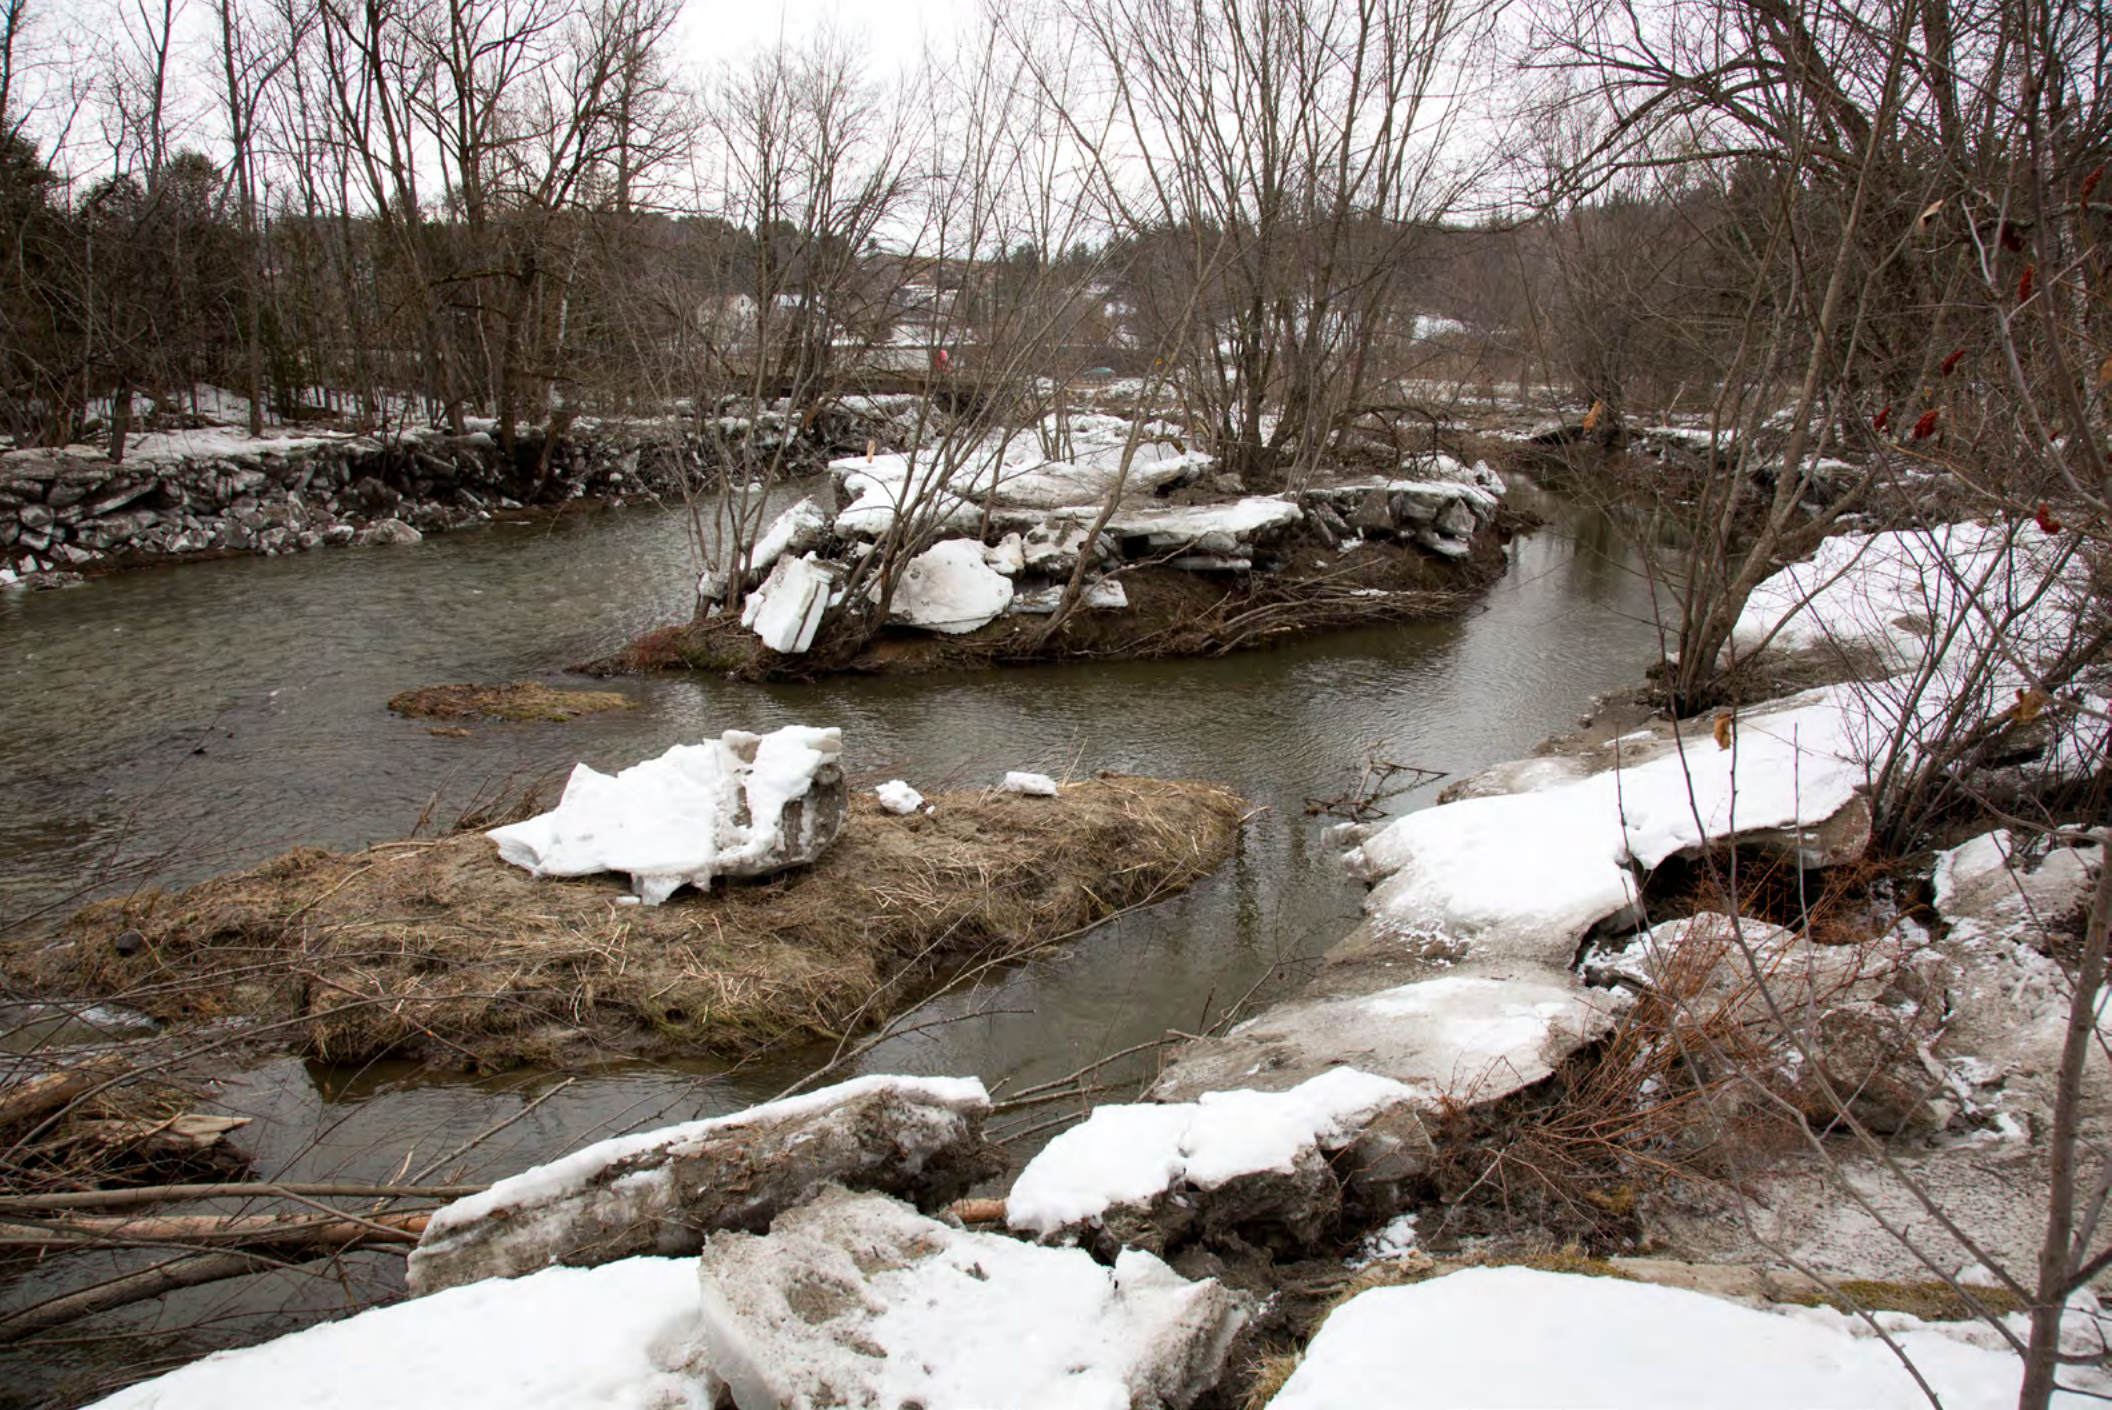
- The island upstream of the Route 14 North Bridge may be aggrading and impacting the channel's ability to transport ice.
- The recent jam of March 2025 did not cause extensive flooding.

The island that exists in the Black River upstream from the Route 14 North bridge reduces the flow area of the river. Sands and fines were observed on the top of the island

Thoughts - Islands in river next to village do serve to inhibit flow of ice and are one cause of ice jamming?

- Two channels serve to reduce river intensity; thus slowing movement of ice through main channel to left
- Narrowing and deepening channel would reduce ice jam?

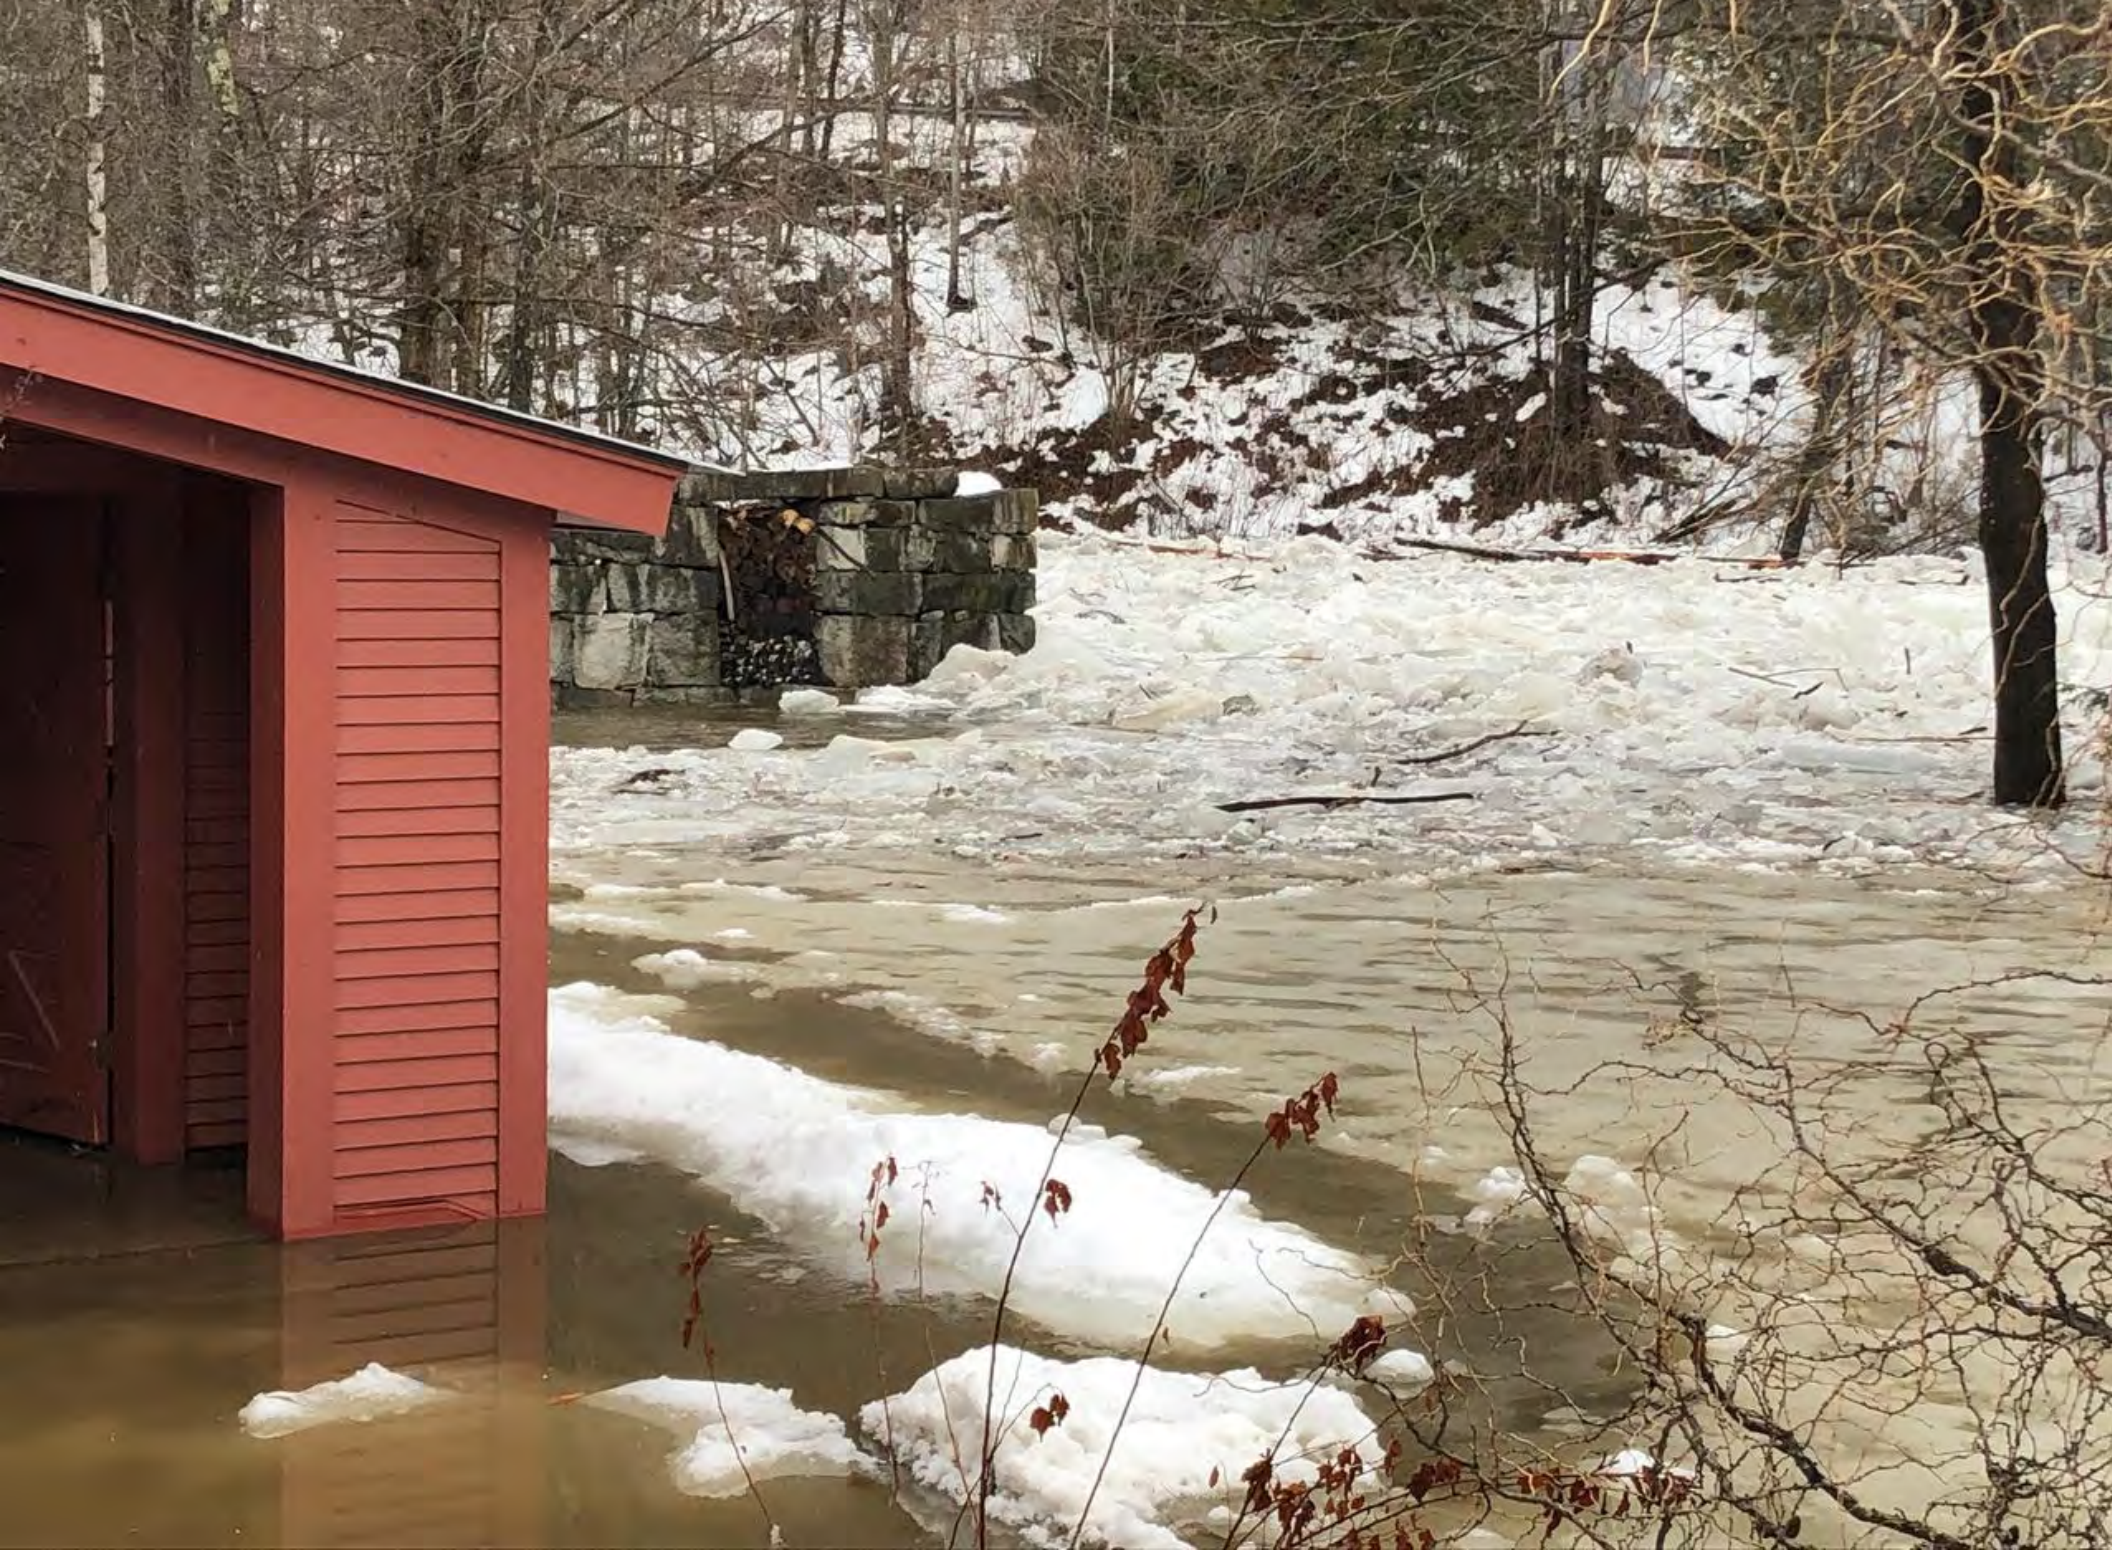
Ice Jam December 22, 2018

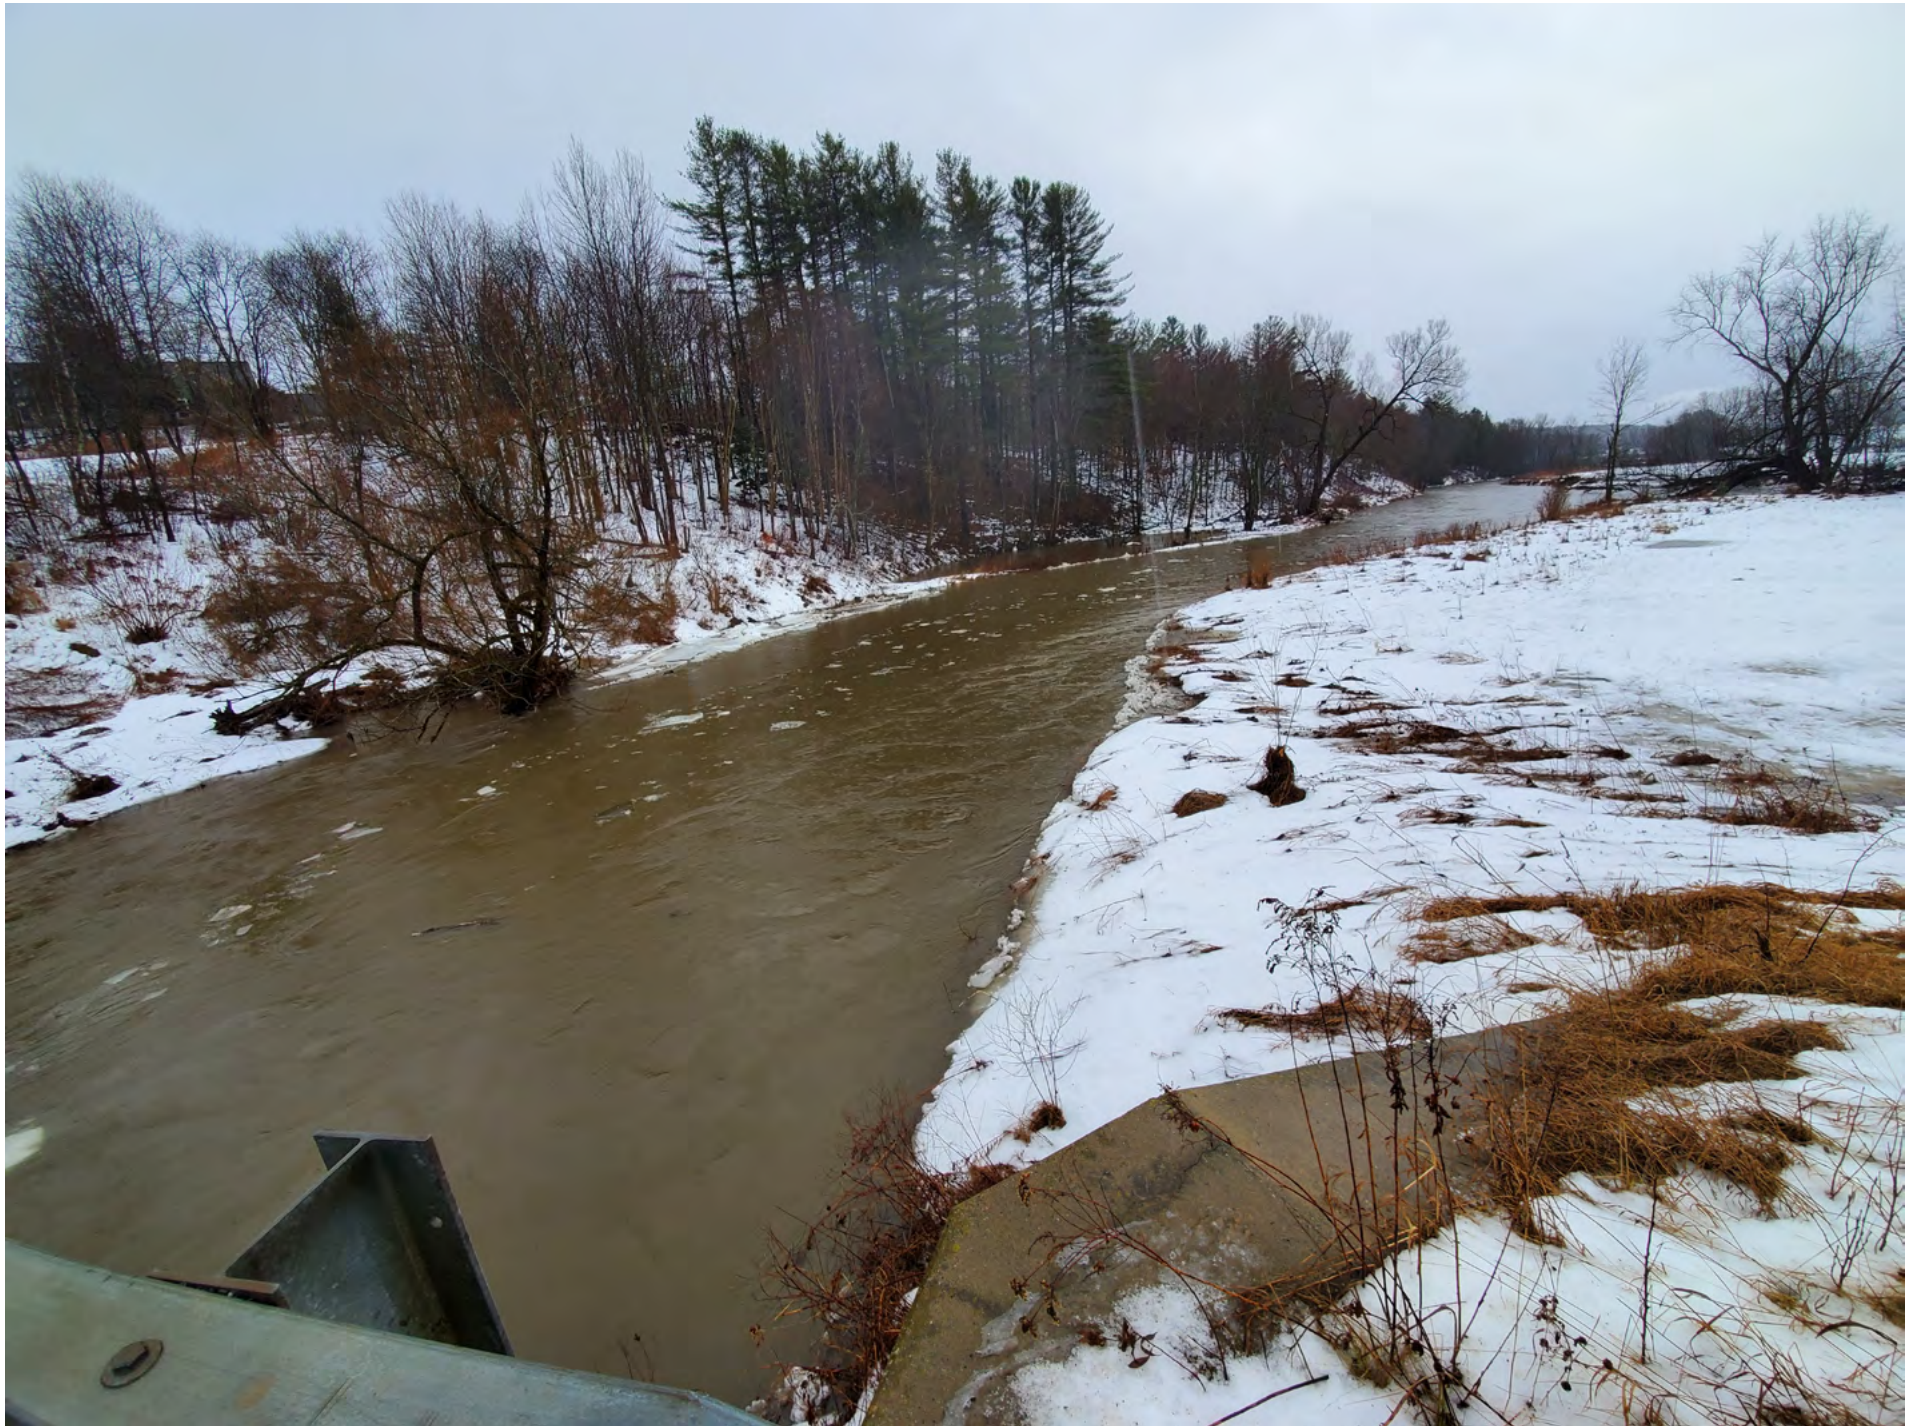
Ice jam and high water Jan 12, 2020 - At bridge above Upper Falls

Note: River channel now open with very little remaining ice at this point for it has travelled downstream into oxbow area

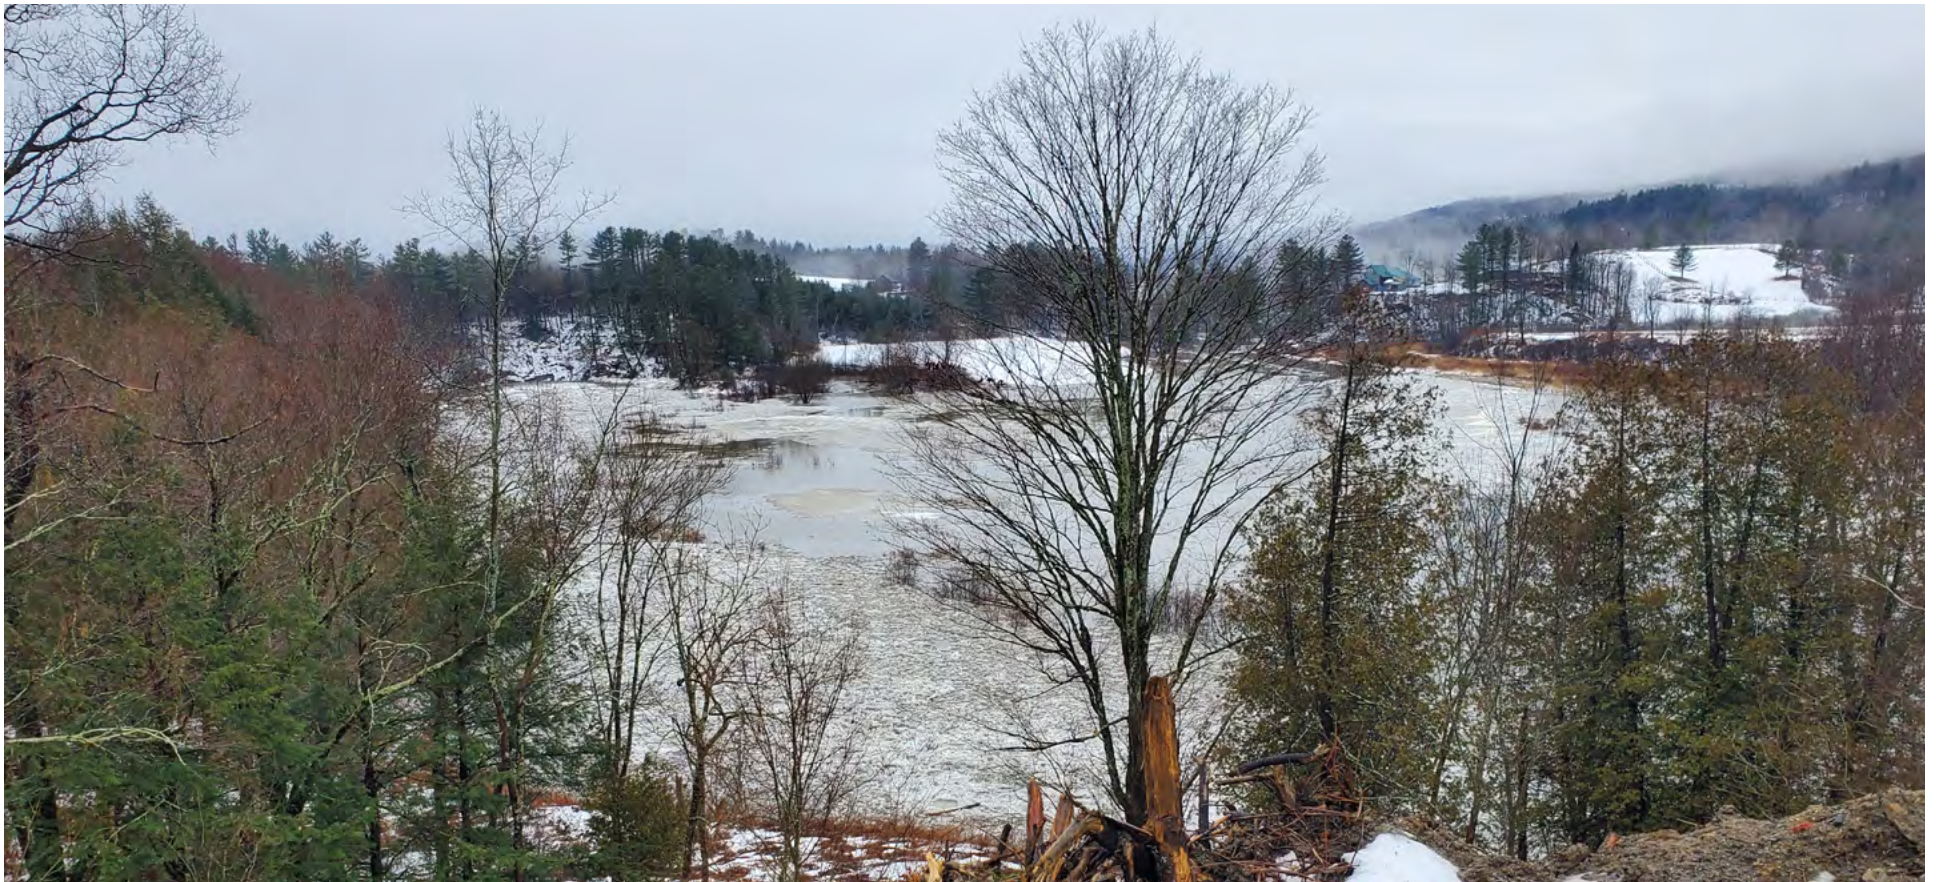
Coventry ice jam January 12, 2020 Ice jammed in oxbow upstream from village. Fortunately, this jam froze and did not inundate the village below
