COVENTRY ICE JAM FLOOD STUDY OF THE BLACK RIVER COVENTRY, VERMONT

**Prepared for:
Town of Coventry, VT**

**DuBois
& King^{INC.}**

October 10, 2025

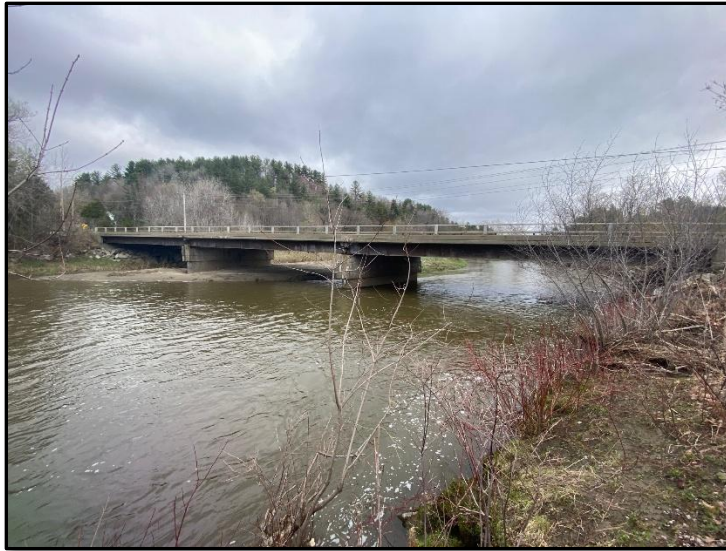
Photo 3. Looking at the Rte 105 Bridge from upstream to downstream

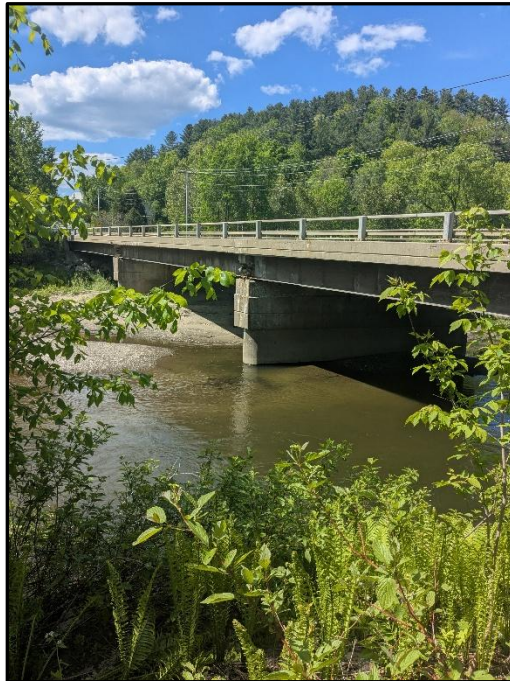
Photo 4. Looking at the Rte 105 Bridge from the right bank towards the left bank

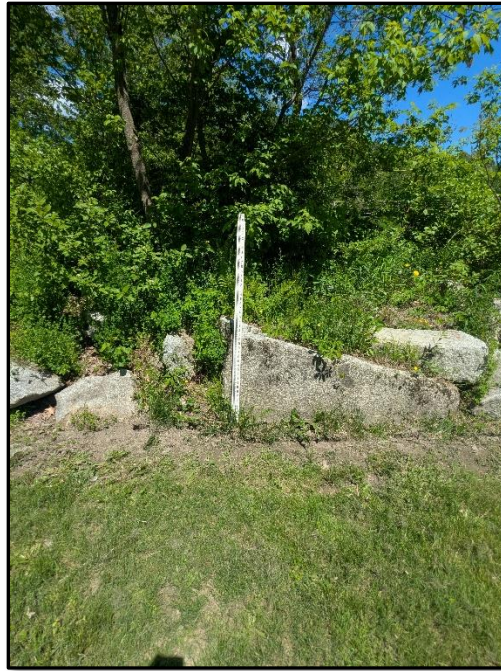
Photo 5. Large riprap along the right bank just upstream of the Rte 105 bridge. The riprap was placed along the right bank when the bridge was constructed (see Photo 2a.)

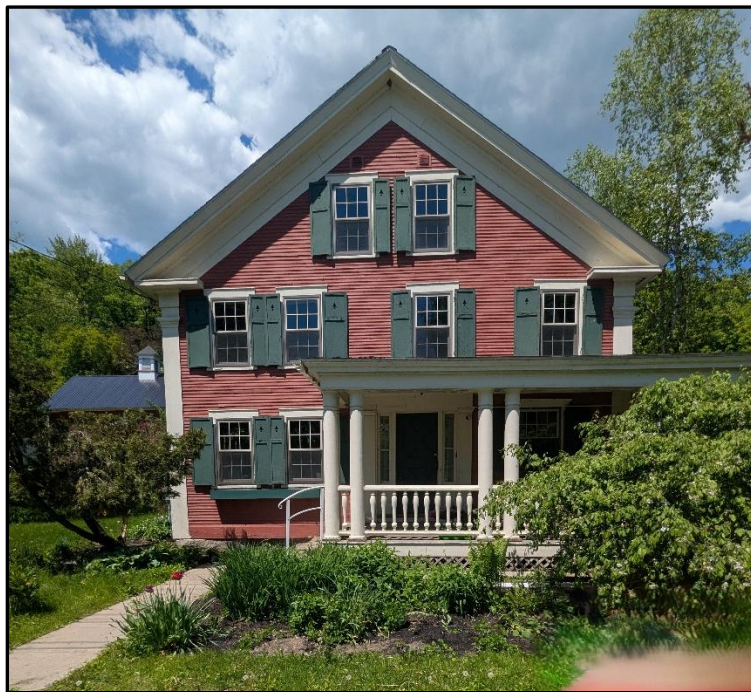
Photo 6. The home at 23 Conway Court, previously owned by John Miller. Flood waters have filled the basement of this home but not reached the first floor. The river typically overtops the right bank in the side yard of this property before flowing toward town.

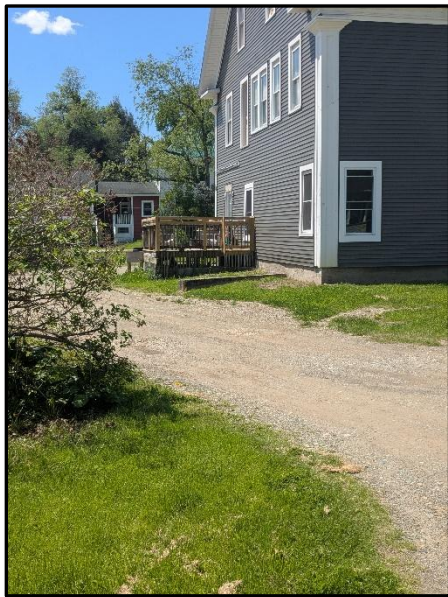
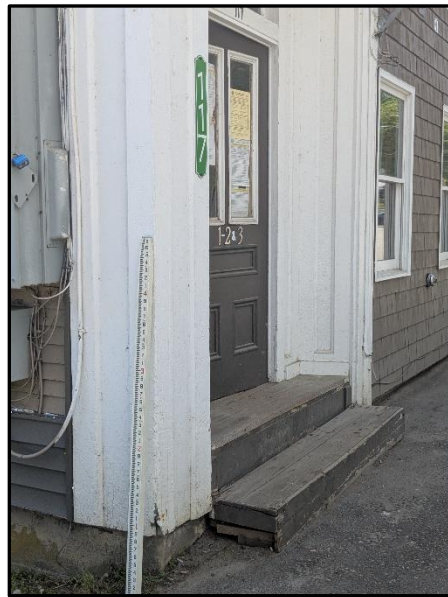
Photo 10a and 10b. Back entrance (left) and front entrance (right) of 117 Main Street. This building has been impacted by the ice jam floods.

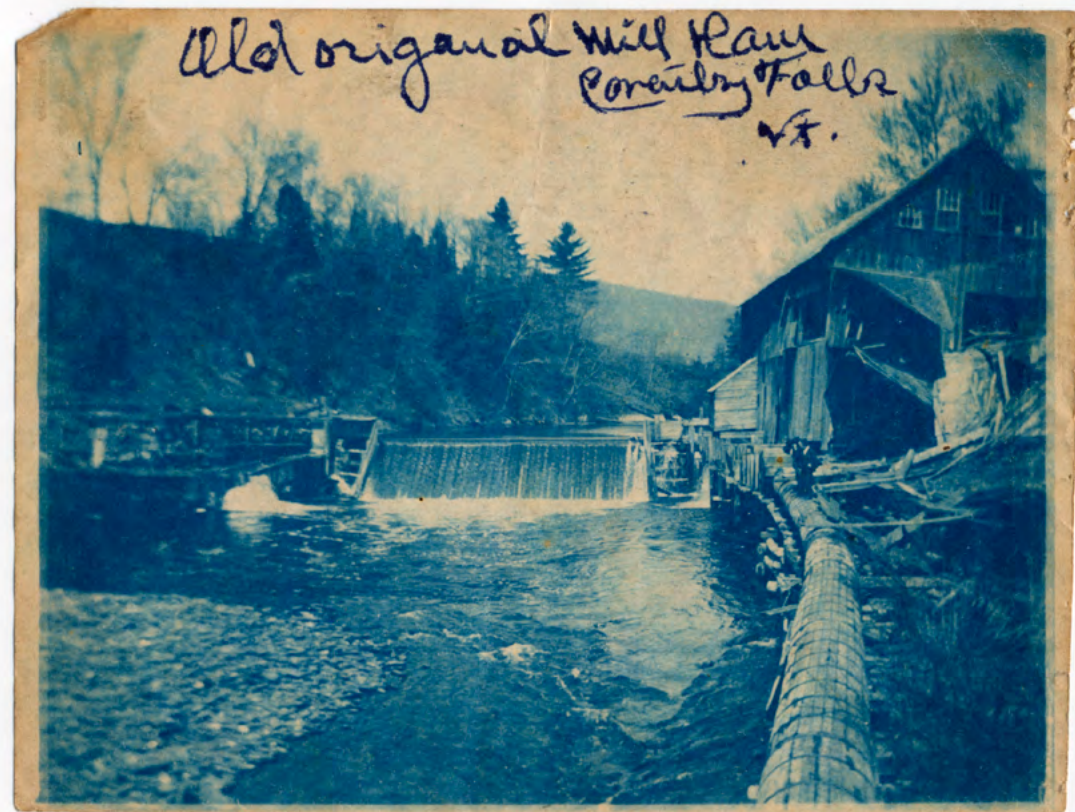
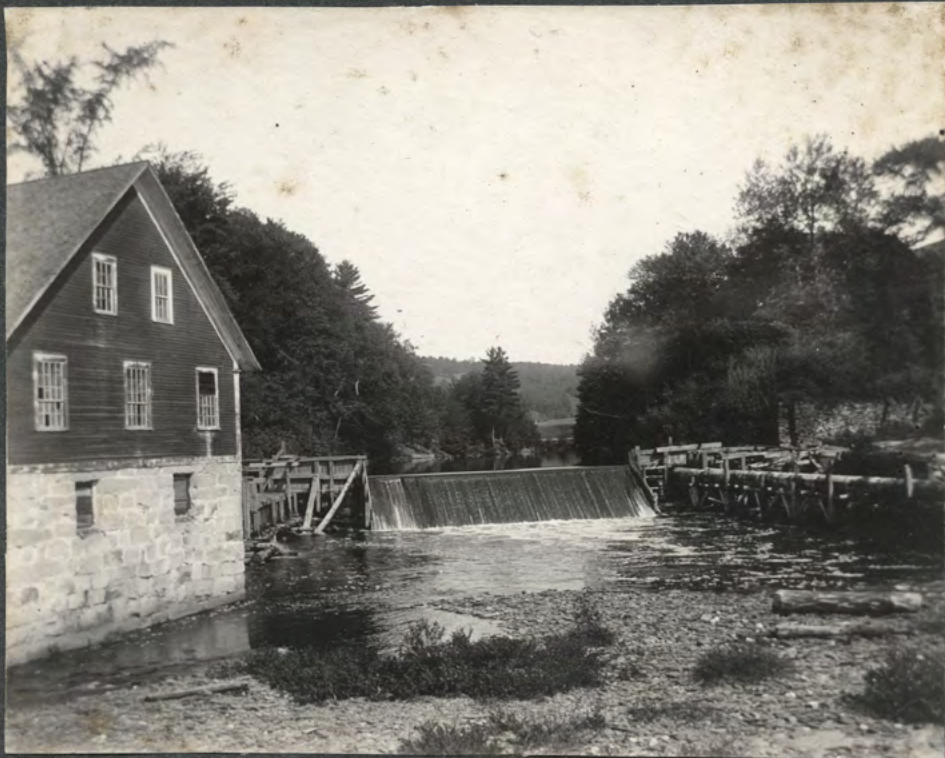
Grist mill, mill dam and penstock, Black river, Coventry village, circa 1900.
There were mill dams like this upstream - in Irasburg, Albany, Craftsbury -
all helped to deter ice jams by trapping ice during thaws at varying points
along the river.

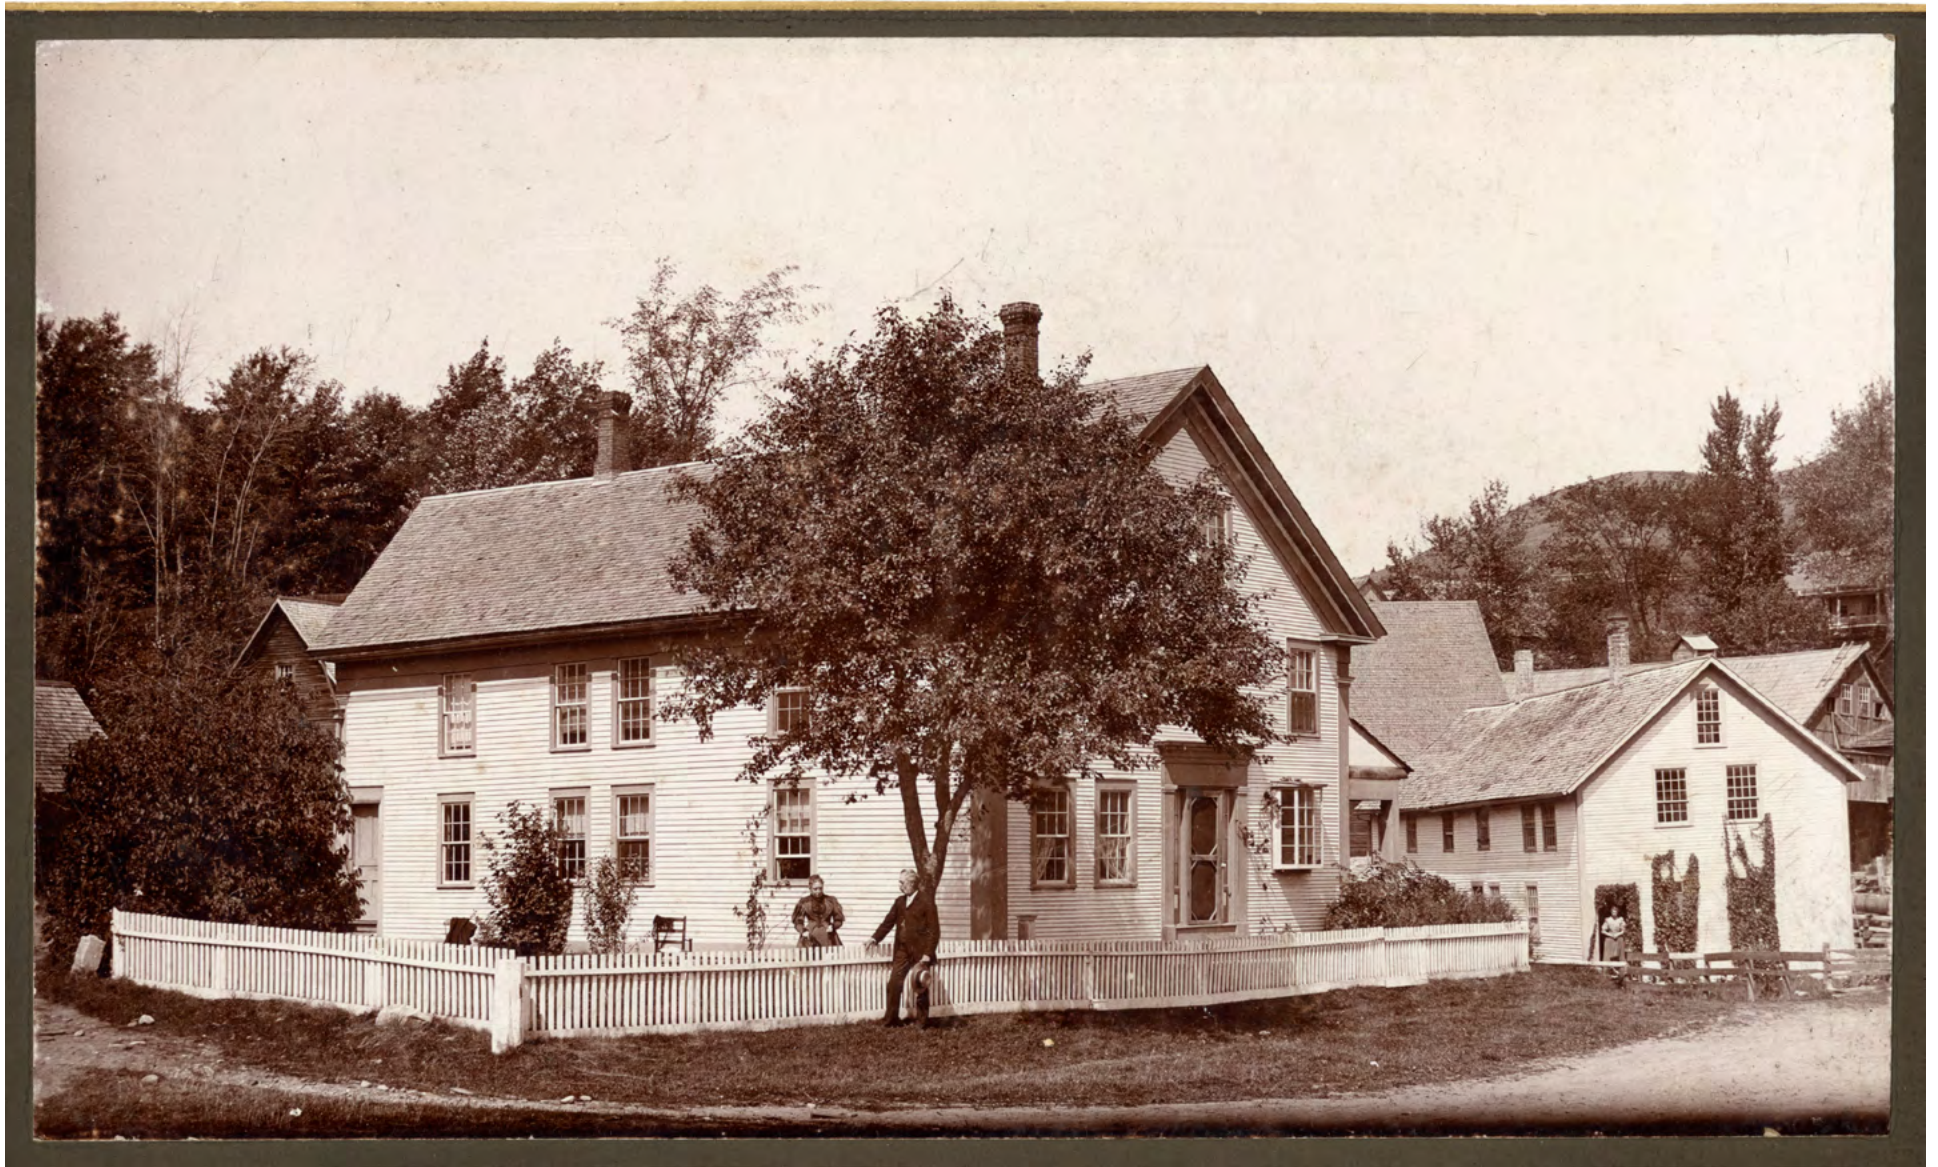
Seth Cowle house - tinsmith shop on right - grist mill roof beyond left and starch factory beyond right (across river)

As with many villages near water and water falls in Vermont, not only were the affiliated industrial buildings placed near water for power but often houses were built in close proximity. Question - How familiar were these homeowners and mill proprietors with prior history of flooding and ice jams? **Because of mill dams upstream to Craftsbury (Albany and Irasburg), ice jams may not have posed as significant a problem because of their ability to serve as catch/stop basins for ice along sections of the river. Also, flooding frequency may have been such that there was little cause for concern?**

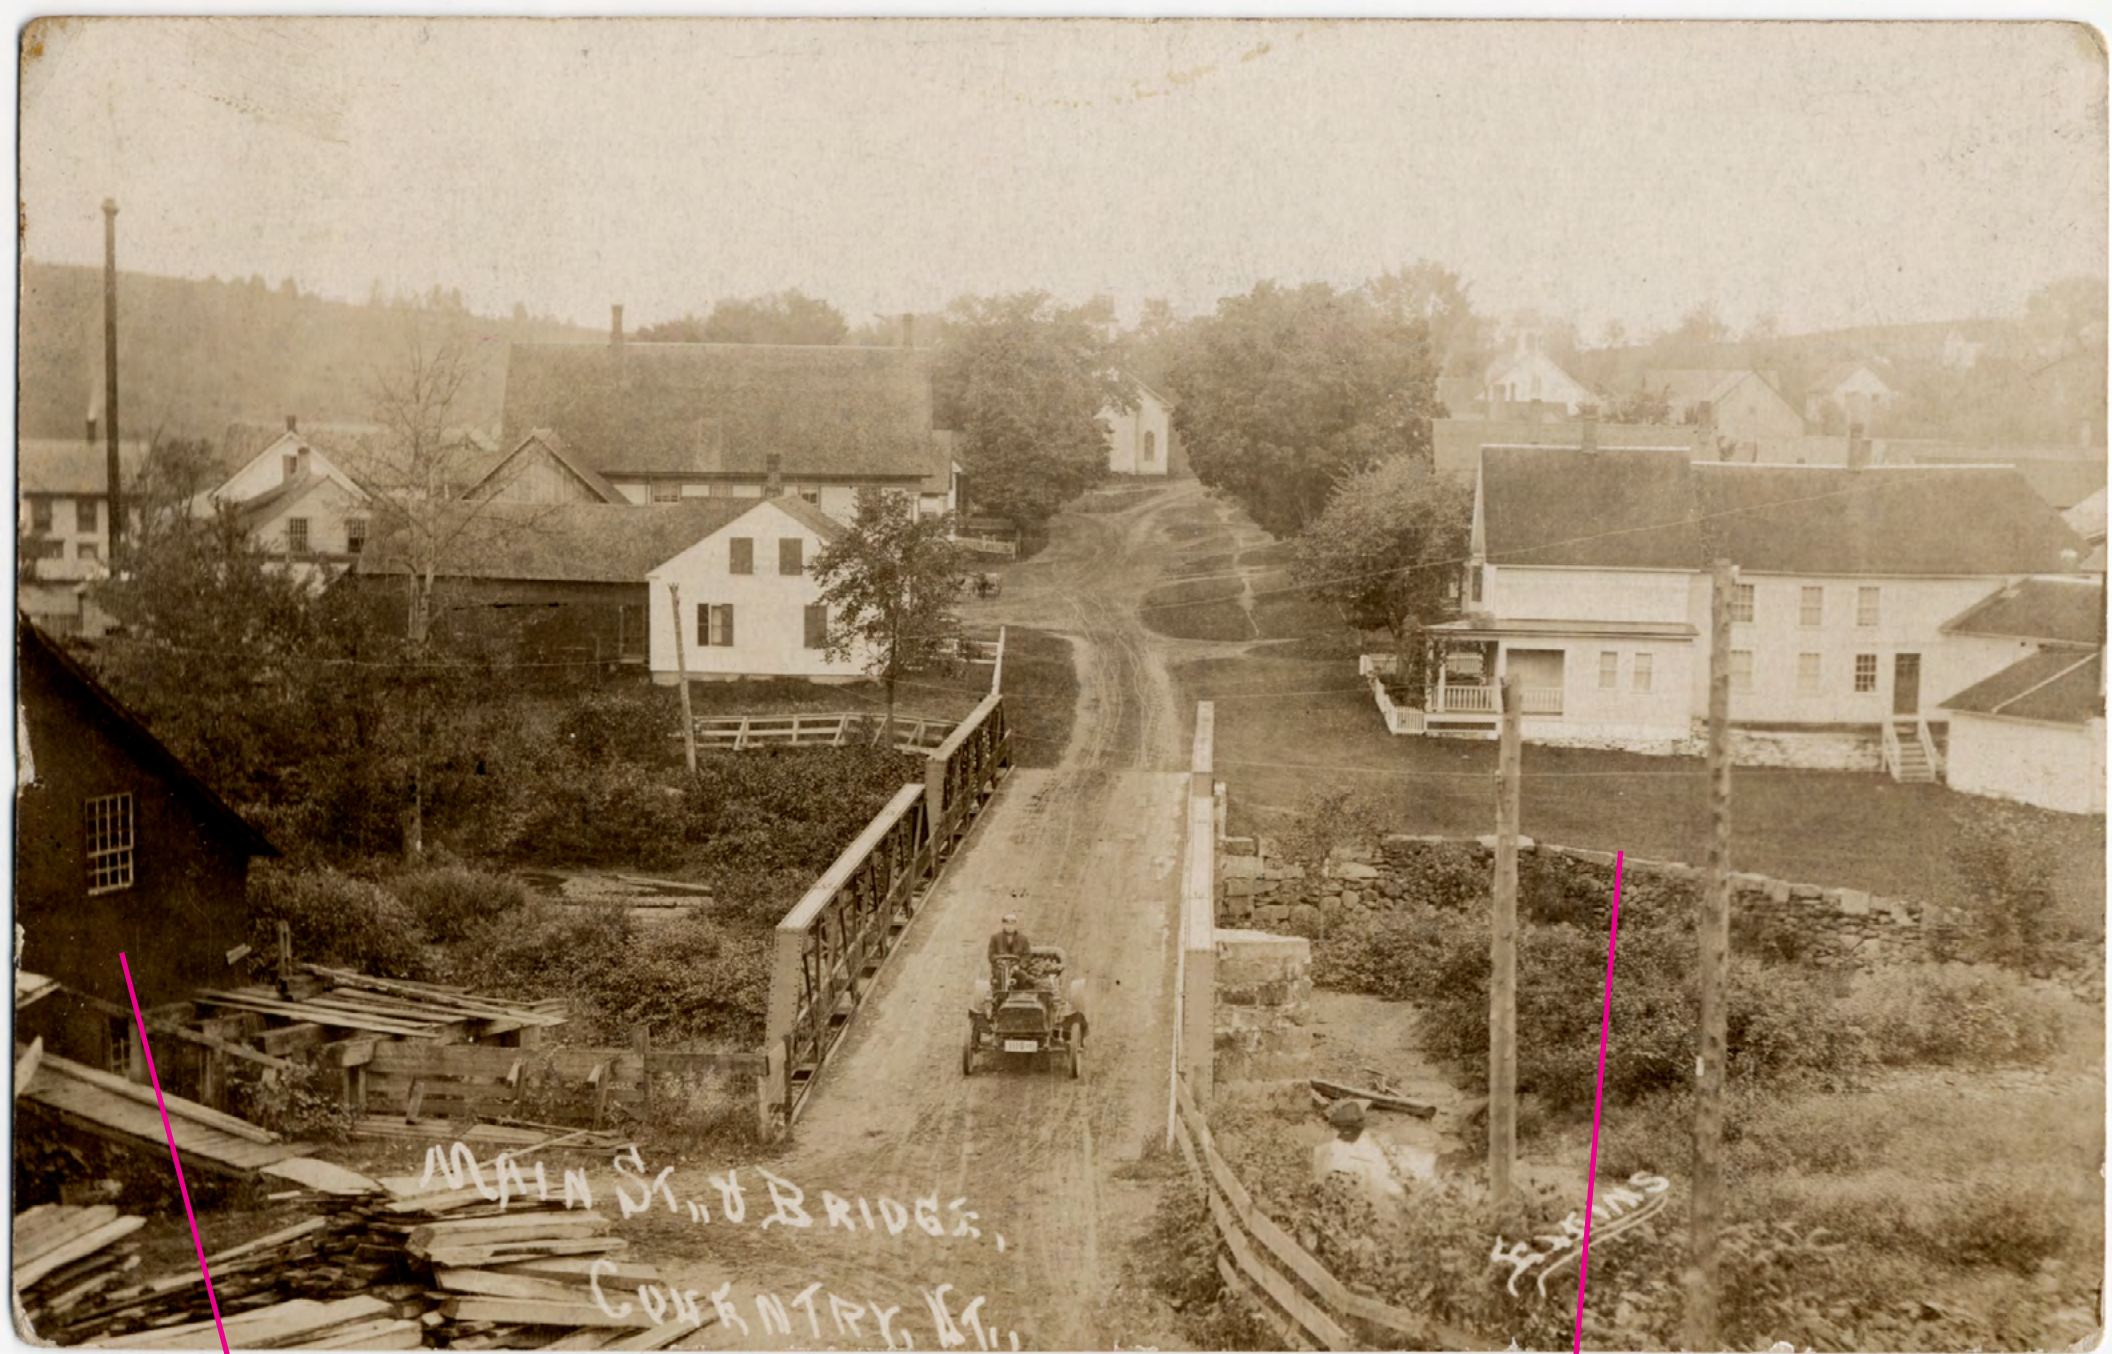
Early Rte 14 steel bridge across Black River, Coventry, circa 1910

See picture on previous page
Note: Tinsmith shop has been removed. Why?
Closed business, ice jam, flood?
Only the slate and granite foundation remains

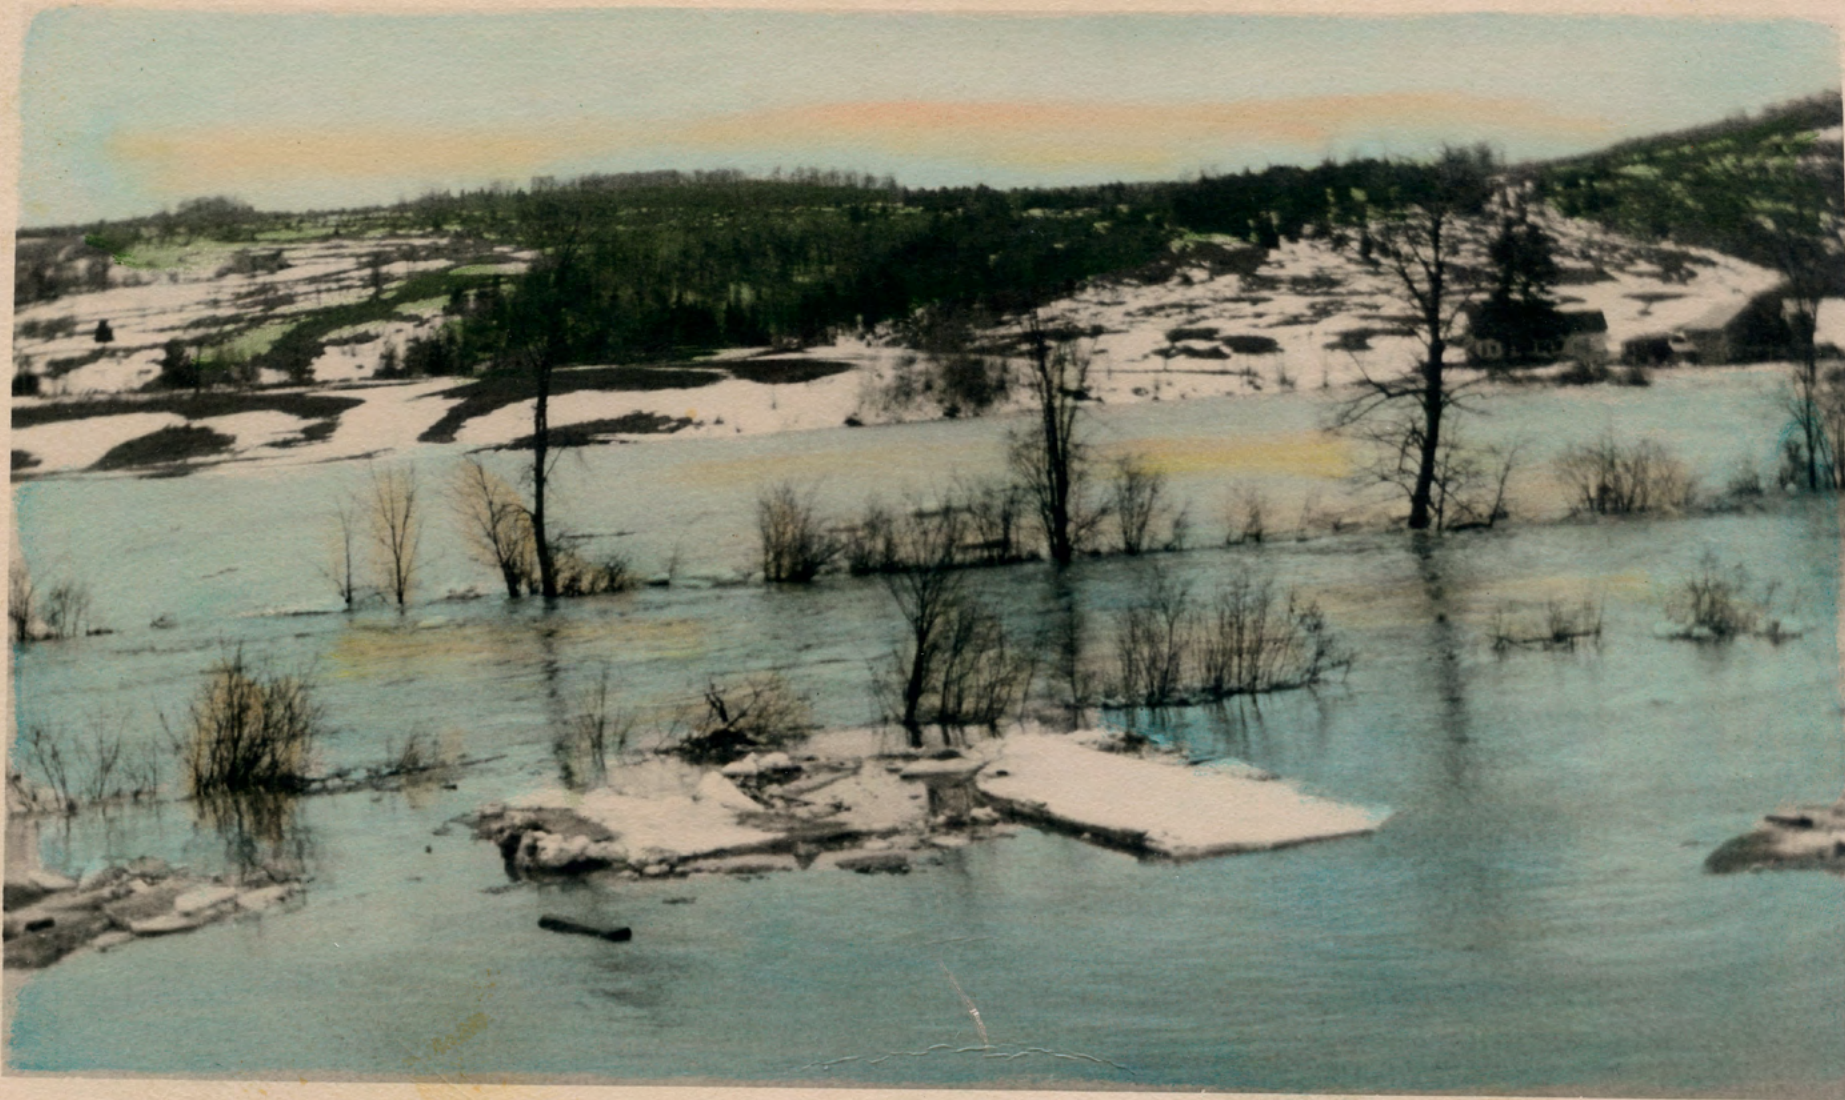
This hand-colored photo was made in April 1936, upstream from the village, and just above the upper falls at Heermanville. Photo was made only a month after the ice jam flooding in Coventry village downstream (prior photographs). Heerman's sawmill, next to the upper falls and just downstream from this photo, had been washed away during the flood of 1927 - see next page

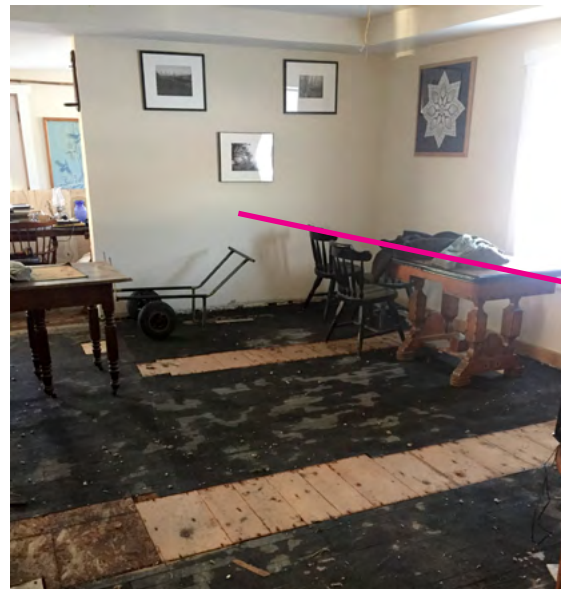
Hardwood kitchen floor, dry wall, insulation, furniture, personal items destroyed

Note wet drywall to water depth

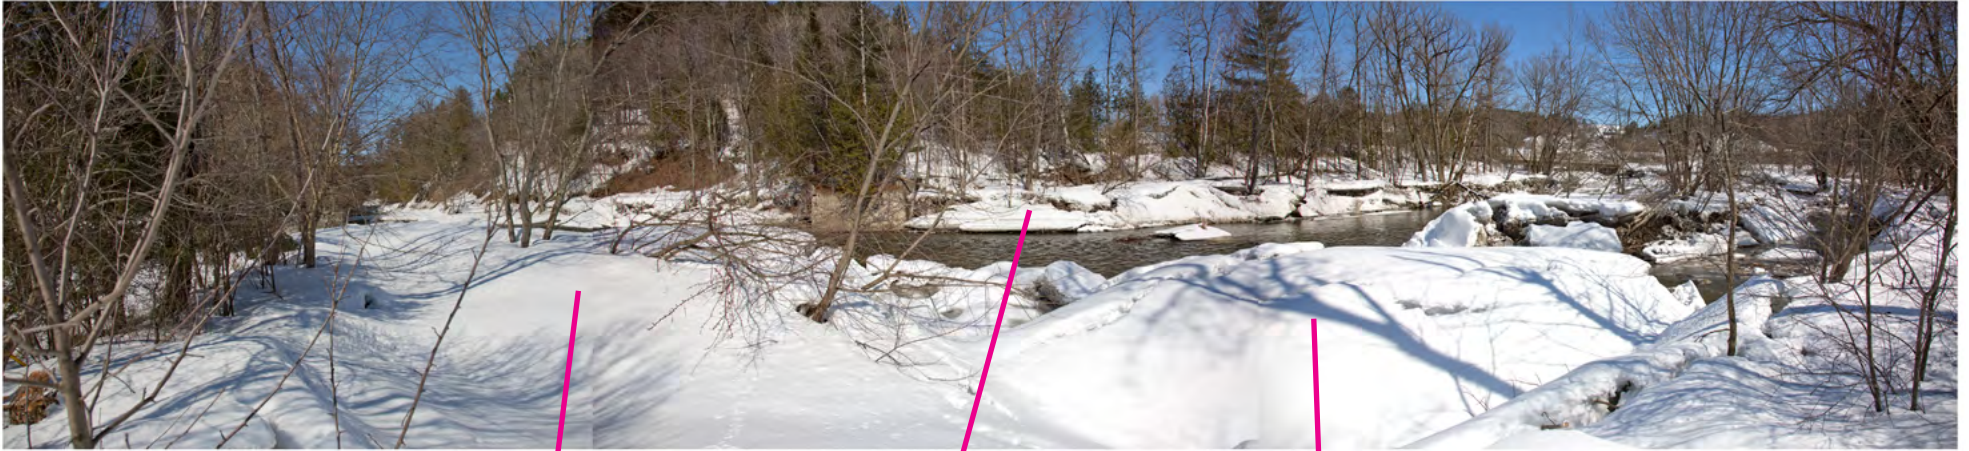
Black River, remains of late December 2018 ice jam (3rd ice jam in 2018) This photo taken in mid-March 2019. River channel opening with thawing. Ice jam under this snow pack is 8-10 feet deep in places

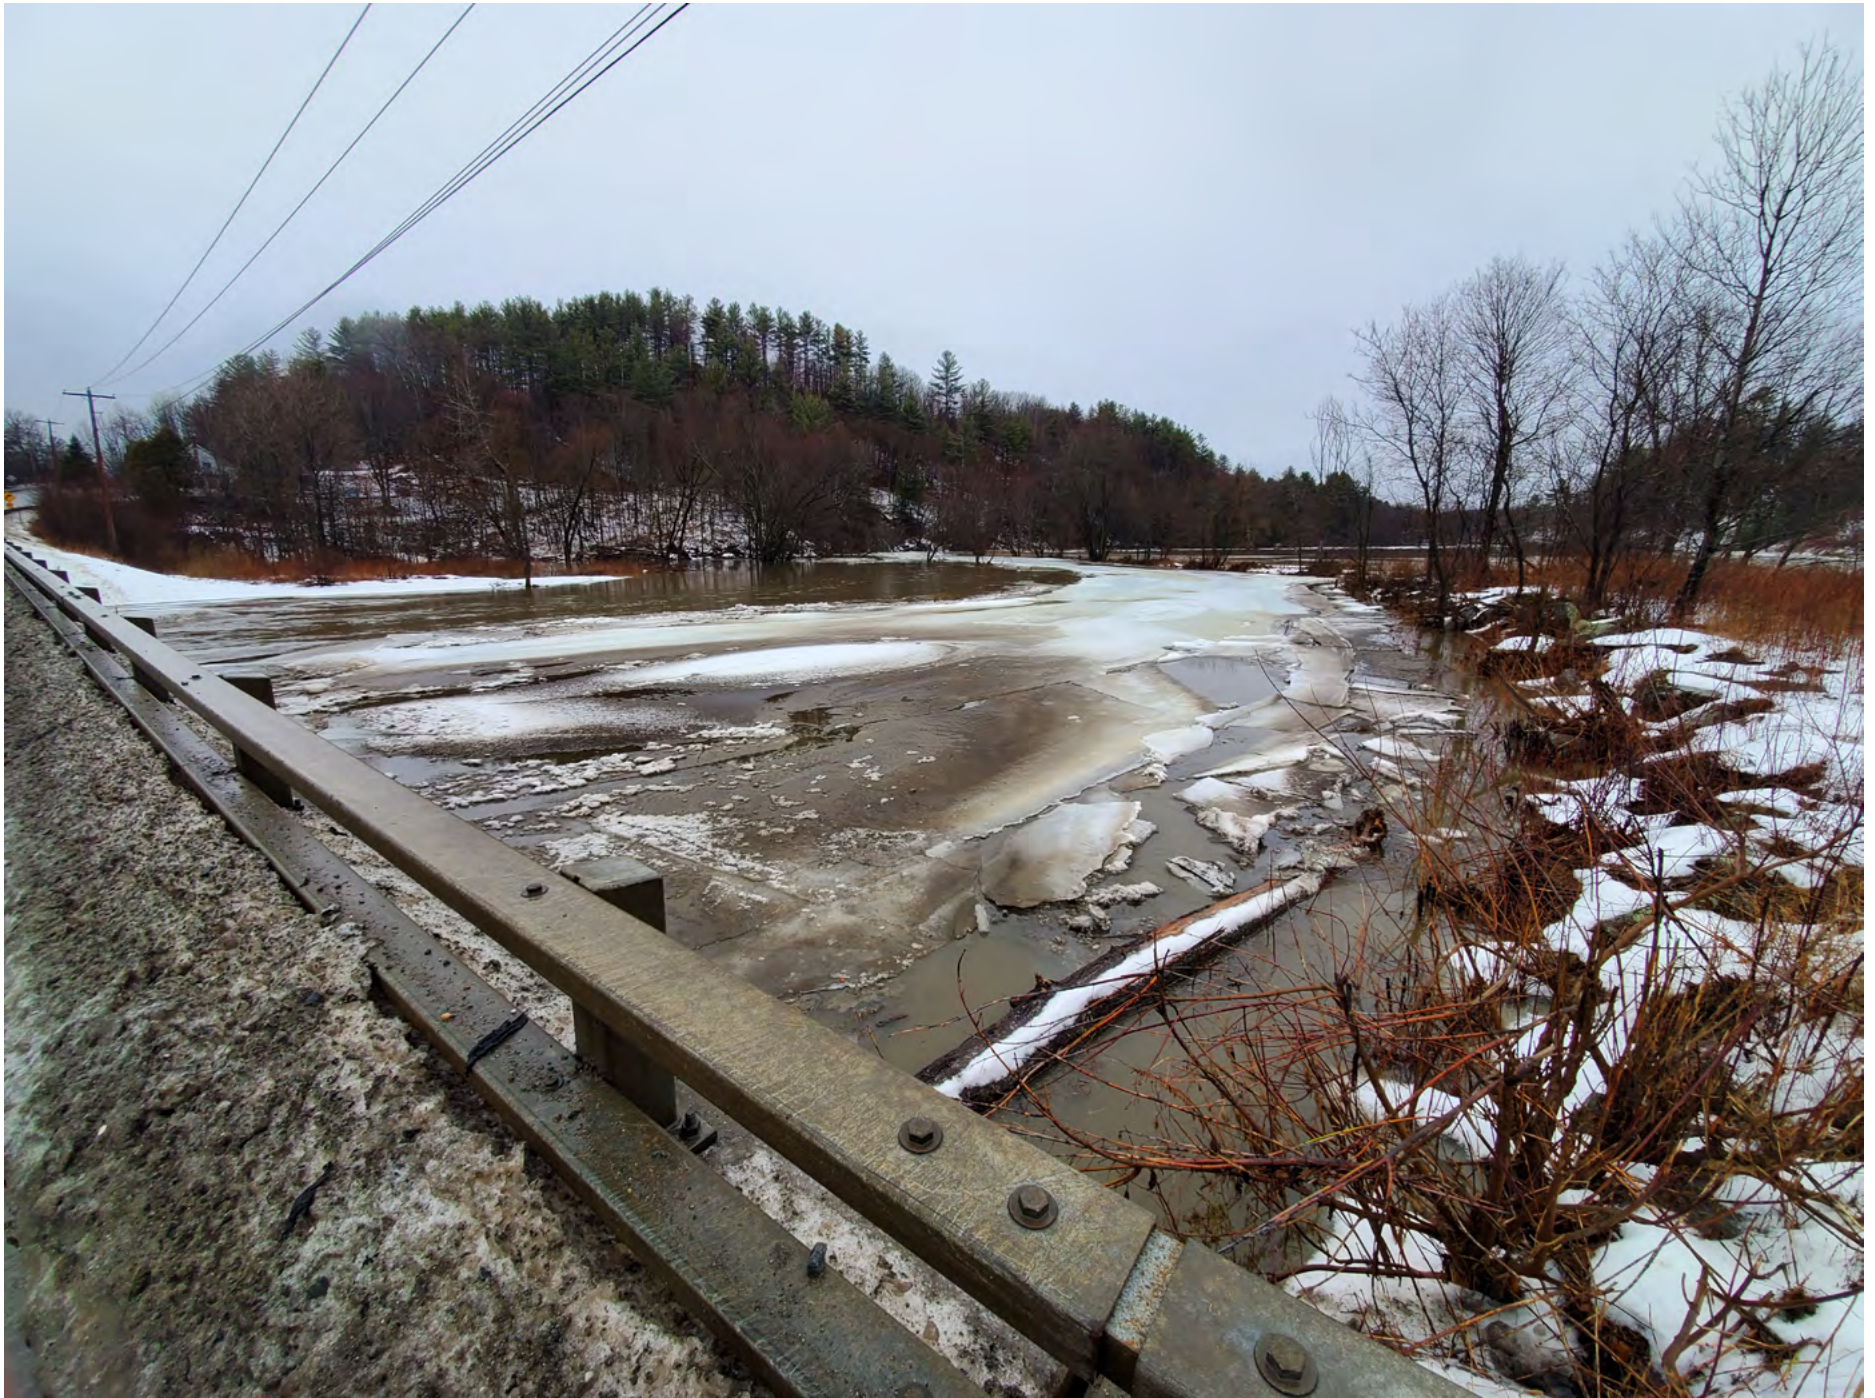
View downstream toward Newport from Rte 14 bridge Jan 12, 2020
