COVENTRY ICE JAM FLOOD STUDY OF THE BLACK RIVER COVENTRY, VERMONT

**Prepared for:
Town of Coventry, VT**

**DuBois
& King^{INC.}**

October 10, 2025

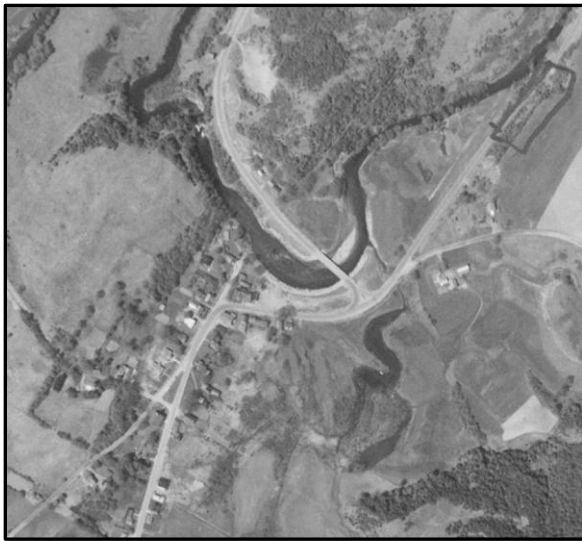
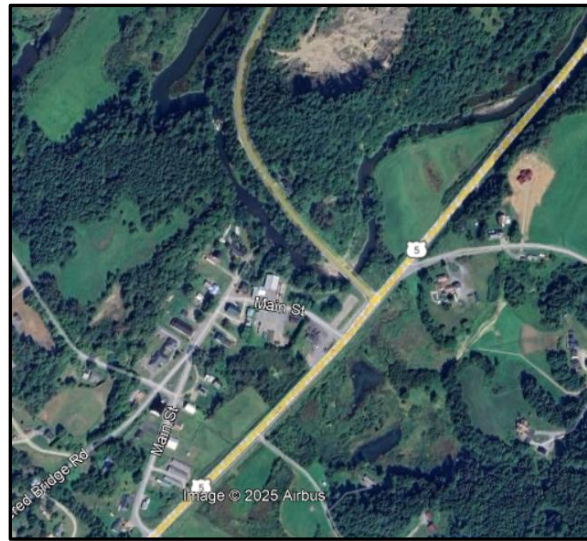
Photo 2a and 2b. Aerial view of the town in 1963 (left) and 2024 (right). The Rte 105 bridge had recently been built in 1963, however, Rte 5 had not yet been realigned.

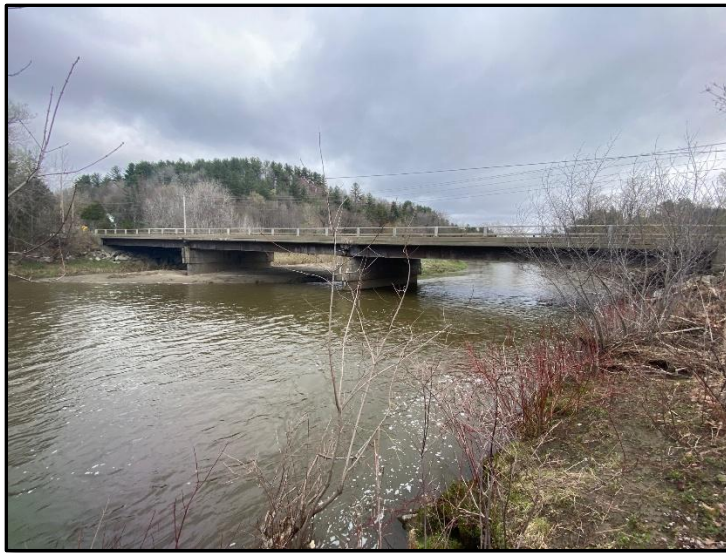
Photo 3. Looking at the Rte 105 Bridge from upstream to downstream

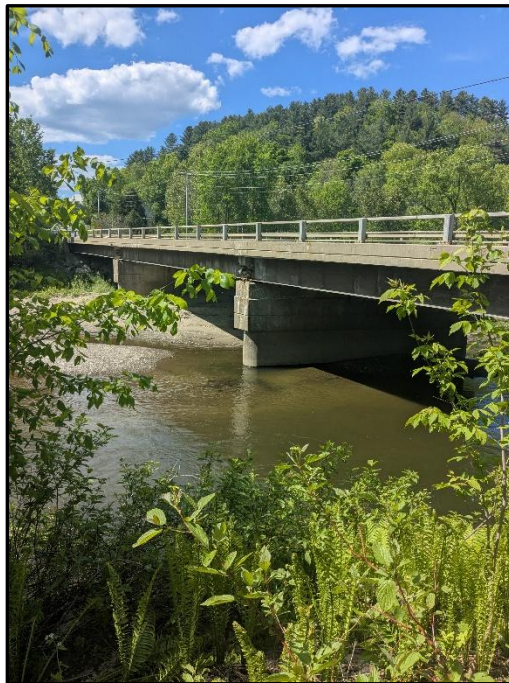
Photo 4. Looking at the Rte 105 Bridge from the right bank towards the left bank

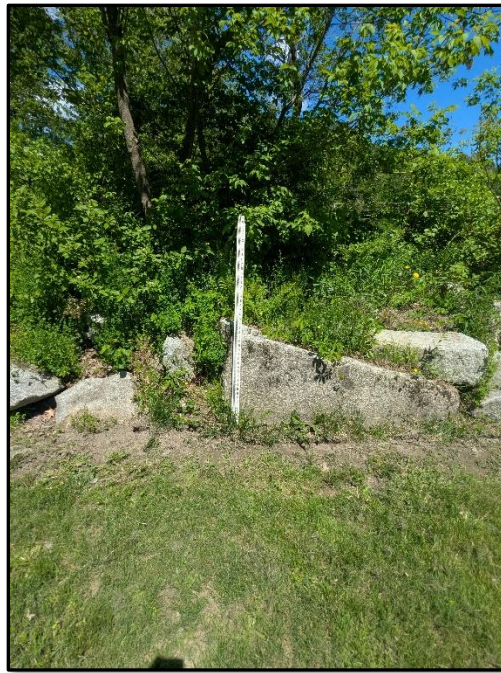
Photo 5. Large riprap along the right bank just upstream of the Rte 105 bridge. The riprap was placed along the right bank when the bridge was constructed (see Photo 2a.)

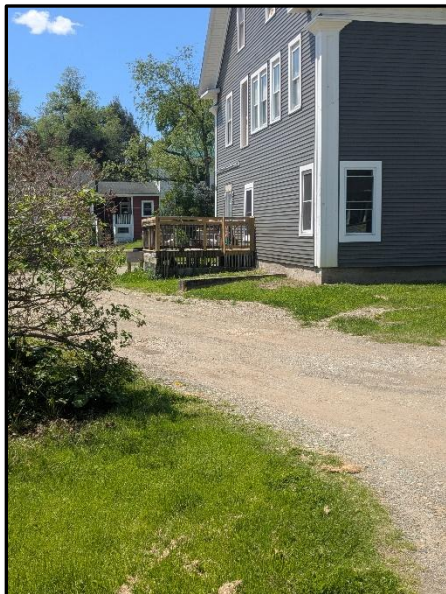
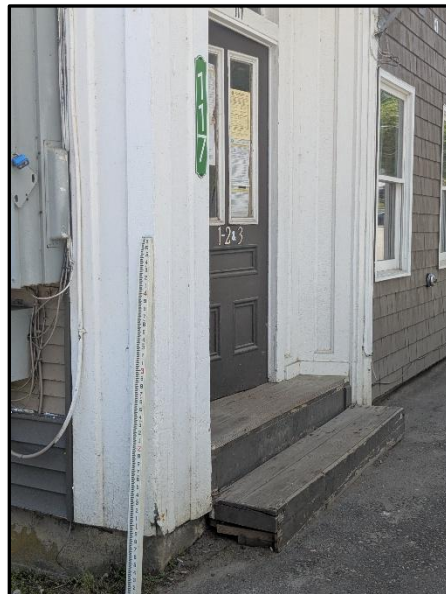
Photo 10a and 10b. Back entrance (left) and front entrance (right) of 117 Main Street. This building has been impacted by the ice jam floods.

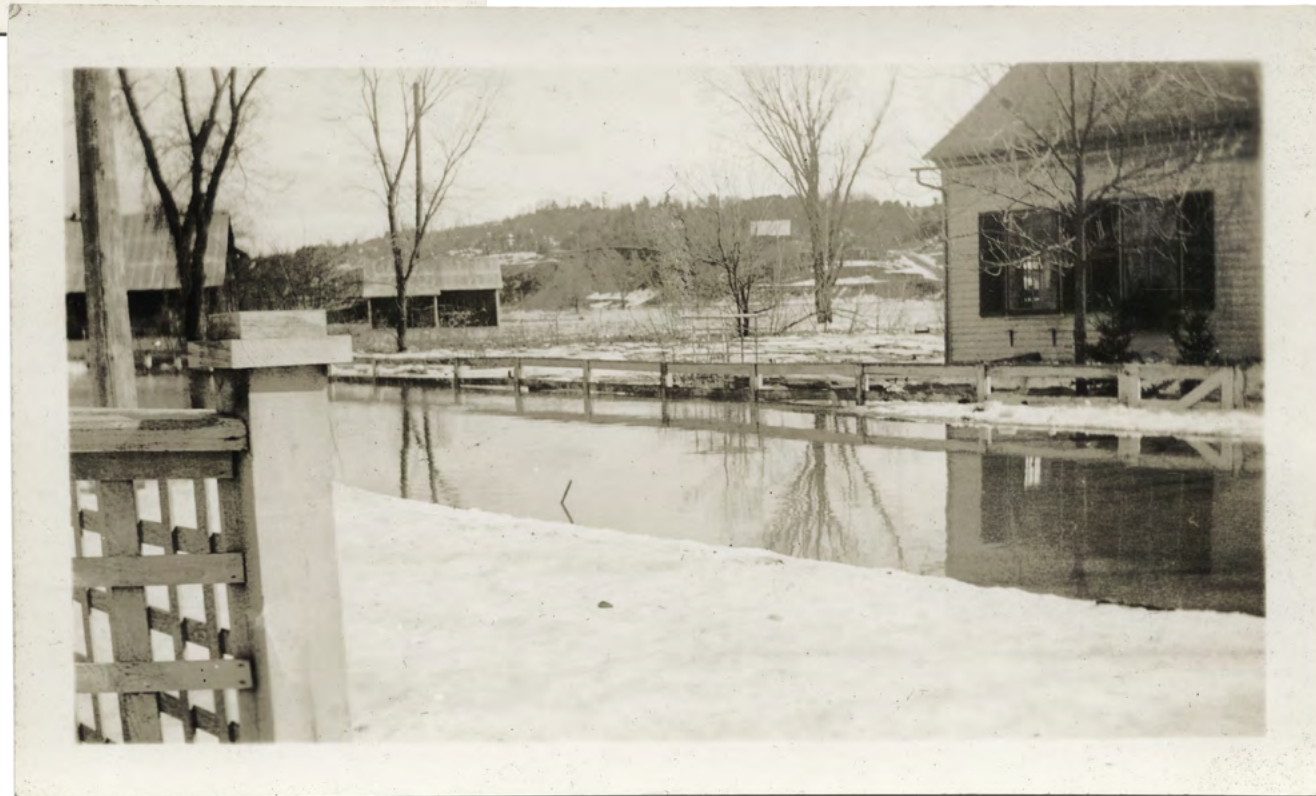
Spring flooding with ice jams on main streets
March 19th 1936 - the Black river is beyond far
fence - river level is same or above that of the street
in these images. Street in foreground with water is
old Rte 14. In far background is Rte 5. Both roads
intersected in the center of the village until 1960.

In terms of ice jam and related flood water height,
ice would have had to be 10 + feet or so in depth to
push water over river banks in village

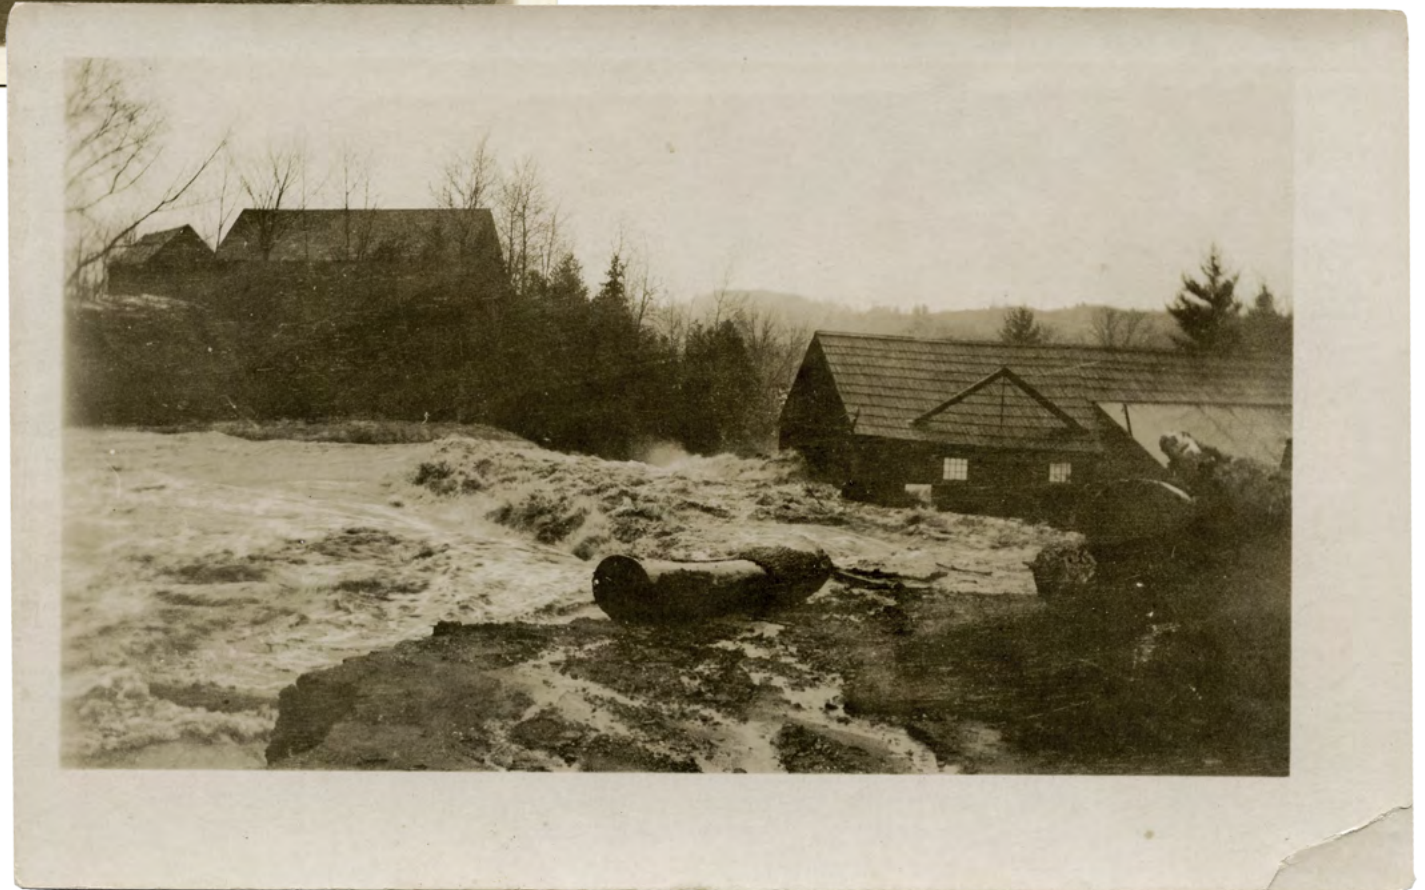
Heerman sawmill inundated and detached from its foundation begins to float over the upper falls in November 1927.

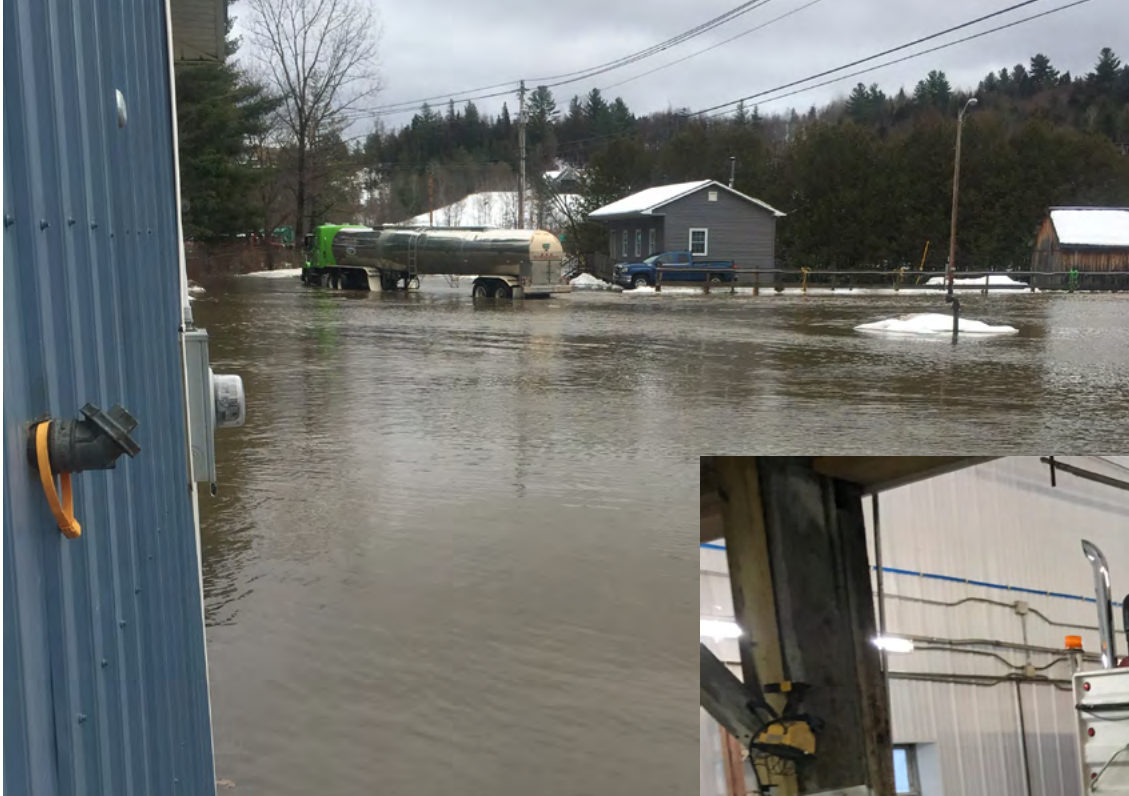
Main street Coventry village

When ice jam occurred, flood water crests very quickly in the middle of the night so no time to remove valuable items! And in January water freezes quickly

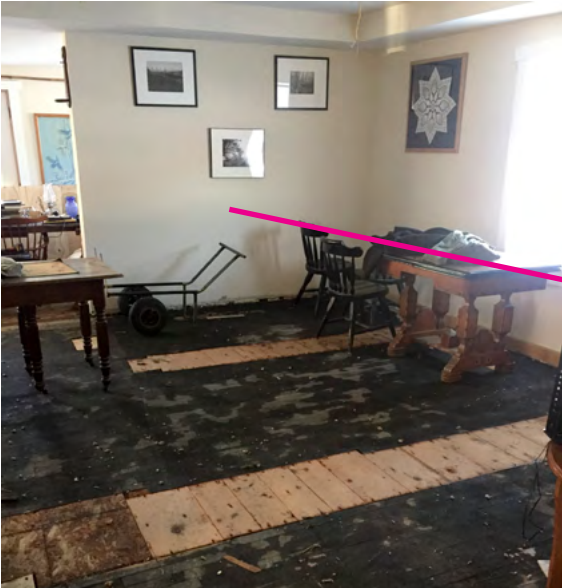
Note wet drywall to water depth

Soon after removal of carpeting

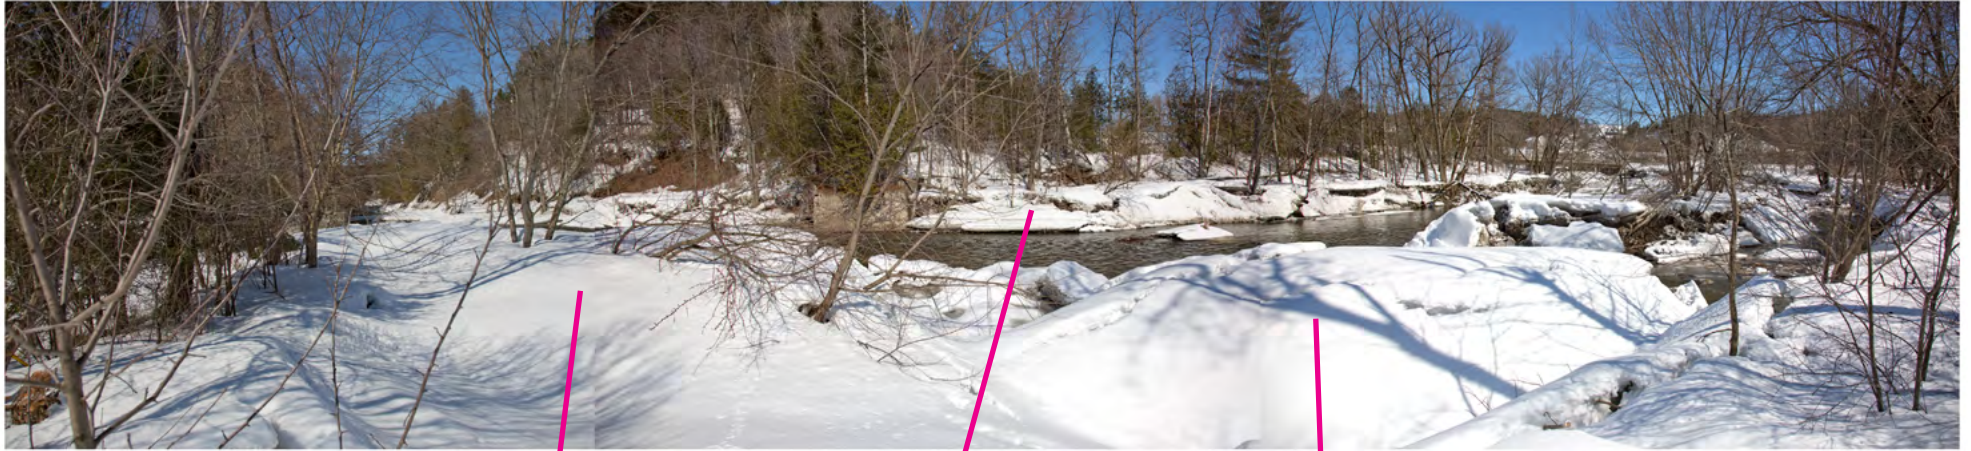
Black River, remains of late December 2018 ice jam (3rd ice jam in 2018) This photo taken in mid-March 2019. River channel opening with thawing. Ice jam under this snow pack is 8-10 feet deep in places

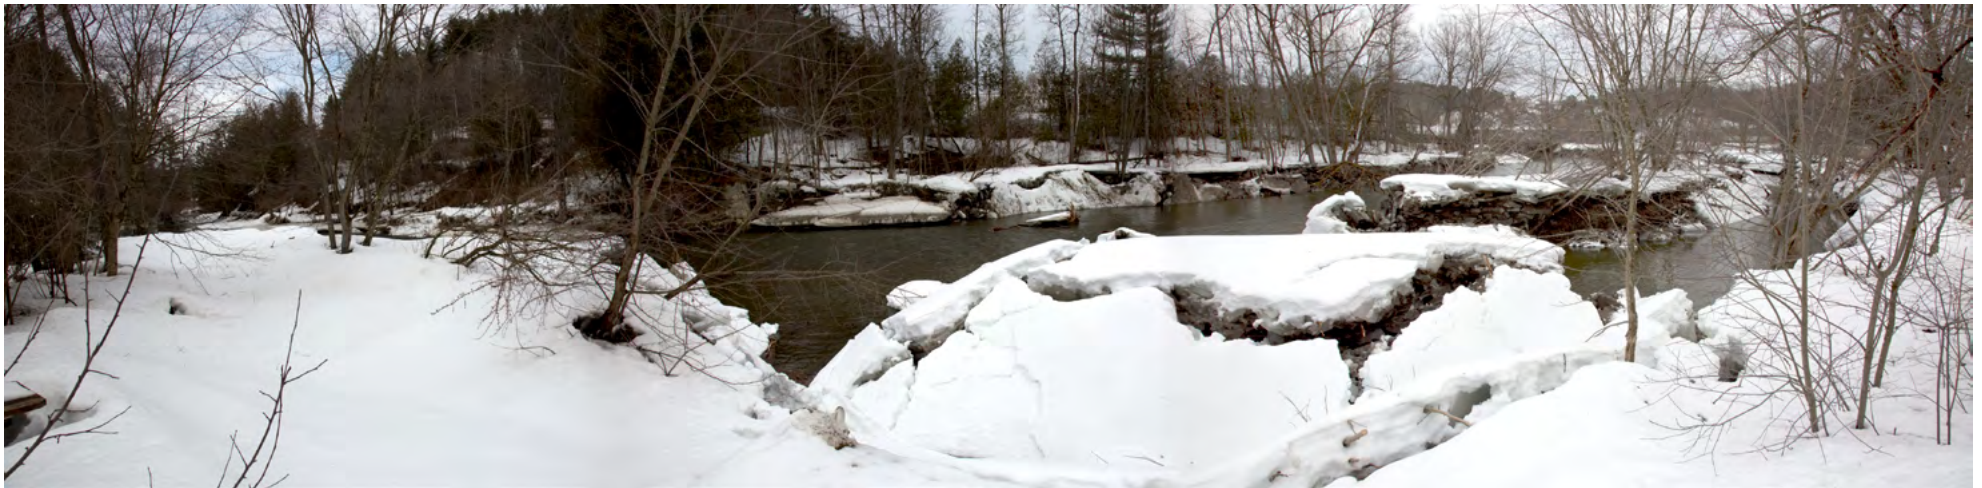
Black River, late-March 2019. River channel opening with more thawing.

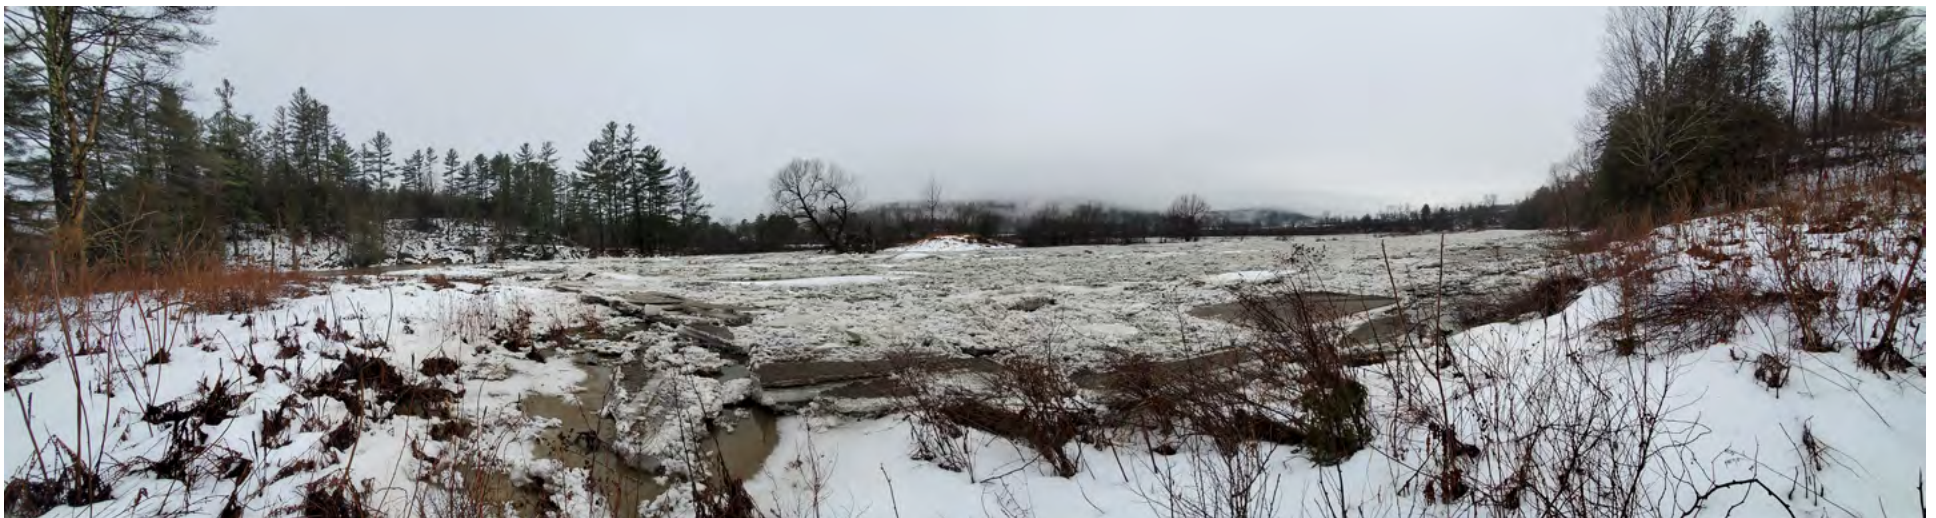
Coventry ice jam January 12, 2020 Ice jammed in oxbow upstream from village. Fortunately, this jam froze and did not inundate the village below

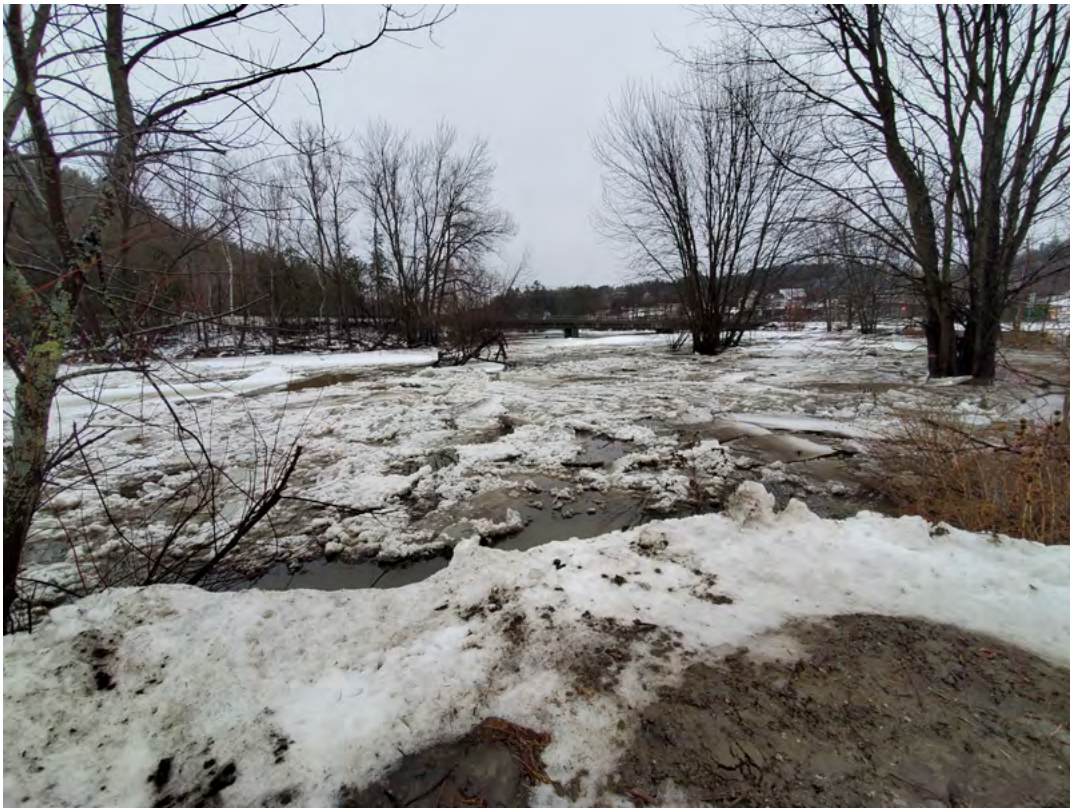
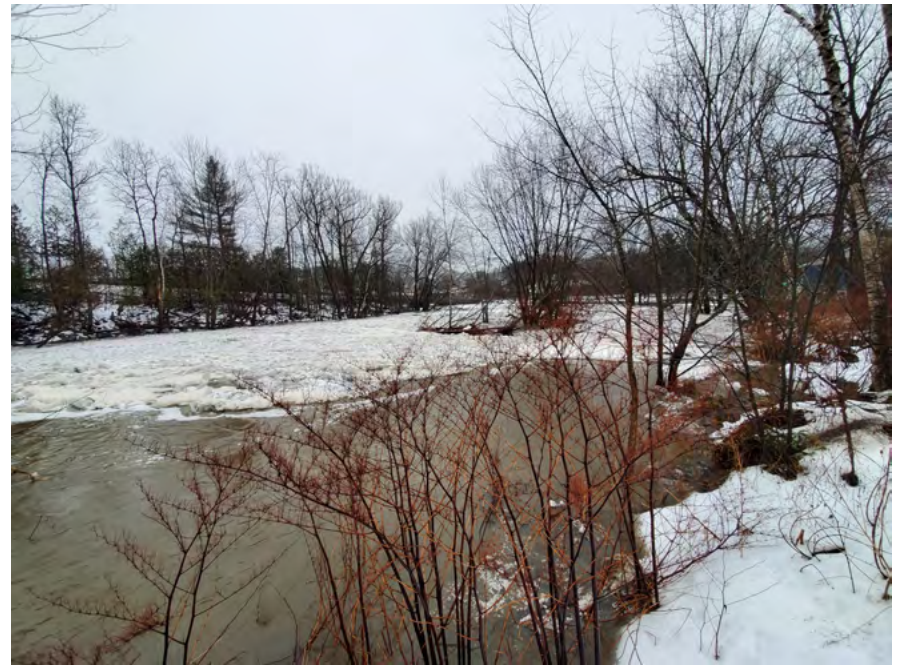
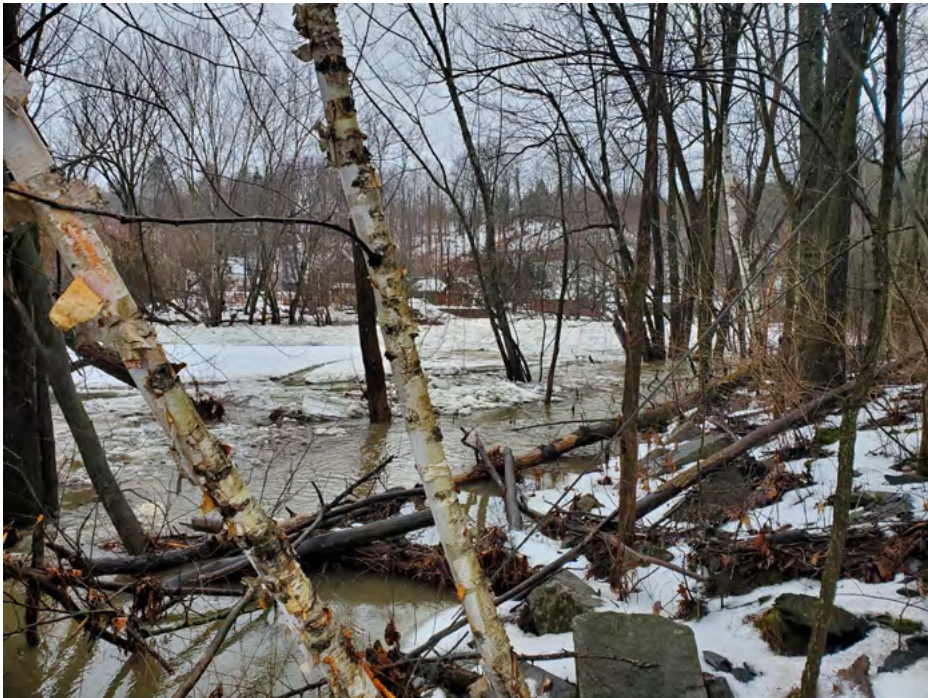
Jan 12, 2020 ice jam at village and above Rte 14 village.

Note: ice pack almost at height of right bridge support girder
